Observations of Mining Activities in Siskiyou National Forest Riparian Reserves and Probable Impacts to Aquatic Organisms

March 7, 2002

Richard K. Nawa
Siskiyou Project
213 SE "H" Street
Grants Pass, Or 97526
541-476-6648
rich@siskiyou.org

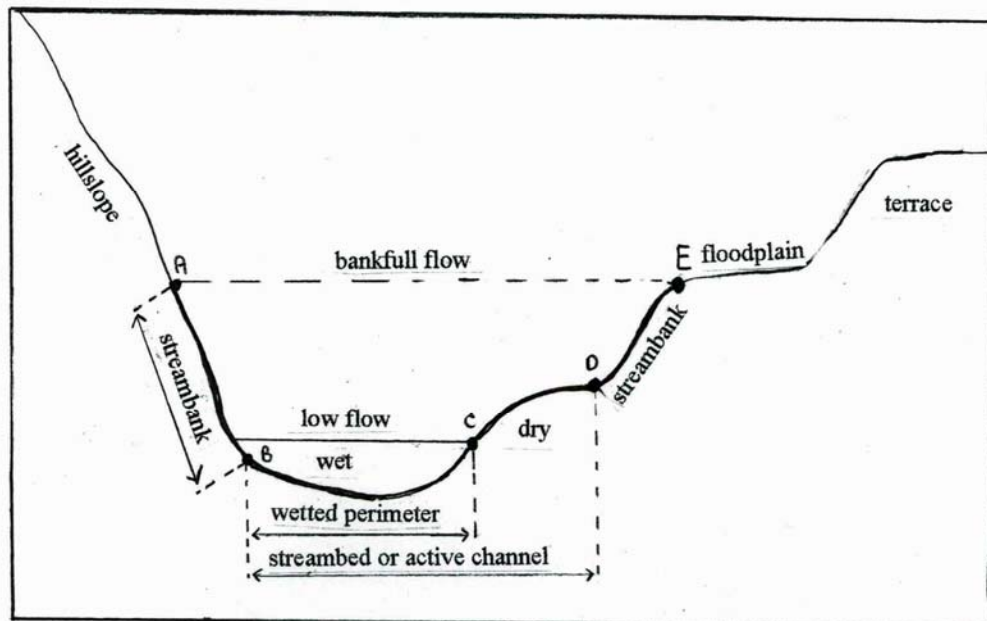
Figure 1. Generalized cross-section of a small mountain stream during summer low flows. The lower extent of the streambank is identified by a change in slope from near vertical to horizontal. Streambanks are steeply sloping or near vertical. The streambed is gently sloping to nearly horizontal. At least one streambank usually extends into the wetted perimeter (the lowermost portion of streambank A-B).

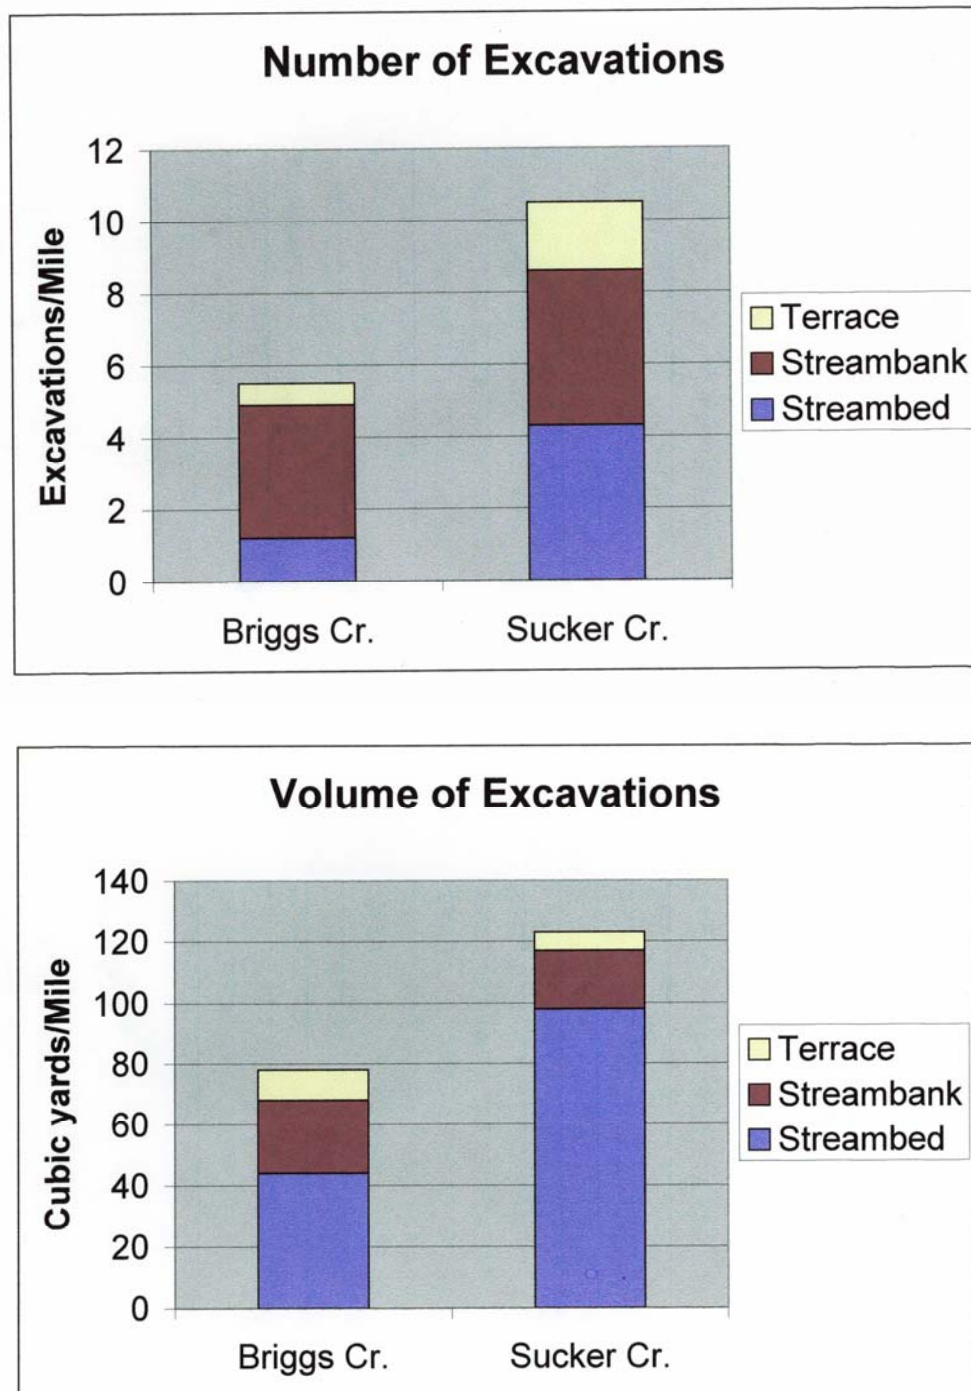
Figure 2. Number (top) and volume (bottom) of excavations from suction dredging along Sucker Creek and Briggs Creek during 2000-2001.

Streambank excavations were the most common kind of physical impact found, but streambed excavations had higher total volumes (Table 1, Figures 2-5). Most streambank excavations followed the streambank contour but in at least four locations trenches up to 12 ft long were excavated perpendicular to the streambank. Streambank excavation length ranged from 3-88 ft and averaged 18 ft. Estimated volumes of streambank excavations ranged from 0.3-27 yds³ and averaged 6.1 yds³.
