Upper Slate River Watershed Plan Executive Summary

Prepared For:
The Coal Creek Watershed Coalition
Upper Slate River Steering Committee
PO Box 39 Crested Butte, CO 81224
www.coalcreek.org

Prepared By:
Ashley Bembenek
Alpine Environmental Consultants LLC

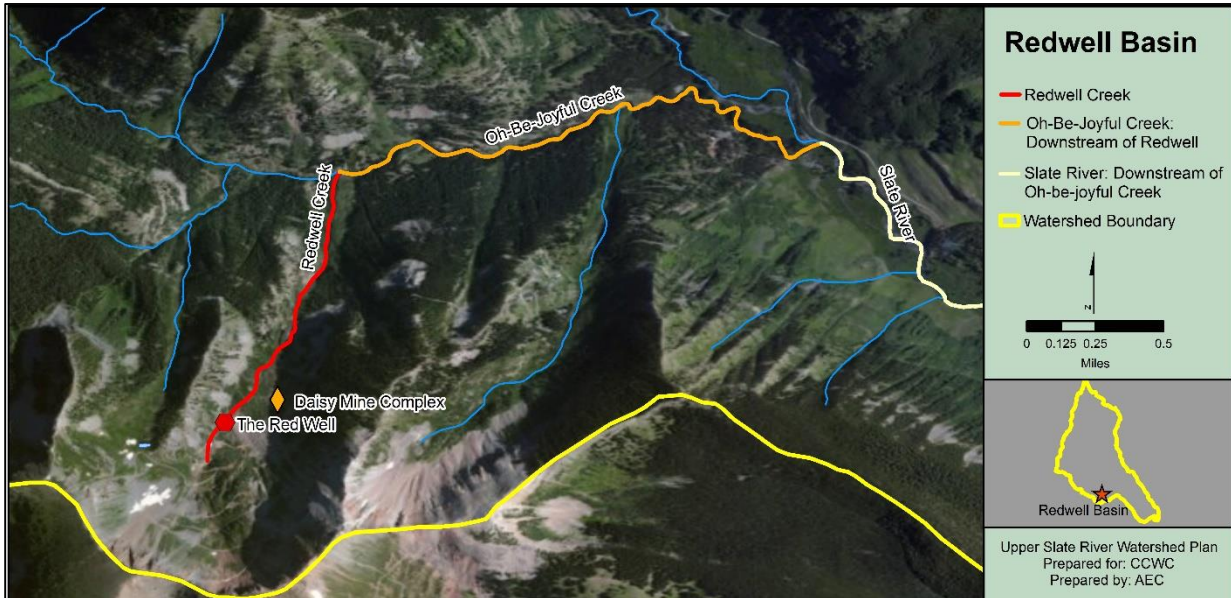
Metals that originate from historic abandoned mines and natural features pollute Redwell Creek. Redwell Creek, which has elevated concentrations of several metals, flows into Oh-B-Joyful Creek which is tributary to the Slate River. The effect of metals from Redwell Basin is apparent in Redwell Creek, Oh-Be-Joyful Creek and the Slate River.

The water quality standards assessment painted a clear picture. Metals that originate from historic abandoned mines and natural features impair water quality in Redwell Creek. Redwell Creek and the adjacent features accounted for seventy-five percent of the water quality exceedances. Redwell Creek delivers metals to Oh-Be-Joyful Creek and Oh-Be-Joyful Creek below Redwell Creek accounted for ten percent of the exceedances. The water in Oh-Be-Joyful Creek above Redwell Creek generally met all water quality criteria and accounted for less than one percent of the exceedances. Conservatively, Redwell Basin was the origin of eighty-five percent of the pollution in the Watershed. Although Oh-Be-Joyful Creek provides dilution, it is evident that metals that originate in Redwell Creek reach the Slate River. The Slate River below Oh-Be-Joyful Creek accounted for ten percent of the exceedances. The Slate River above Oh-Be-Joyful Creek typically met water quality criteria; only two percent of the evaluations exceeded applicable standards. Water quality exceedances in tributaries to the Slate River, including poverty Gulch, accounted for just over one percent of the exceedances.

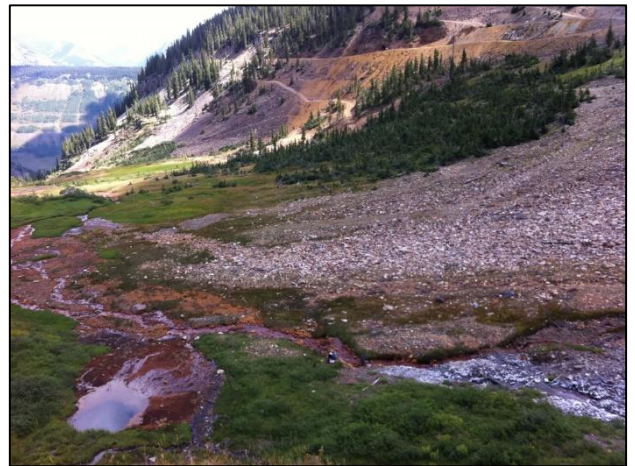
A view of Redwell Basin. The orange slopes on the upper right of the photo are a part of the Daisy Mine, the drainage tunnel is located in the lower portion of the mine waste. In the lower right of the photo, flow from the Drill Hole enters Redwell Creek. The Redwell is in the lower left of the photo. Photo Credit: Nicki DeVanni (2011).

In the early 1970s, many holes were drilled to characterize the molybdenum deposit beneath Mount Emmons. In Redwell Basin a drill hole, located in the upper portion of the basin, was improperly abandoned. The Drill Hole penetrates the molybdenum deposit and allows water to flow under pressure to the surface. It delivers poor-quality groundwater to Redwell Creek. At the Drill Hole, metal concentrations increased dramatically over upstream locations in Redwell Creek.

The Redwell is the naturally-occurring namesake of Redwell Basin. The Red Well is approximately 2,800 years old. The age was established by analyzing an iron oxide, called ferricrete, collected from the edge of the Red Well. The age indicates the feature is natural, not man-made. Metal concentrations measured at the Red Well are elevated, and occur in ratios similar to those found at the Drill Hole, but in lower concentrations. This suggests the two features share source waters, groundwater associated with the molybdenum deposit and the adjacent mineralized fracture network, but additional dilution occurs at the Red Well. Small seeps and wetland vegetation up-gradient of the Red Well indicate the area is saturated regularly. Given the hydrology of wetlands, some dilution with surface or groundwater is likely at the Red Well.
