Southside Project

Proposed Scotsman Creek Stream Bank Restoration - 2016 Jason Farmer Fisheries Biologist, Nantahala National Forest

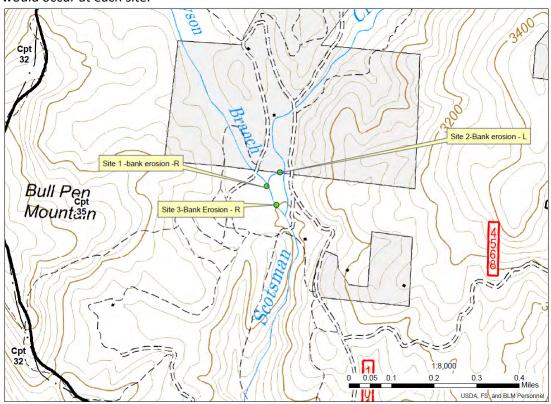
Figure 1. Locations of 3 eroding stream banks. Installation of a log j-hook and toe wood structures would occur at each site.

Three locations along Scotsman Creek (Figure 1) are currently experiencing severe stream bank erosion. Each site has high, steep banks which are contributing sediment to Scotsman Creek. Each site is approximately 50 feet in length (linear length of stream bank) but actual length of ground disturbance may be approximately 100 feet when installing structures. Approximately 100 feet (measured from top of bank perpendicular to stream flow) of material may need to be excavated at each site to construct toe-wood structures, log j-hooks, and multi-stage flood plain.

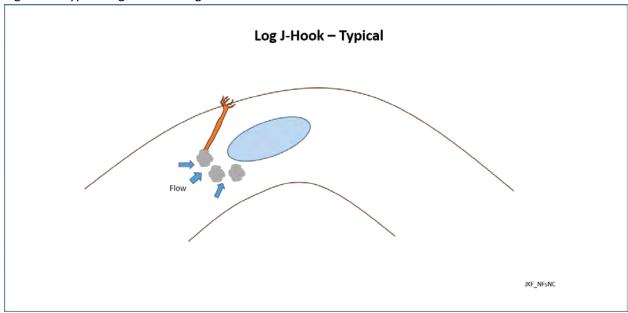
Figure 2. Typical log J-hook design.

Log J-hook installation would consist of utilizing locally a sourced tree with its root wad attached. The tree would be placed into the stream channel using an excavator. The root wad would be placed at an elevation of ½ the stream's bankfull height in the eroding bank (Figure 2). The trunk of the tree would be placed in the channel with its end buried in the substrate, directed upstream.

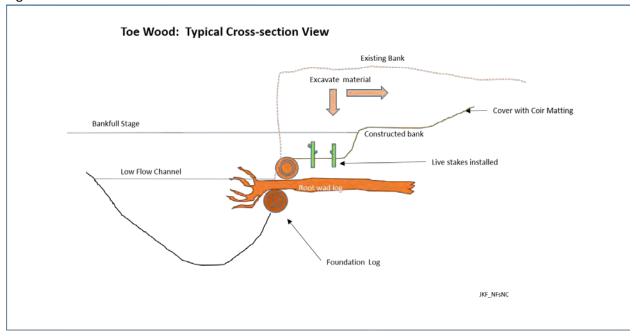
Figure 3. Cross-sectional view of toe wood structure.

The top of the eroding bank would be excavated down to approximately ½ bankfull to allow for the installation of toe wood structures (Figure 3). Locally sourced logs with root wads attached would be used to construct a bank at this new elevation. The new bank would provide a bankfull flow bench and an additional small floodplain before connecting with the existing floodplain. This multi-stage floodplain would reduce the potential for stream bank erosion and chronic sedimentation of the stream.

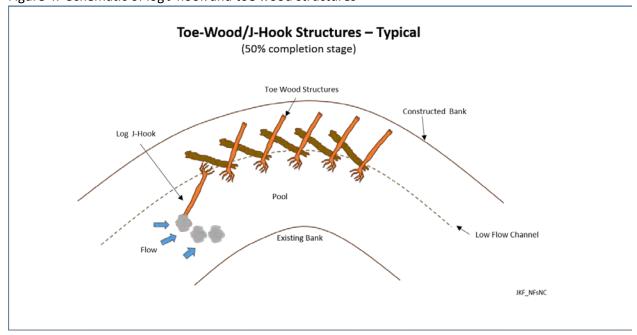
Figure 4. Schematic of log J-hook and toe wood structures
