Studies of fish passage through culverts in Montana

STUDIES OF FISH PASSAGE THROUGH CULVERTS IN MONTANA

Matt Blank (Phone: 406-994-6651, Email: blank@montana.edu) and
Joel Cahoon (Phone: 406-994-5961, Email: joelc@ce.montana.edu), Montana State University,
Department of Civil Engineering, 205 Cobleigh Hall, Bozeman, MT 59717,
Drake Burford (Phone: 406-585-8201, Email: drake@adc-services.com), P.O. Box 582, Livingston,
MT 59047,
Tom McMahon (Phone: 406-994-2492, Email: tmcmahon@montana.edu), 301 Lewis Hall, Bozeman,
MT 59717, and
Otto Stein (Phone: 406-994-6121, Email: ottos@ce.montana.edu), Montana State University,
Department of Civil Engineering, 205 Cobleigh Hall, Bozeman, MT 59717

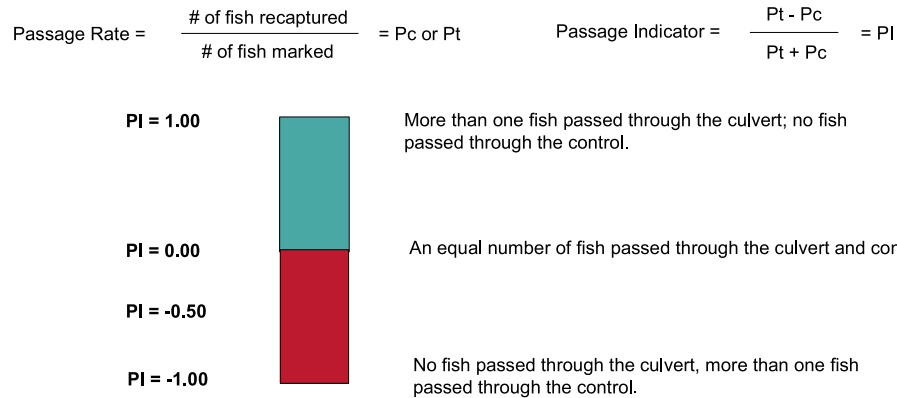
Several comparisons were made to analyze the direct-passage data. Figure 3 shows how we calculated the passage rate and passage indicator. We then used both simple and multiple linear regression to evaluate the effect of physical characteristics including culvert slope, outlet drop, culvert length, water depth, change in slope (between upstream channel slope and culvert slope), and constriction ratio on the passage indicator. The constriction ratio was calculated as the ratio of the culvert width to the average bankfull width. Mann-Whitney tests were used to assess whether the recaptured fish in the treatment had similar lengths to the recaptured fish in the control.

Figure 3. Diagram showing how the passage rate and passage indicator were calculated for each direct-passage study.

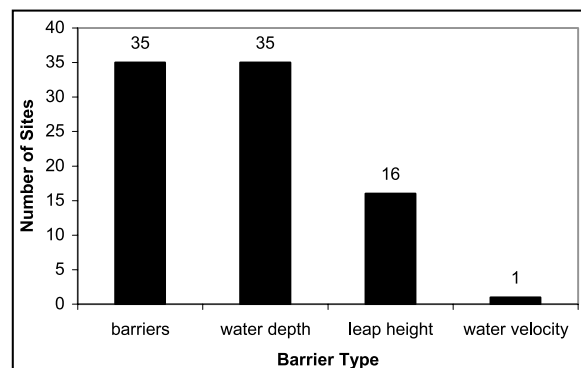
FishXing identified 35 of the 46 culvert sites as barriers at low flow for adult fish. Figure 4 summarizes the type of barrier designation (insufficient depth, excessive leap, or water velocity). All 35 of the barrier culverts were identified as having insufficient water depth. It should be noted that some culverts were designated as having multiple types of barriers, insufficient depth, and excessive leap for instance. Six of the 11 culverts that were not identified as water-depth barriers simulate natural channel conditions. Therefore, these sites were considered passable at low flow. These sites were analyzed with FishXing by changing the settings to indicate the culvert was embedded and increasing the roughness to a value equivalent to the substrate size in the culvert. FishXing protocol recommends caution when analyzing culverts with substrate bottoms as the physics of 1-D hydraulics cannot account for irregular flow patterns that will exist as water moves over the irregular substrate surface. These irregularities provide reduced velocities and micro-eddies that the fish, especially juvenile fish, can utilize to pass. It is interesting to note that FishXing identified five of the six pipes with natural channel beds as barriers to adults because of insufficient water depth.

Figure 4. Barrier determinations for low flow adult fish analyses by FishXing. We used a minimum water depth of 3 cm for low flow based on size of adult fish, observed water depths in natural channels and conditions fish moved through without impedance as observed during direct passage experiments.

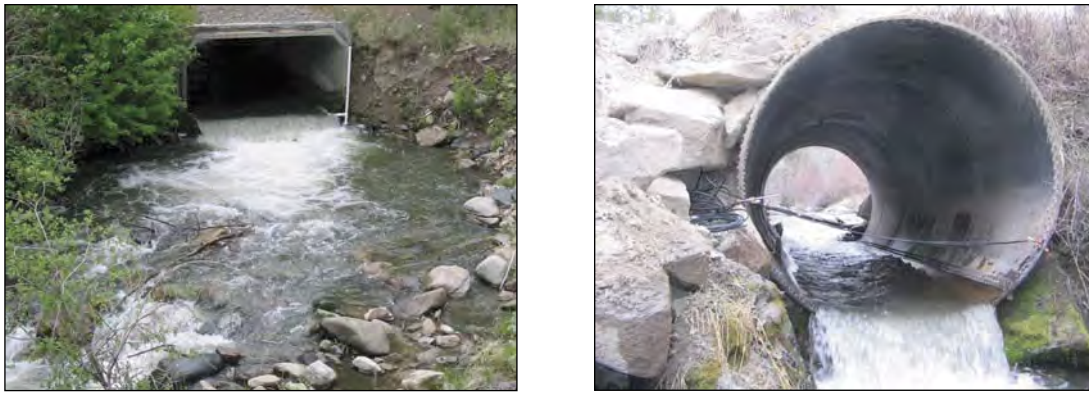
Figure 2A. The outlet of culvert 1, a box pipe (l), and the outlet of culvert 4 (r).

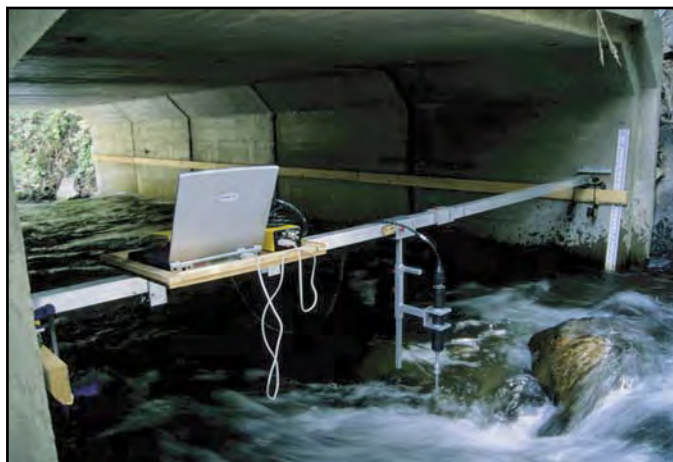
Velocity data were collected as sets in culvert 1 and culvert 2 with the aid of a trolley system. Figure 3A shows the Acoustic Doppler Velocimeter (ADV) collecting data in culvert 2. The trolley system allows for an absolute minimum of flow disturbance as the instrument is the only object to penetrate the flow field. These sets comprised combinations of inlet-velocity profiles and plan-view profiles. Velocity measurements were collected using both a pygmy current meter and an ADV. The pygmy current meter was set to collect average velocities at 30-second averaging periods. The ADV was set to sample at 25 Hz for a minimum of 1 minute. The ADV collects velocities in three directions: x, y, and z. The high frequency of the ADV allows for some estimation of point turbulence. The density of point-velocity measurements varied according to the dynamics of the flow in the culverts. During periods of fluctuating flow, as experienced on the rising and falling limbs of the spring runoff hydrograph, data sets were collected in less than 6 hours. Late in the summer, when flows were more stable, data sets were collected over a period of time that ranged up to two days. A typical inlet-velocity profile would include data collected at every 15-cm horizontal and 3-cm vertical. Plan-view velocity data sets were typically collected at a height of 6 cm above the culvert bed, with horizontal spacing of 15 cm and longitudinal spacing of 1.5 m.

Figure 3A. ADV harness in culvert 2 inlet region.

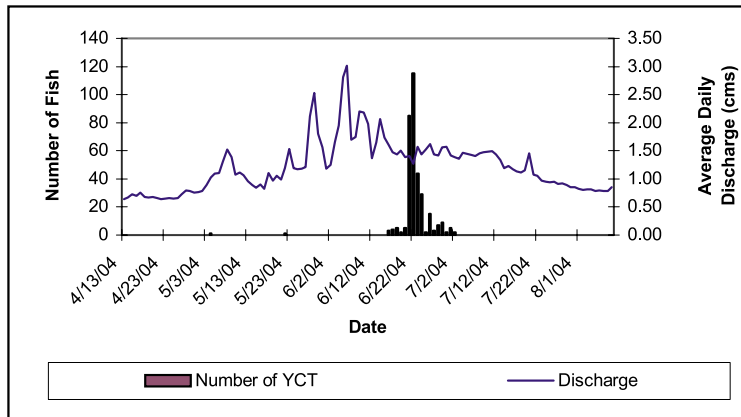
A total of 390 fish were captured and cataloged during the course of the 2004 fish collection portion of the project. The predominant species collected was Yellowstone cutthroat trout, at a total of 339. Figure 6A compares the average daily flow observed during the period from May 1 to August 31, 2004 against the number of YCT captured. The fish were observed to enter in mass during the falling limb of the hydrograph when water temperatures consistently reached 12° C during the afternoon hours.

Figure 6A. Average daily flow compared to number of YCT captured, summer 2004.
