Report No. CDOT-DTD-R-2005-12
Final Report

FACTORS IMPACTING THE HEALTH OF ROADSIDE VEGETATION

Nichole A Trahan and Curt M. Peterson
University of Northern Colorado

COLORADO DEPARTMENT OF TRANSPORTATION
RESEARCH BRANCH

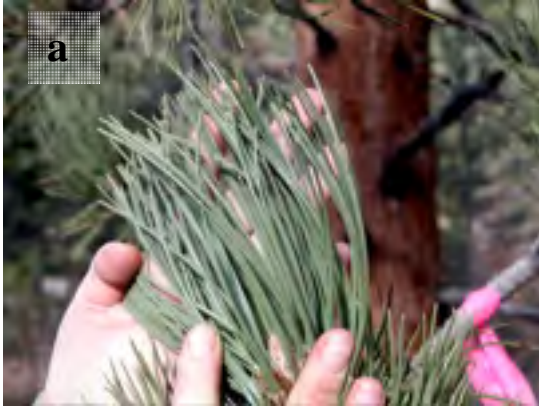
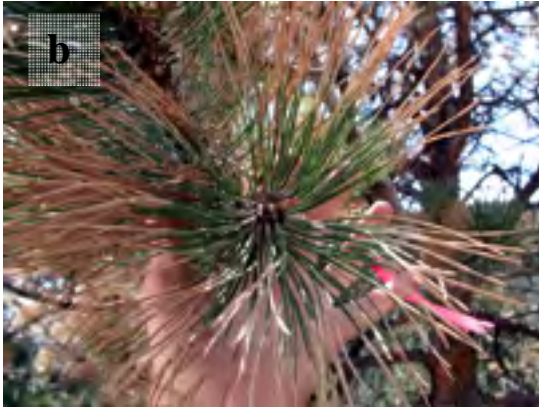
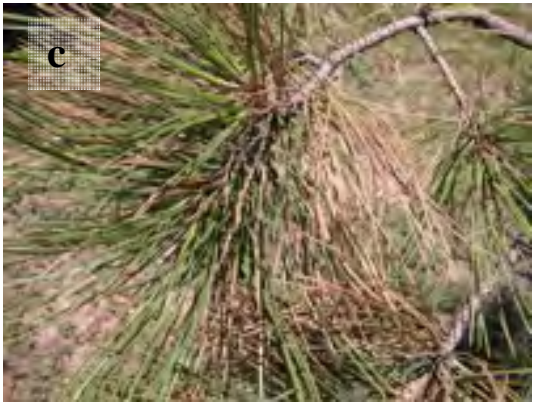
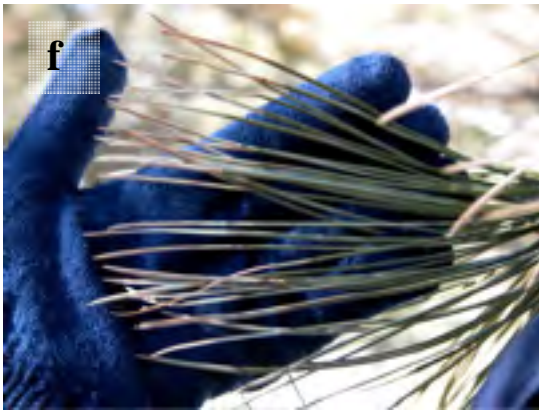
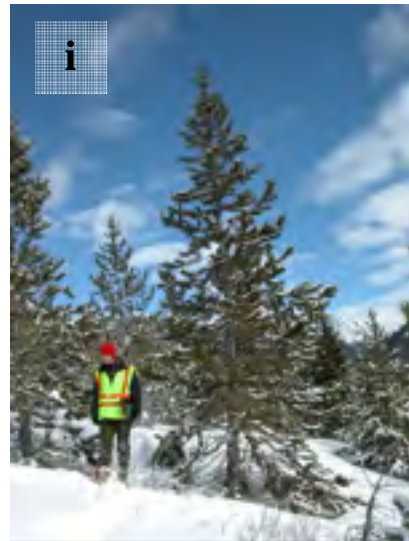
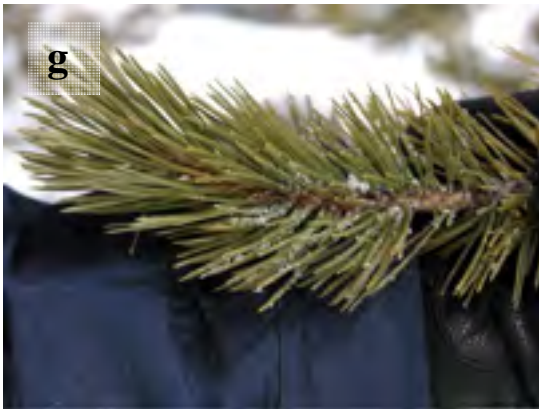
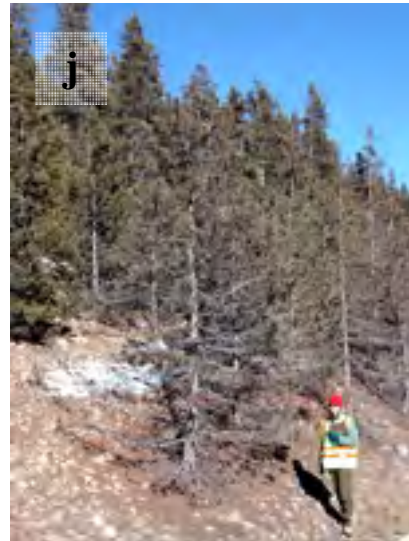
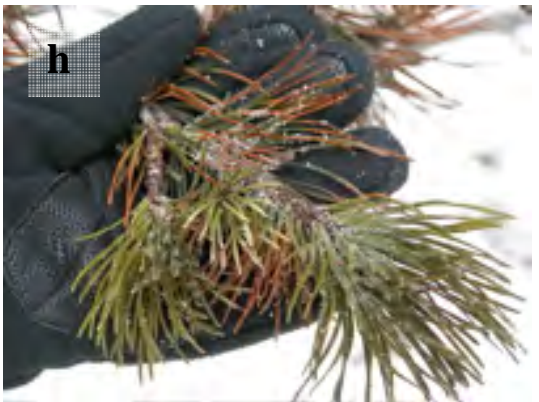
Figure 2. Comparisons of foliage health in studied conifers adjacent and distant from the roadside. *a:* *P. ponderosa* needles away from roadside, site 121H. *b:* *P. ponderosa* needles adjacent to the roadside exhibiting necrosis from the tips, site 122D. *c:* *P. ponderosa* needles adjacent to the roadside exhibiting necrosis primarily in previous years (older) needle tissues, site 132D. *d:* *P. ponderosa* off-road, site 132D. Note density of foliage. *e:* *P. ponderosa* adjacent to roadside, site 132D. Note scarcity of foliage. *f:* *P. ponderosa* needles adjacent to the roadside exhibiting tip necrosis and banding, site 121H. *g:* *P. contorta* needles from off-road tree, site 111D. *h:* *P. contorta* needles adjacent to roadside exhibiting necrosis in older growth, site 111D. *i:* *P. contorta* away from roadside, site 111D. Note foliage density. *j:* *P. contorta* adjacent to roadside, site 114D. Note foliage scarcity on trees facing the roadside.

In general, damaged needles characteristically displayed necrosis and chlorosis in their tips first, with tissue death advancing to the needle base. In addition, occasional banding in ponderosa pine needles was noted. Observed damage was in all cases concentrated in older needle growth, and was frequently more severe on the side of the tree facing the roadway. Figure 2. displays characteristic foliage damage in roadside ponderosa and lodgepole pines, and provide a comparison with off-road undamaged conifer foliage.

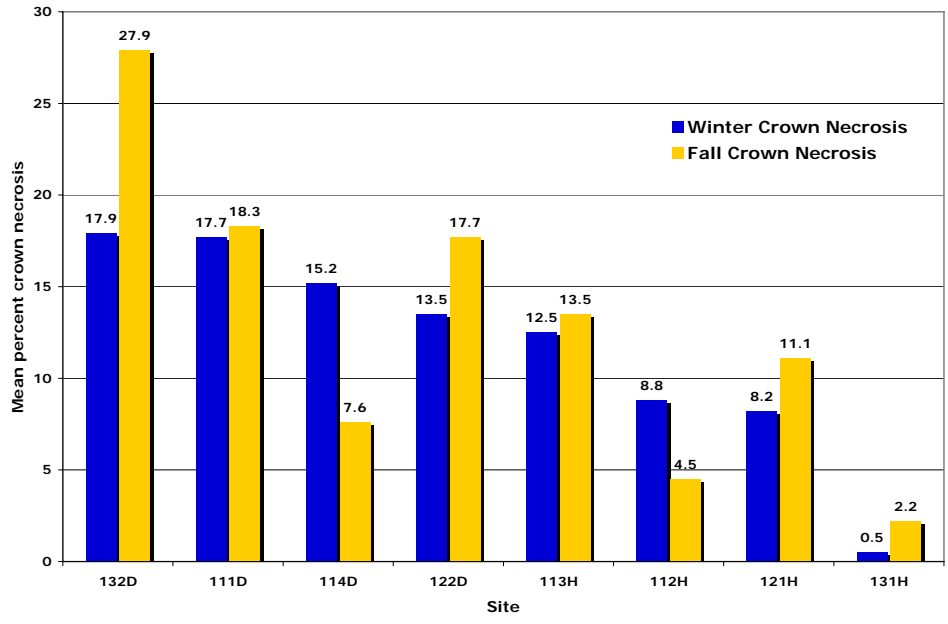
Figure 3. Mean percent necrotic foliage in tree crown in winter 2004 and subsequent fall by field study site

132D, 122D, and 121H, while a decrease in overall necrotic foliage during the growing season was observed in sites 114D and 112H (Figure 3.).

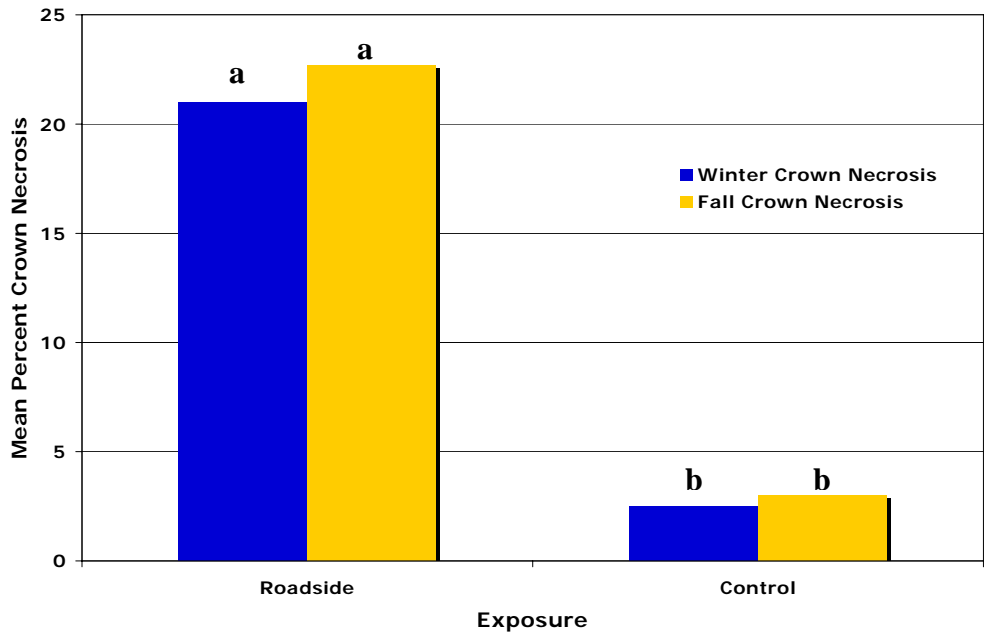
Figure 4. Mean percent crown necrosis in roadside versus control trees across study sites

Across all sites and seasons, trees adjacent to the roadside demonstrated significantly more foliage damage than trees removed from the roadside environment (Figure 4). During the winter, mean percent overall crown necrosis across study sites for roadside conifers was 21.0%, while off-road trees exhibited only 2.6%. In the subsequent fall, mean percent crown necrosis was 22.7%, while control trees exhibited 3.0%. No significant differences were observed between the health observations in the winter and subsequent summer and fall by tree exposure.

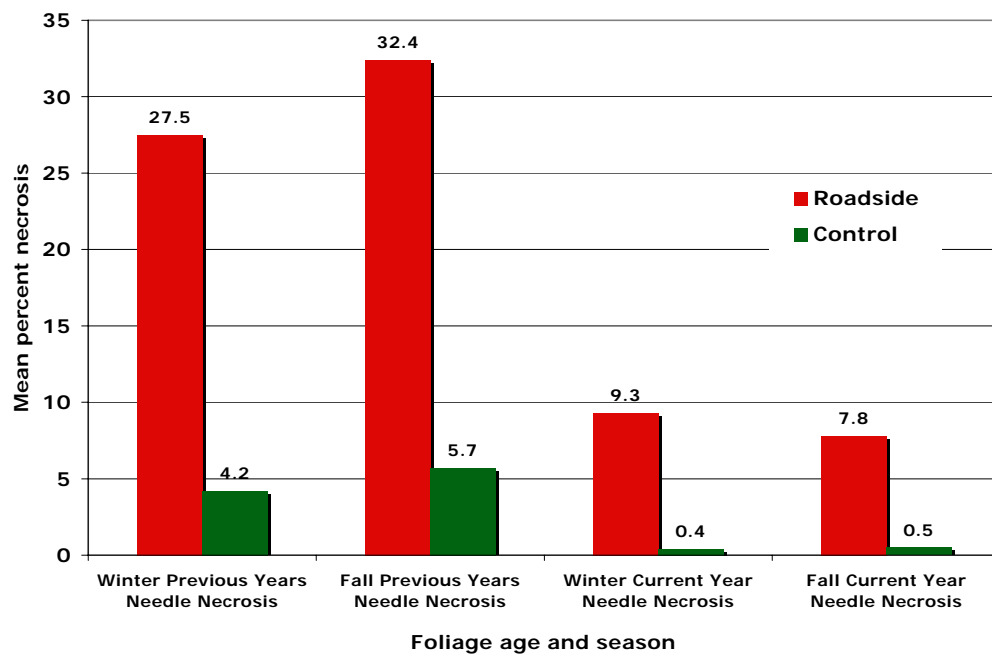
Figure 5. Mean percent necrosis in previous years' needle growth and current year needle growth by tree exposure and season.

Older foliage was more susceptible to damage than new needle growth. Levels of overall crown necrosis, previous years needle necrosis and current year needle necrosis significantly differed from one another ($F = 49.32, p < 0.0001$), differed by exposure ($F = 21.90, p < 0.0001$), and differed over time ($F = 4.39, p < 0.05$). Figure 5. indicates that damage in conifers adjacent to the roadside is concentrated primarily in older needle growth, and that this damage increases in the subsequent growing season but decreases in new growth put out by the trees.

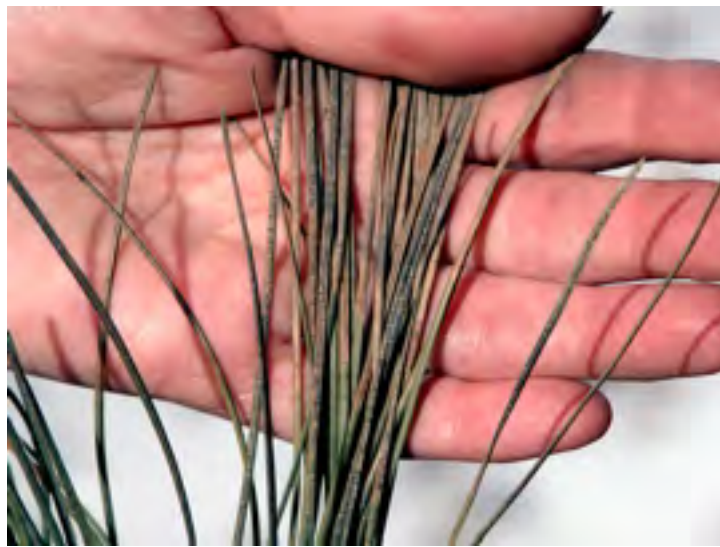
Figure 6. *P. ponderosa* needles from site 132D (Denver) displaying a dark mottling of surface deposits on needle tissue.

Conifer Foliage Exposure to Aerosolized Salts: After field work revealed the presence of a deposited coating on the foliage of roadside conifers (Figure 6.), needle samples from each study site were collected in the winter of 2004 and analyzed through scanning electron microscopy (SEM) for the presence and characteristics of surface deposits. From these analyses, it becomes apparent that trees in proximity to the roadside are more likely than trees further away to exhibit coating on needle surfaces. Presence of needle coating was significantly ($p < 0.0001$) negatively correlated with distance from the roadside, $R^2 = 0.215$.

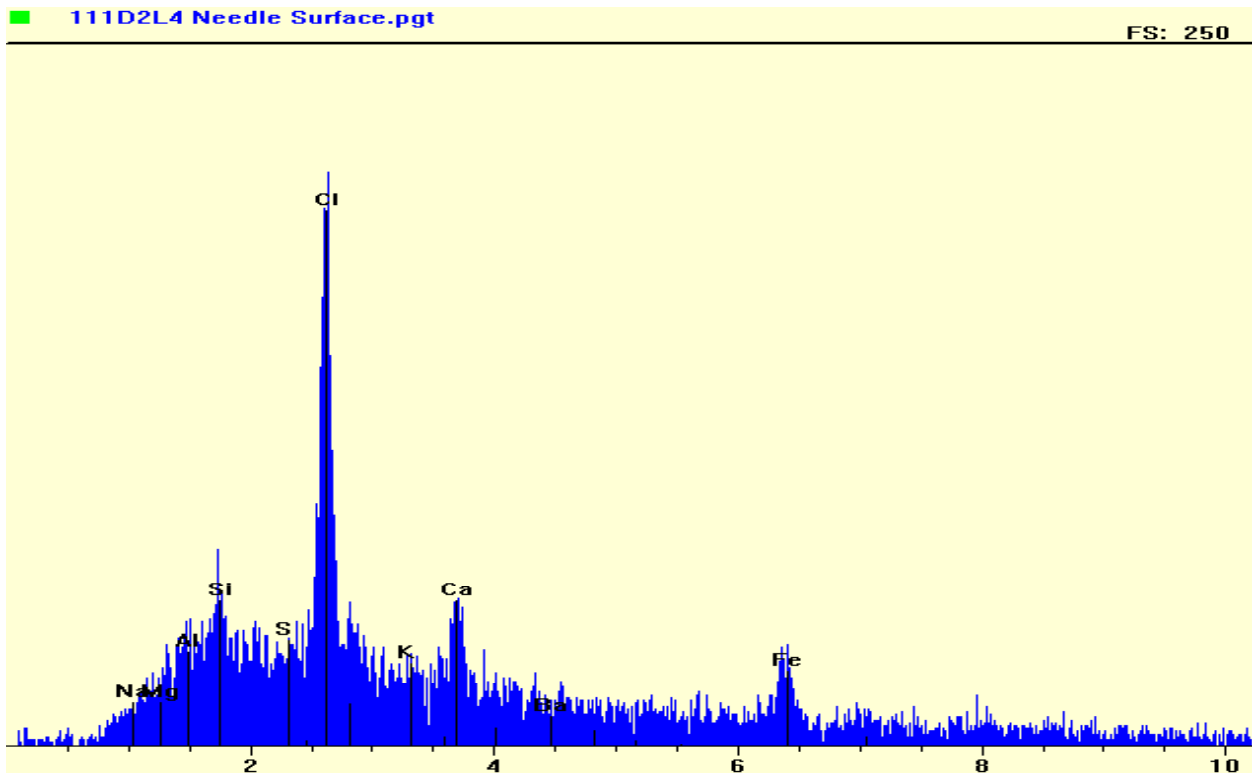
Figure 8. Two elemental analyses of surface deposits on *P.contorta* needles, site 111D (I-70), documenting the presence of Na, Mg, and Cl, as well as minerals associated with quartz and feldspars (see also Figure 7. f).

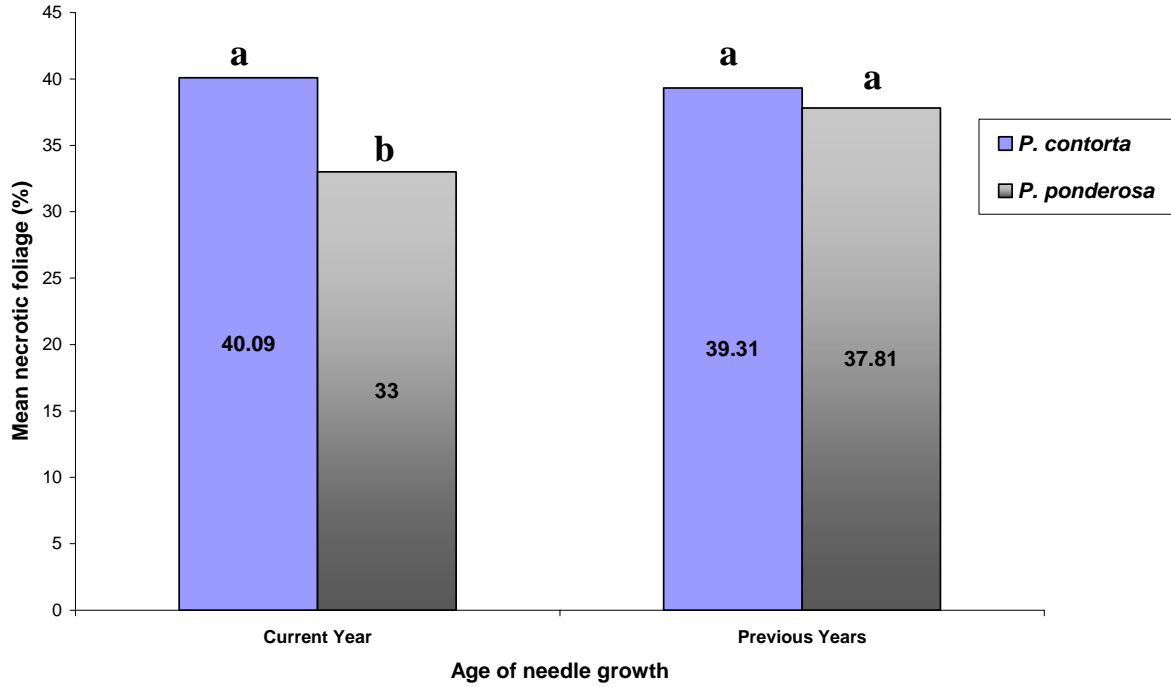
Figure 15. Mean percentage of necrotic foliage in *P. contorta* and *P. ponderosa* saplings across deicer treatment types and concentration levels

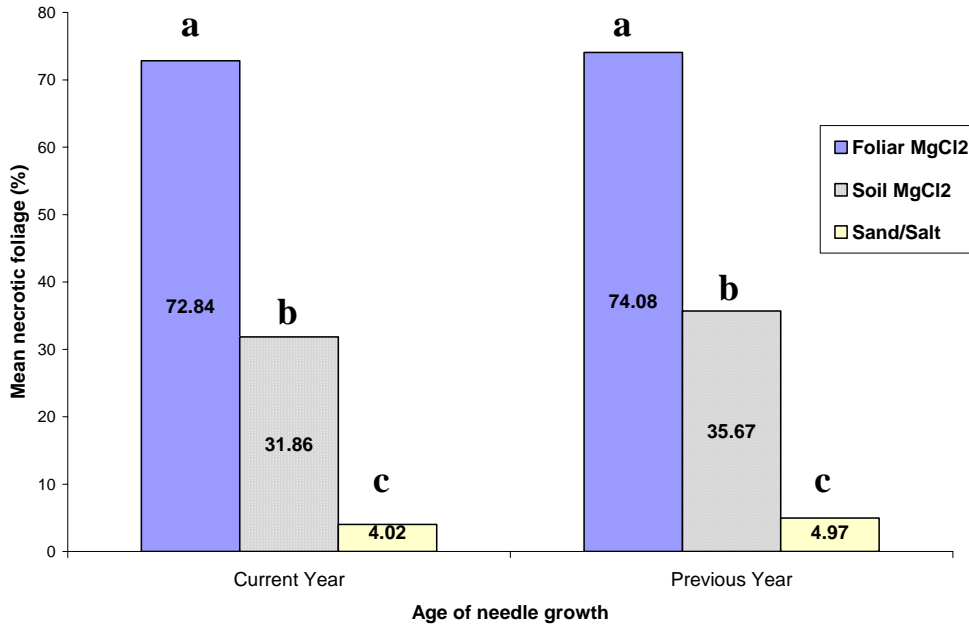
Figure 16. Mean necrotic foliage in current year and previous years needle growth by deicer treatment type

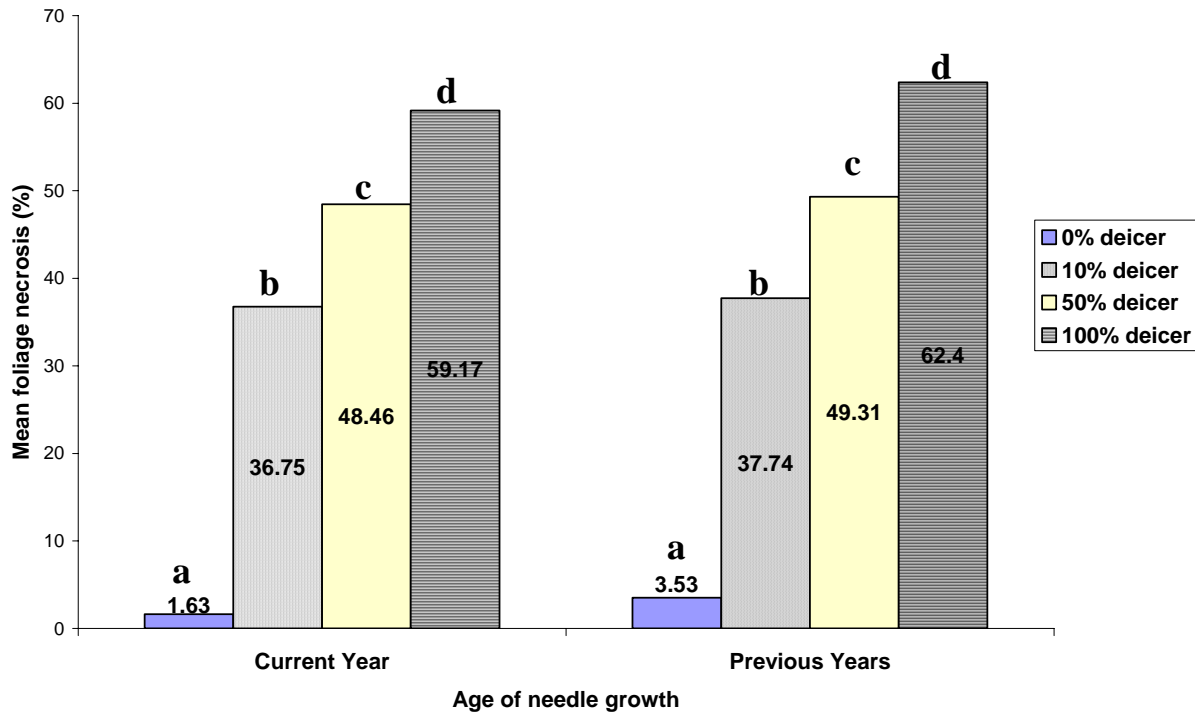
Figure 17. Mean foliage necrosis of current year and previous years needle growth across concentration levels of deicer

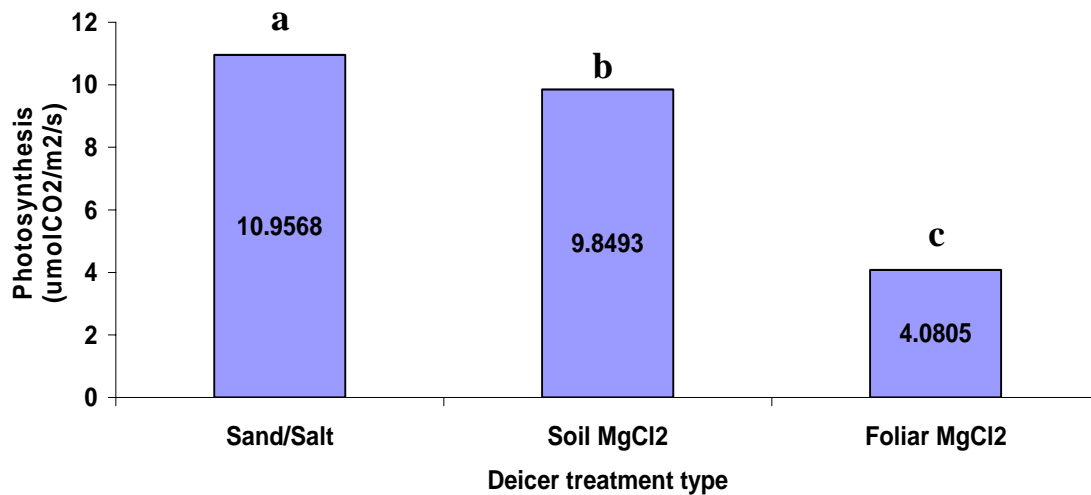
Figure 18. Mean leaf-level net carbon assimilation in relation to initial deicer exposure type

Mean gas exchange characteristics in the conifer saplings varied significantly in response to initial deicer treatment exposure, with a general greater inhibition of physiology observed in saplings treated with liquid $MgCl_2$ based deicers than solid sand/salt deicer for photosynthesis and stomatal conductance. Leaf-level net carbon assimilation (photosynthesis) in the saplings varied significantly by each deicer treatment type via Bonferroni post-hoc comparisons ($\alpha = 0.05$, $n = 96$). Saplings measured immediately after exposure to $MgCl_2$ deicer applied to the foliage in a fine mist exhibited lower gas exchange parameters. Saplings exposed to $MgCl_2$ deicer through the soil matrix also demonstrated lower overall levels of initial leaf-level photosynthesis than saplings treated with sand/salt applications to the soil (Figure 18.).

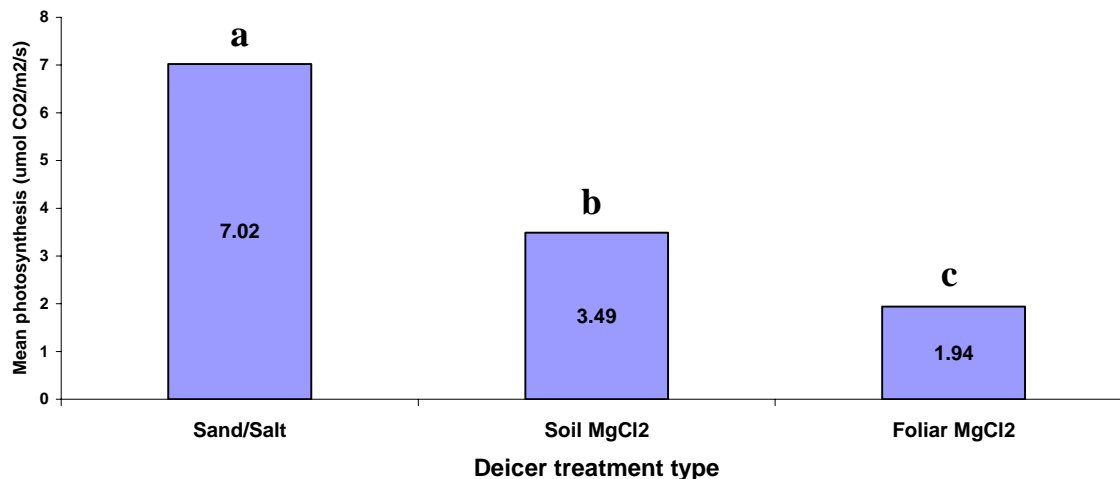
Figure 19. Mean post treatment leaf-level net carbon assimilation in saplings exposed to varying deicer treatment types.

Additionally, according to Bonferroni post hoc comparisons ($\alpha = 0.05$), saplings exposed to sand/salt treatments demonstrated higher overall levels of net carbon assimilation (A) than saplings exposed to MgCl_2 deicer treatments. Additionally, saplings exposed to soil treatments of MgCl_2 deicer maintained higher leaf-level photosynthetic rates than saplings exposed to foliar applications of MgCl_2 deicer (Figure 19.).

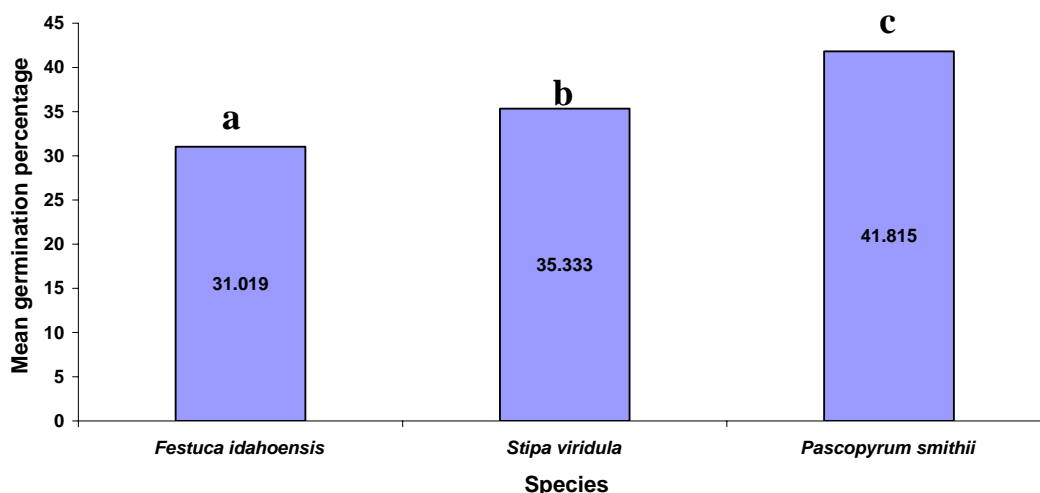
Figure 20. Mean germination percentages across deicer type exposure by species

Species were found to significantly differ in their germination responses to deicers. Bonferroni post hoc comparisons ($\alpha = 0.05$) demonstrated that *P. smithii* had the greatest deicer tolerance, $\bar{x} = 41.815$, followed by *S. viridula* $\bar{x} = 35.333$, then *F. idahoensis* $\bar{x} = 31.019$ (Figure 20.).

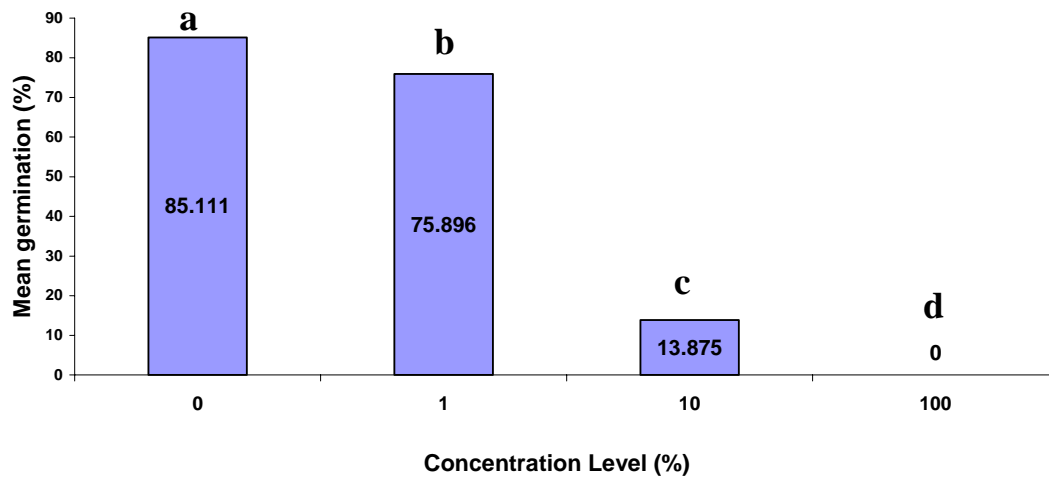
Figure 21. Mean germination percentages of *F. idahoensis*, *P. smithii*, and *S. viridula* by deicer concentration level

Finally, deicer concentration levels all demonstrated unique and significant impacts on germination percentages via Bonferroni post hoc comparisons ($\alpha = 0.05$). Mean germination percentages of control (0%) groups were 85.111. The mean percentage dropped steadily and significantly with each concentration increase: 1% deicer $\bar{x} = 75.896$, 10% deicer $\bar{x} = 13.875$, and 100% deicer $\bar{x} = 0$ (Figure 21.).

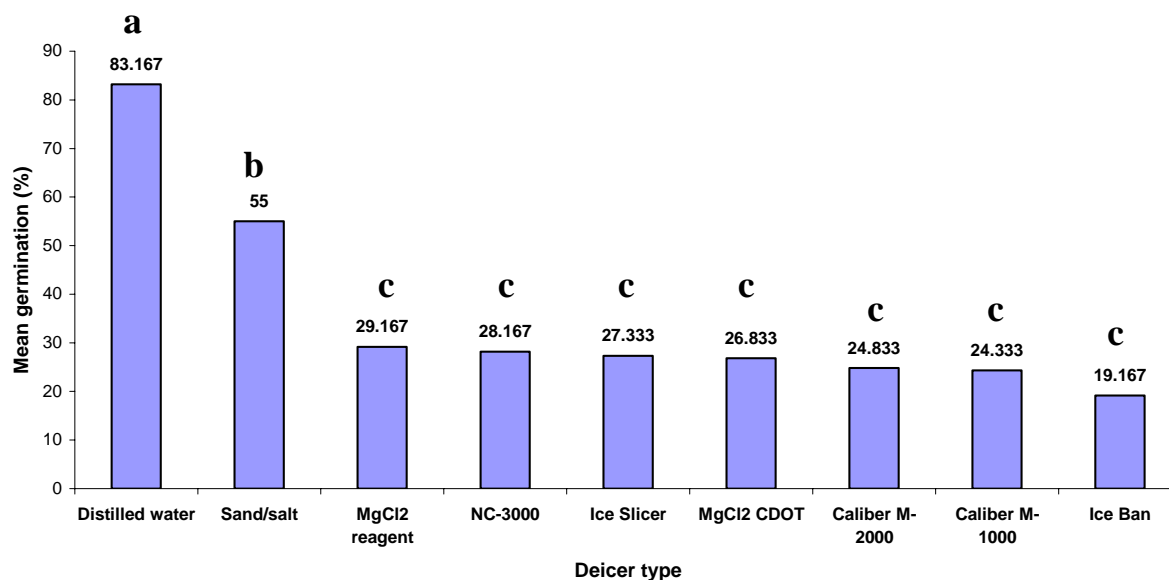
Figure 22. Mean germination in *S. viridula* across deicer type

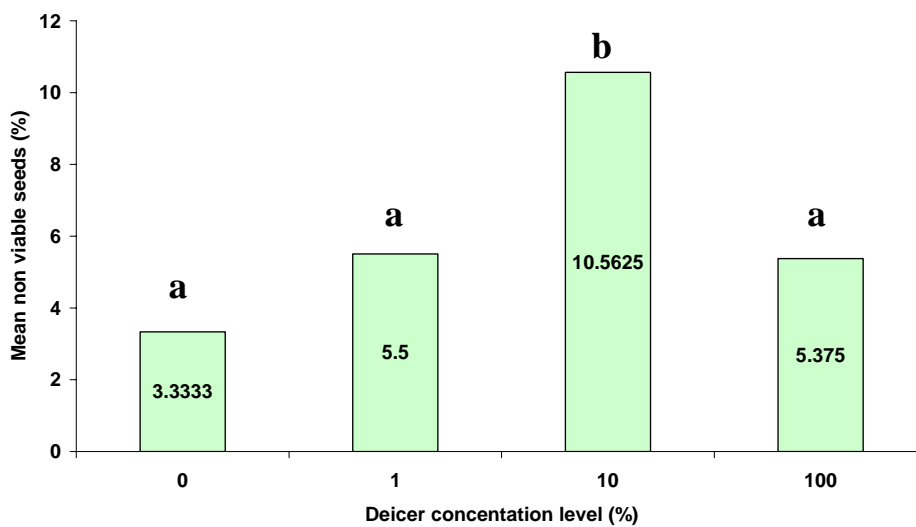
Figure 24. Mean non-viable seed count in *S. viridula* across deicer concentration levels

Viability was only significantly unique in the 10% deicer solutions according to Bonferroni post hoc comparisons ($\alpha = 0.05$). Mean non-viable seed counts averaged 10.5625, significantly higher than in other deicer concentration levels (Figure 24.).

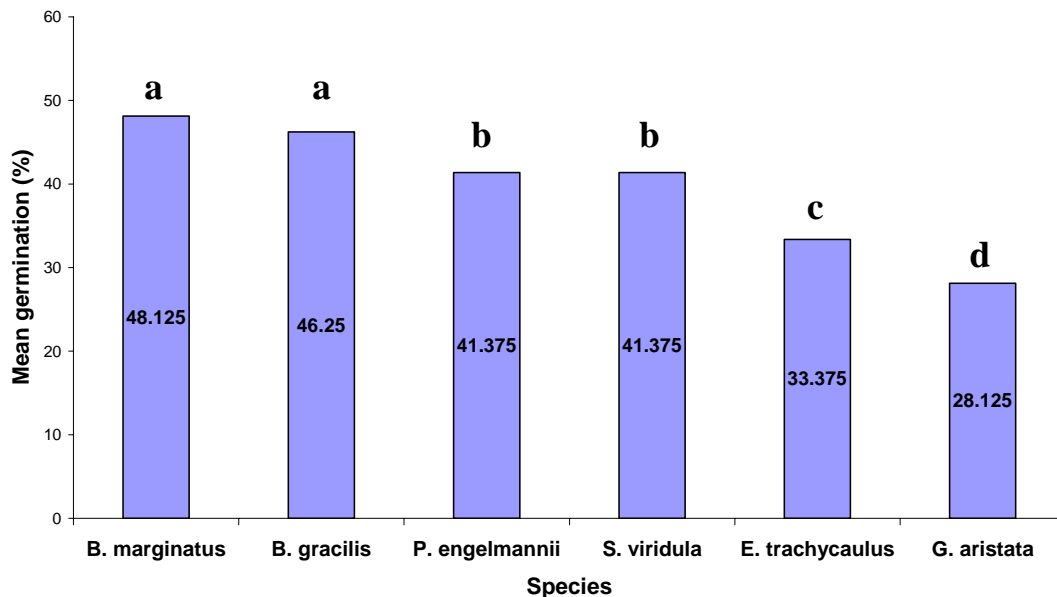
Figure 26. Mean germination percentage of six plant species in response to $MgCl_2$ deicer

Tested species could be placed into four significant groups based on their mean germination response to $MgCl_2$ deicer. Bonferroni post hoc comparisons ($\alpha = 0.05$) demonstrated that *Bromus marginatus* and *Bouteloua gracilis* had higher overall mean germination percentages ($\bar{x} = 48.125$) and ($\bar{x} = 46.250$), respectively, followed by *Picea engelmannii* ($\bar{x} = 41.375$) and *Stipa viridula* ($\bar{x} = 41.375$). *Elymus trachycaulus* ($\bar{x} = 33.375$) demonstrated a much lower mean germination percentage, and *Gaillardia aristata* had the lowest overall mean germination percentage ($\bar{x} = 28.125$) (Figure 26.).

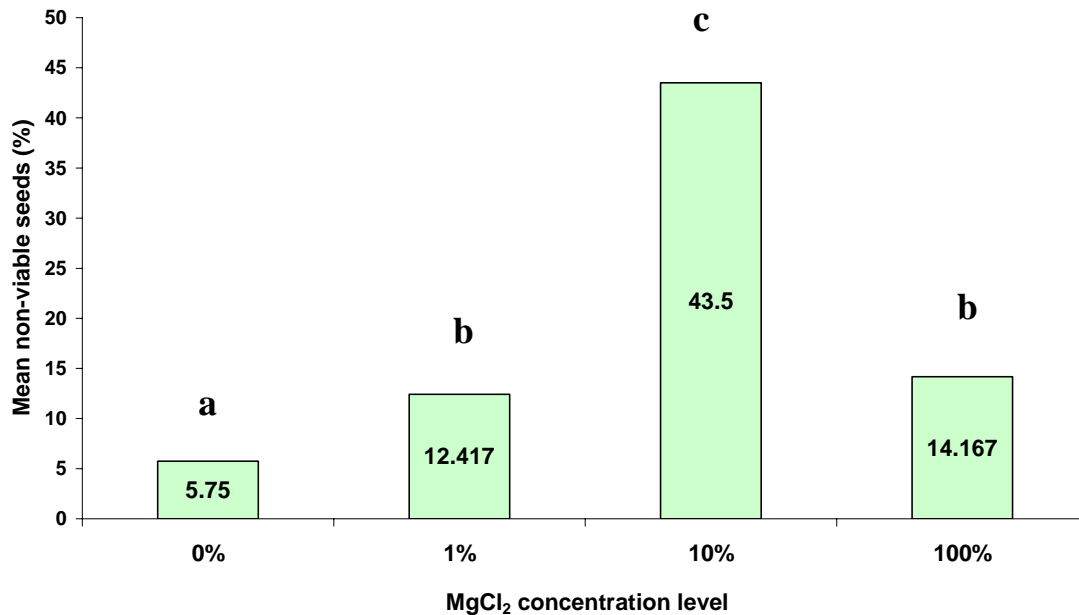
Figure 27. Mean non-viable seed percentages of six plant species across a MgCl₂ deicer concentration gradient

Viability in seeds also differed significantly across MgCl₂ deicer concentration levels. Non-viable seeds were found in significantly higher percentages in 10% MgCl₂ deicer solution than at any other concentration level via Bonferroni post hoc comparisons ($\alpha = 0.05$). The lowest percentages of non-viable seeds were found in seeds exposed to distilled water ($\bar{x} = 5.750$) (Figure 27.).
