UPPER RAPID CREEK WATERSHED ASSESSMENT

**AN EVALUATION OF CONDITIONS IMPACTING WATER QUALITY IN
NORTH FORK RAPID CREEK
CASTLE CREEK
AND
NORTH FORK CASTLE CREEK
IN THE
BLACK HILLS, SOUTH DAKOTA
NOVEMBER 2004**

**DR. SCOTT KENNER, CHAIRMAN & ASSOCIATE PROFESSOR, CIVIL AND ENVIRONMENTAL
ENGINEERING DEPARTMENT, SOUTH DAKOTA SCHOOL OF MINES AND TECHNOLOGY**

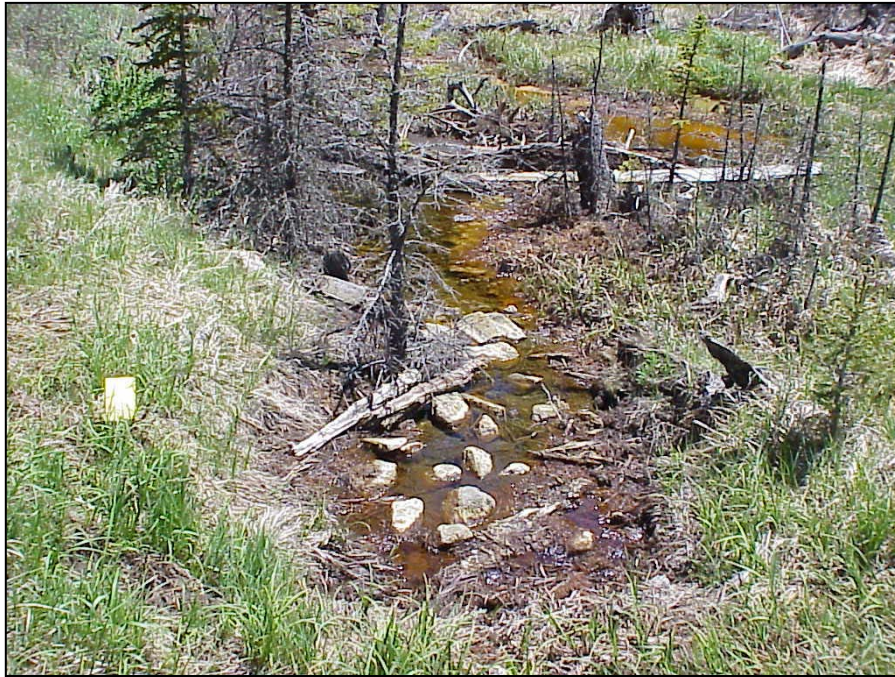
Figure 1: Iron bog water originating from spring (bottom center of photograph). Note red-orange water and dead vegetation.

Acid rock drainage occurs both naturally and due to anthropogenic disturbances, primarily mining. Most acid rock drainage is found at mine sites where it is commonly referred to as acid mine drainage. Acid rock drainage results from the interaction of sulfide minerals with oxygen and water. Iron-oxidizing bacteria catalyze these reactions. Photographs of iron bogs, mined iron bogs, and acid drainage are shown on Figures 1 through 6, Pages 17-19.

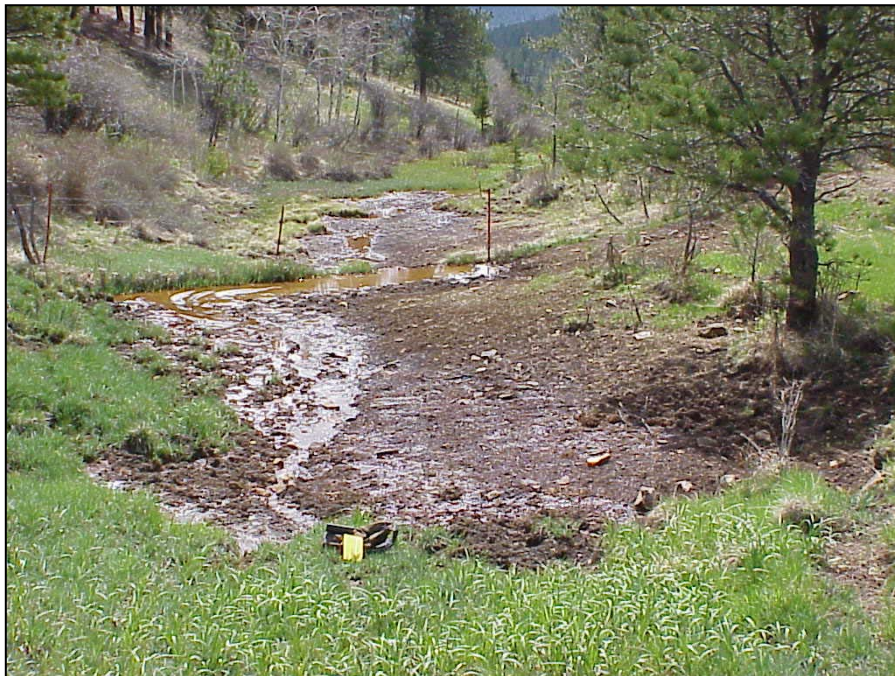
Figure 2: Iron bog with water originating from a spring in the bottom center of photograph. This spring flows into Figure 3.

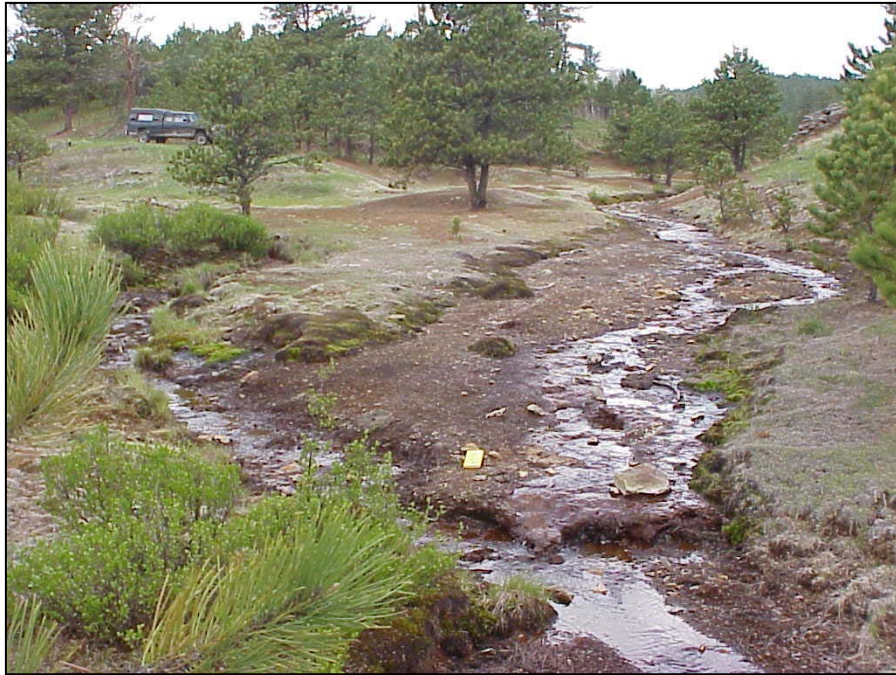
Figure 3: Mined iron bog. Water from spring in Figure 2.

- The land surface immediately around acid springs is typically free of living vegetation (Figures 3 & 4, page 18).
- Fish, plants, and micro- and macro-invertebrates are stressed under these conditions. At high enough concentrations, most plants and animals will die leaving an environment devoid of life (OSMRE, 2000).

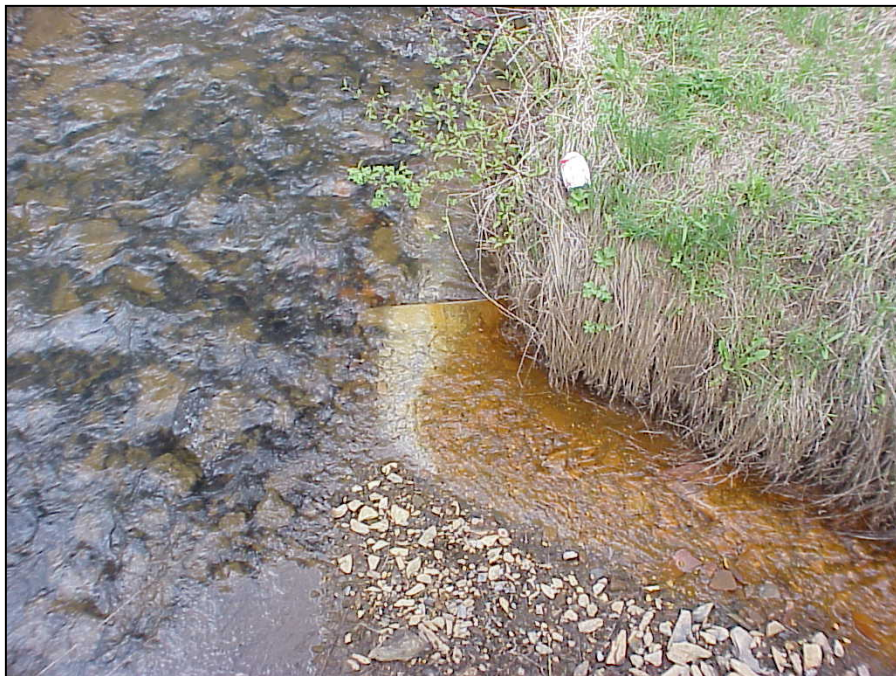
Figure 4: Confluence of acid rock drainage and uncontaminated stream. Note red-orange iron hydroxide and white aluminum hydroxide precipitates.

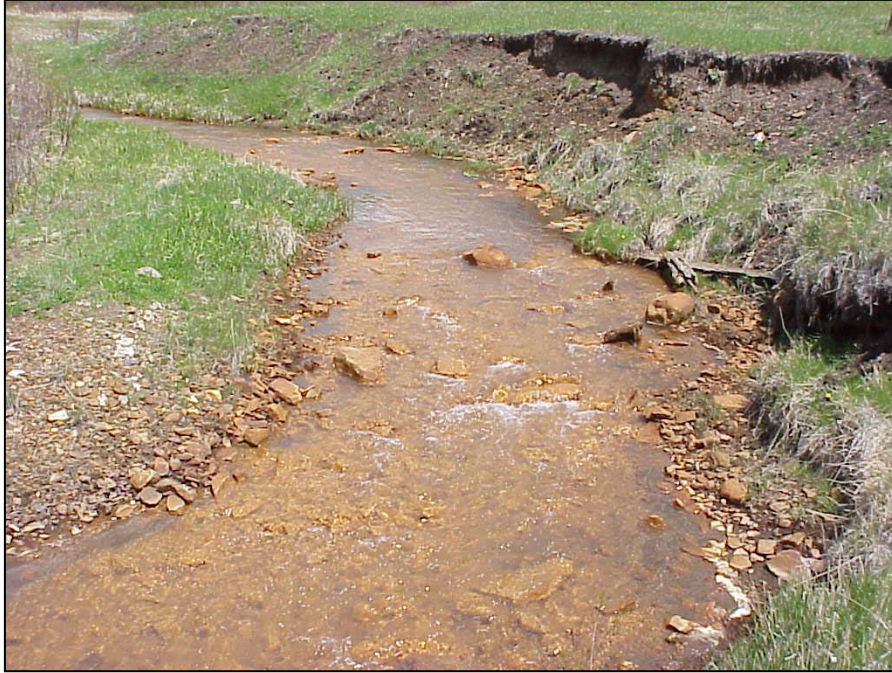
Figure 5: Iron hydroxide precipitate coating stream substrate downstream from confluence of acid rock drainage and uncontaminated stream.

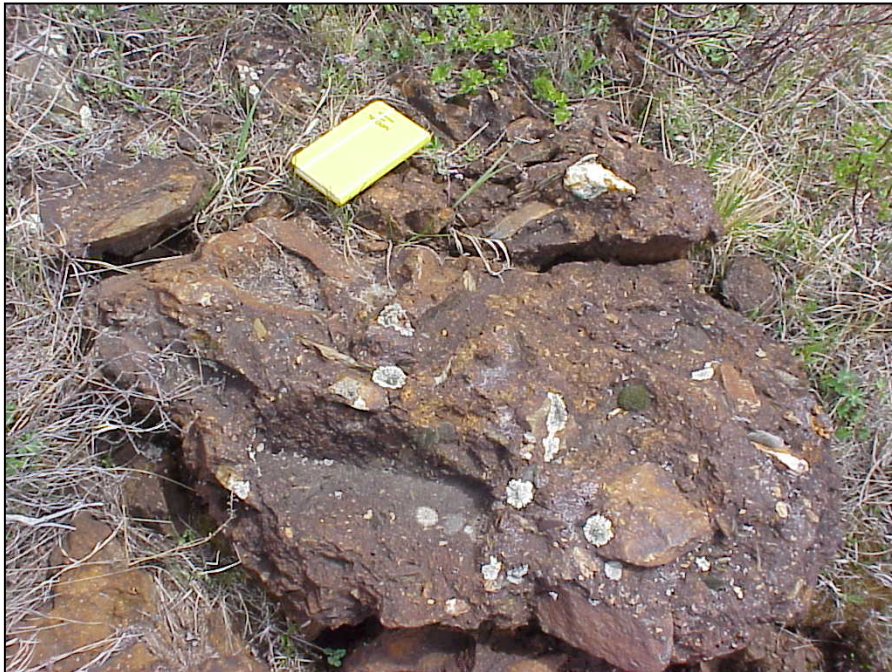
Figure 6: Lithified iron-cemented conglomerate. Resulted from prehistoric acid rock drainage. Iron hydroxide precipitate alters to hematite cement.

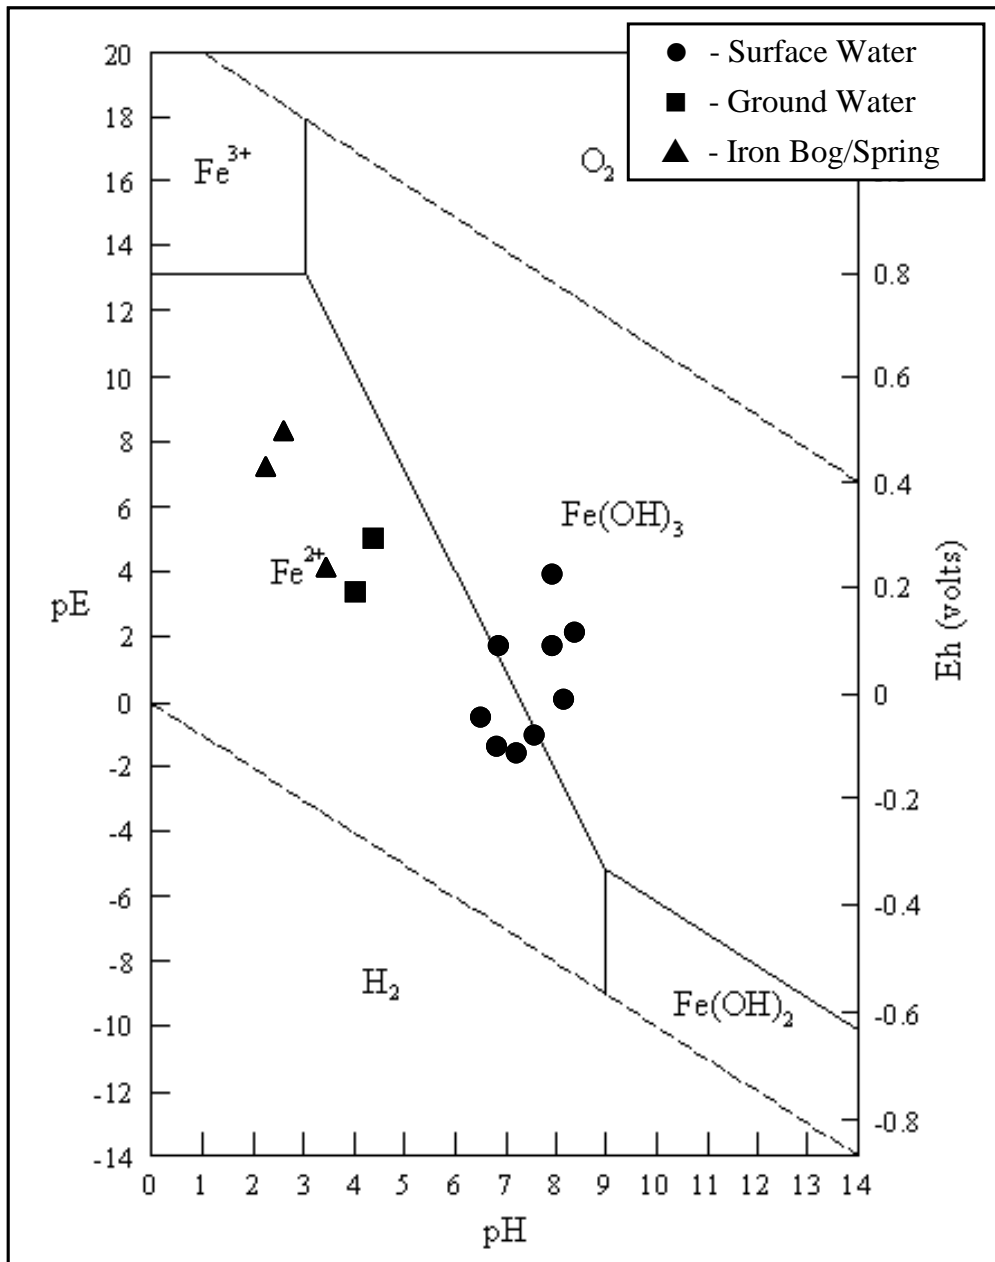
Figure 7: Selected water quality data from upper Rapid Creek watershed plotted on the Eh-pH diagram for the iron

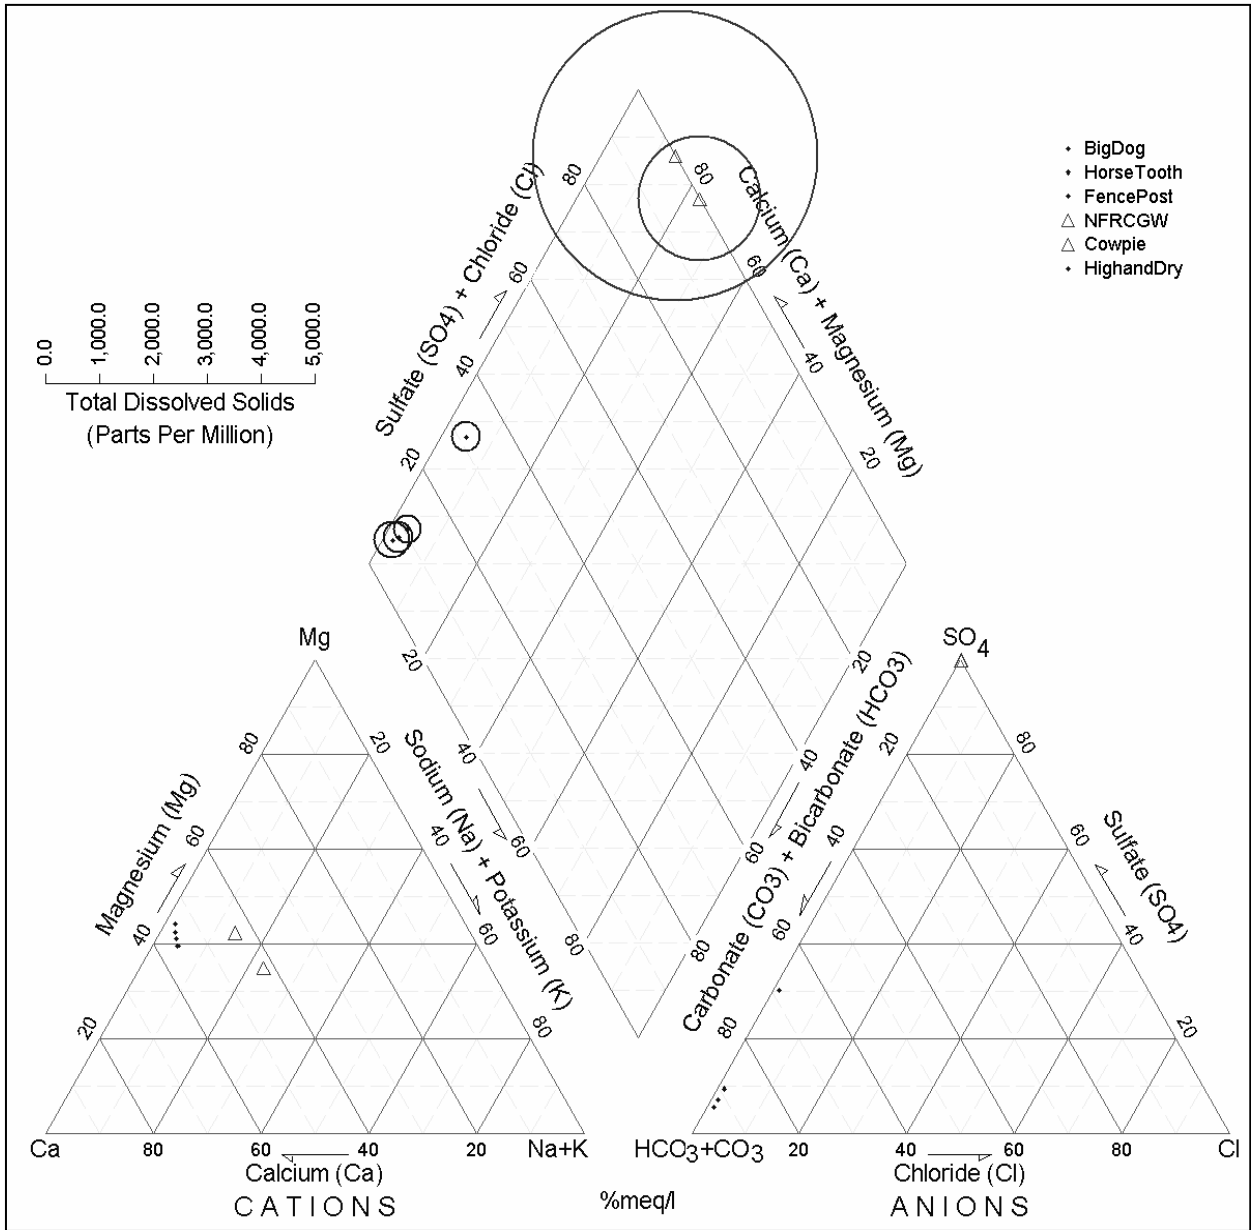
Figure 8: Piper diagram for selected water quality data from North Fork Rapid Creek.

Selected water quality data from ground and surface water samples are plotted on a Piper diagram (Figure 8, Page 23). Piper diagrams consist of three plots: the lower left triangle is for major cations; the lower right triangle is for major anions; and the center diamond is a combination of major cations and anions. These plots allow water to be classified based on major ions.

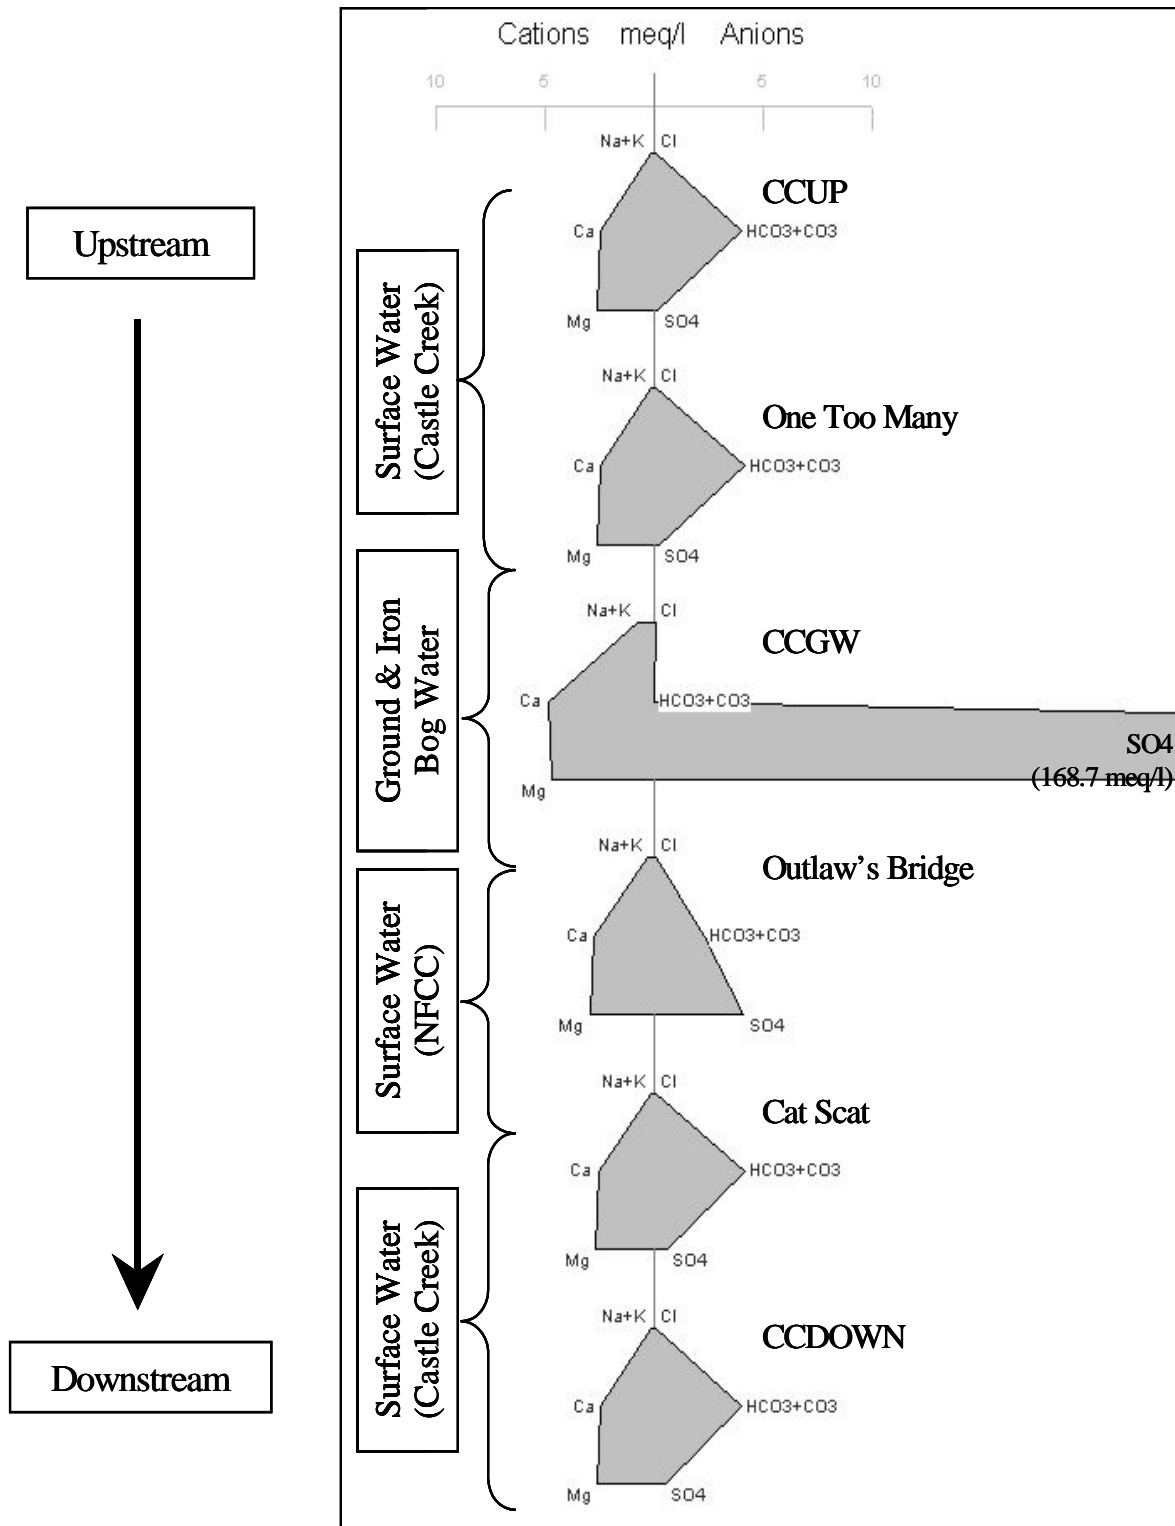
Figure 11: Stiff Diagram Polygons for Selected Water Quality Samples from Castle Creek & North Fork Castle Creek

Selected water quality data are plotted on Stiff diagrams (Figure 11, Page 27). The polygons for the watershed are plotted in an upstream to downstream direction. For Castle Creek, these are One Too Many and Cat Scat surface monitoring locations. The confluence of North Fork Castle Creek and Castle Creek is between One too Many and Cat Scat. The Outlaw's Bridge monitoring site is located on North Fork Castle Creek near the confluence. CCUP and CCDOWN were one-time surface water sample locations further up and further down, respectively, from the permanent surface water stations; CCGW is a ground water monitoring station. Note the polygons are very similar in shape and size, indicating relatively consistent surface water quality along Castle Creek. Ground water sample, CCGW, represents the quality of ground water discharging directly into Castle Creek. Surface water sample, Outlaw's Bridge, represents North Fork Castle Creek surface water that has received abundant acid rock drainage discharge.

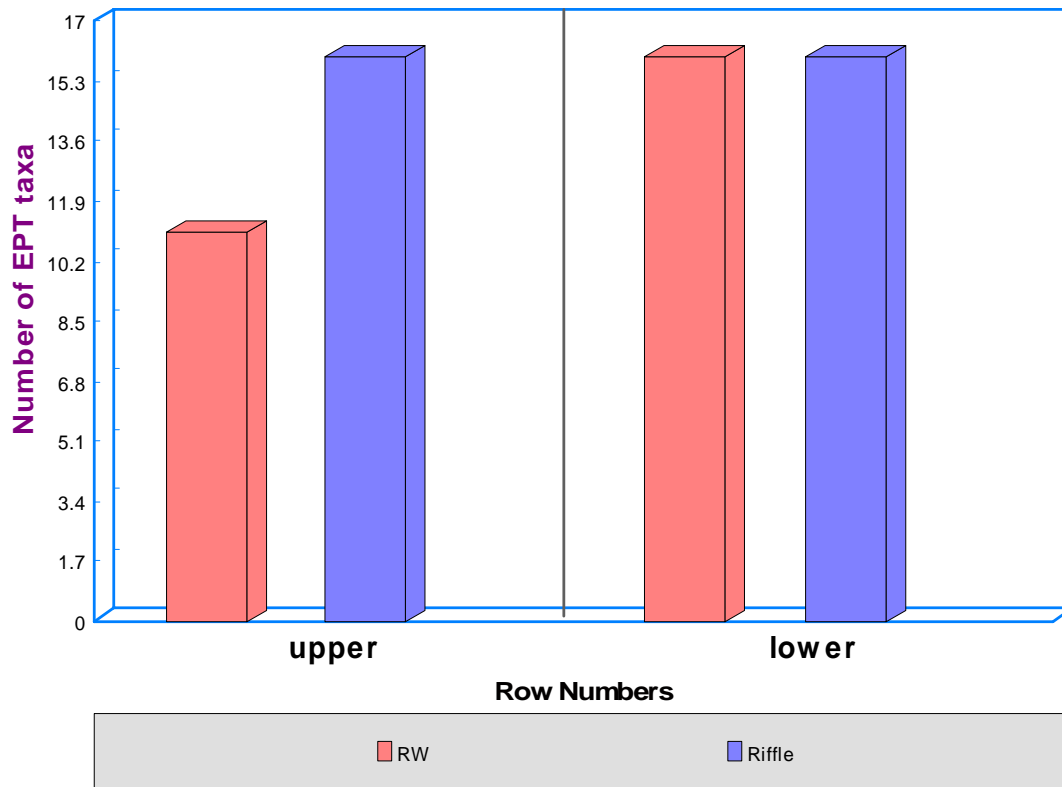
Figure 3. EPT taxa richness for North Fork Rapid Creek upper vs. lower reaches and riffle vs. reach wide (RW) samples.
