A REPORT BY WILD VIRGINIA

FEBRUARY 2023

MOUNTAIN VALLEY PIPELINE POLLUTION IN VIRGINIA WATERSHEDS

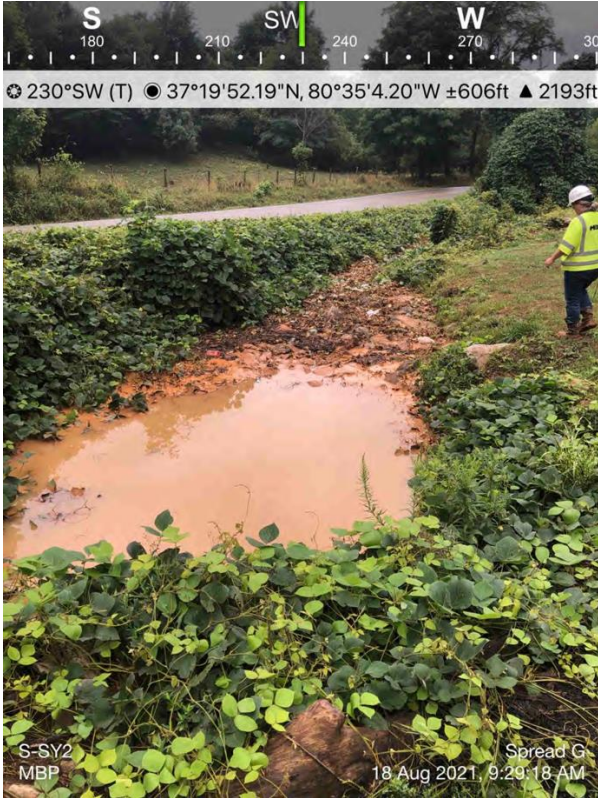
Figure 26 - Sediment deposited in Doe Creek, August 18, 2021, Action Log ID 5068, Source: MBP

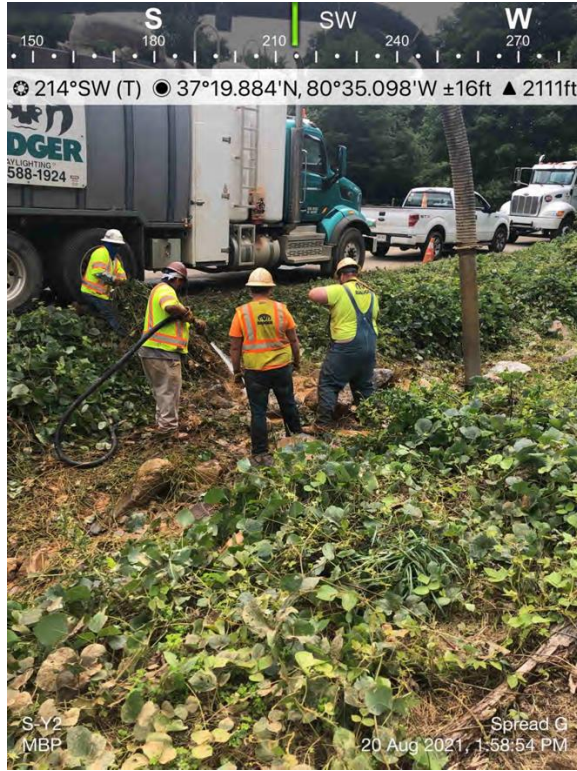
Figure 29 - Workers removing sediment from a landowner's property after the pollution "overwhelmed perimeter controls" at MVP sites. Action Log ID 5067. Source: MBP

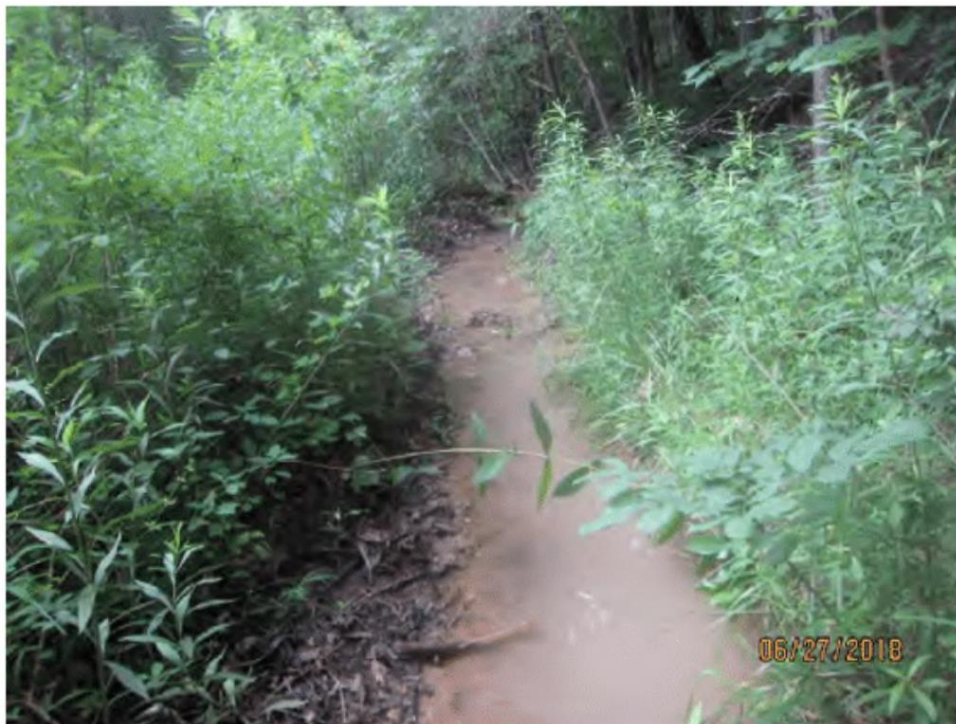
Inspectors found 3,600 linear feet of stream channel in UT Flatwoods Branch "impacted by sedimentation" to depths up to 7 inches. Notations indicate that sedimentation affected the "stream's viable habitat," and that aquatic life movement would be substantially disrupted. See Figures 36 and 37. (from VWP inspection report)

Photo 4: Sediment in stream ~3,485’ from LOD near access road; Depth = 2”
Orientation: Downstream

Figure 37- Sediment deposits in UT Flatwoods Branch, June 27, 2018, VWP Inspection Report, Source: DEQ [original photo caption retained]

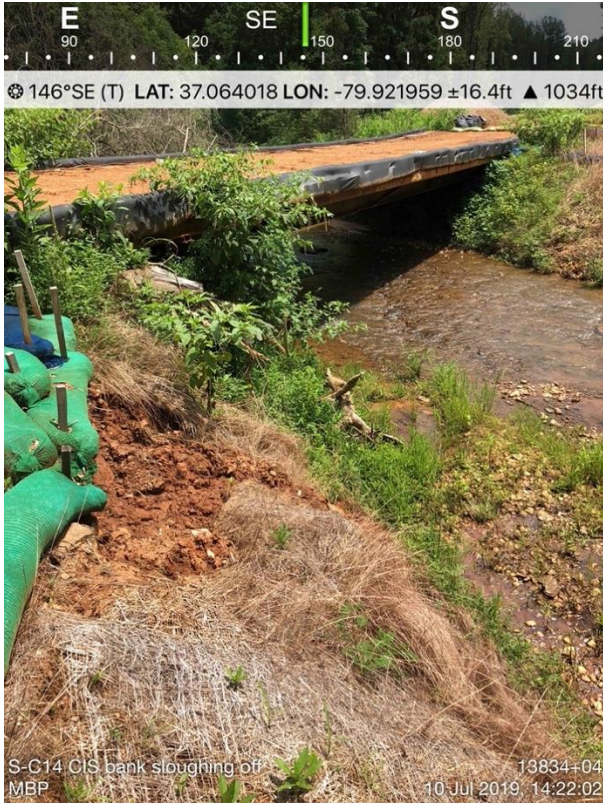
Figures 42 and 43 are just two examples of this pollution source. This damage to actual stream banks and channels can and surely has contributed much greater loads of sediment to affected streams than the periodic discharges from worksites, because they will slough away

Figure 42 - Stream bank eroded at MVP site, Teels Creek, July 10, 2019, Action Log ID 3187, Source: MBP

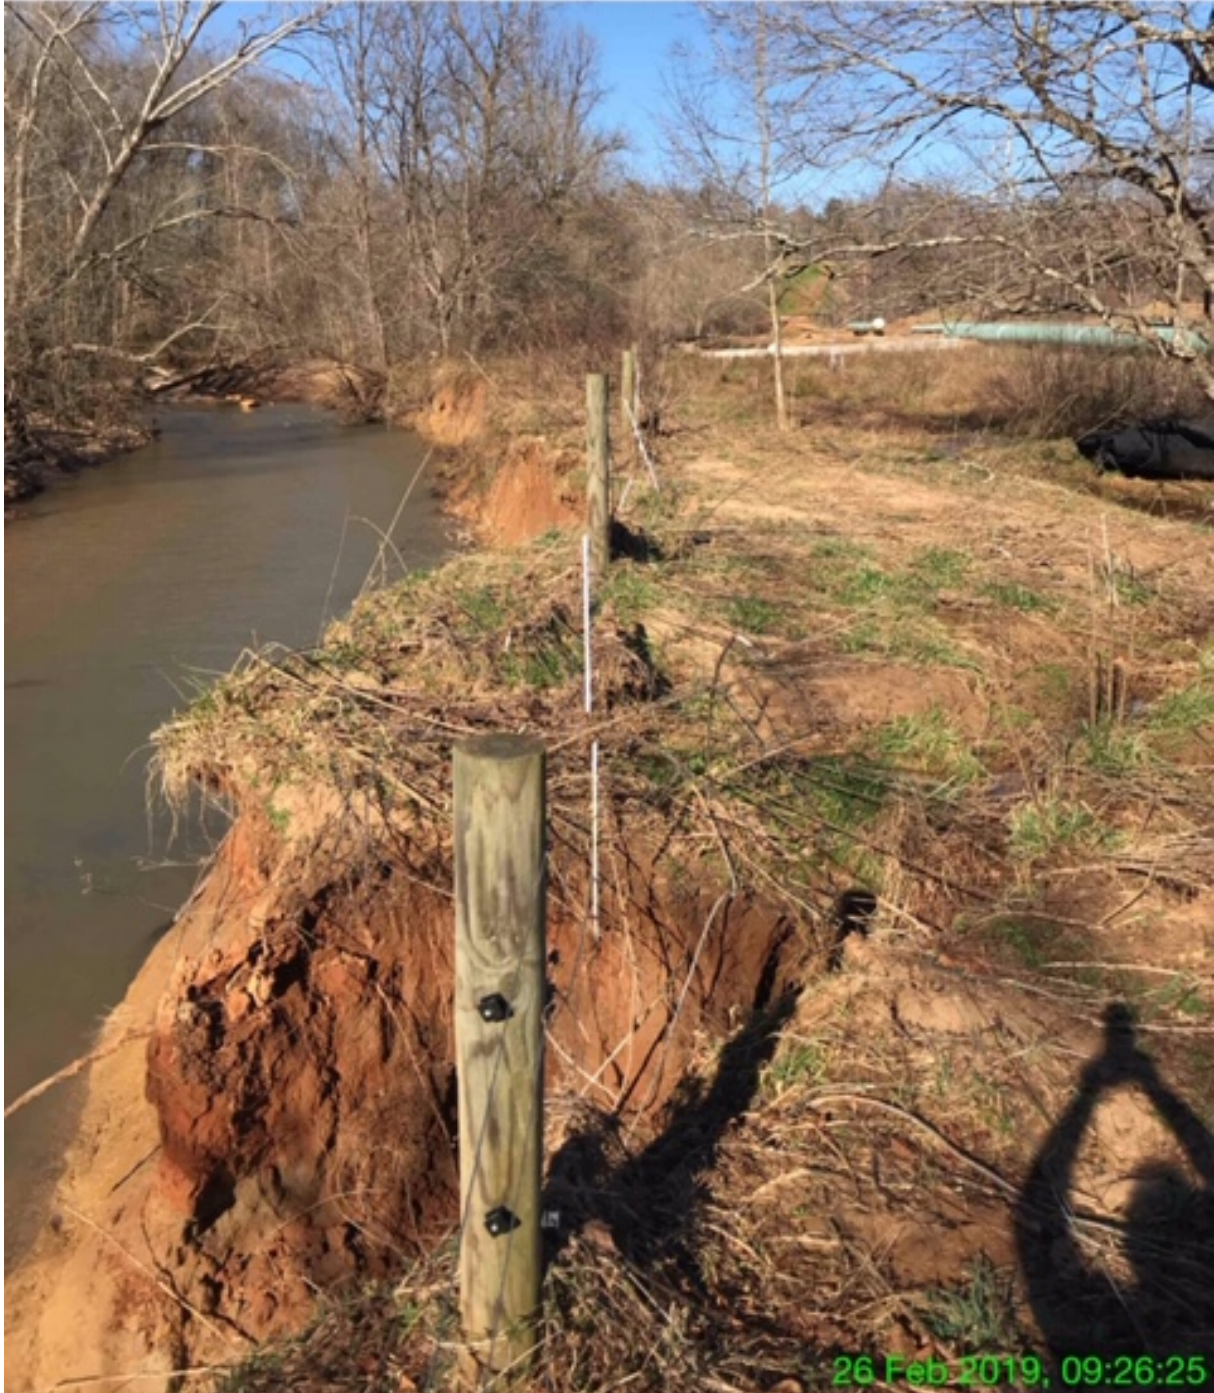
EXHIBIT H – Comparing this photograph to the photograph in Exhibit C, the fence will soon fall into the creek. It took only three months to lose the land between the fence and the creek bank. Exhibits XX – XX show the fence posts dangling by the wires on June 18, 2019

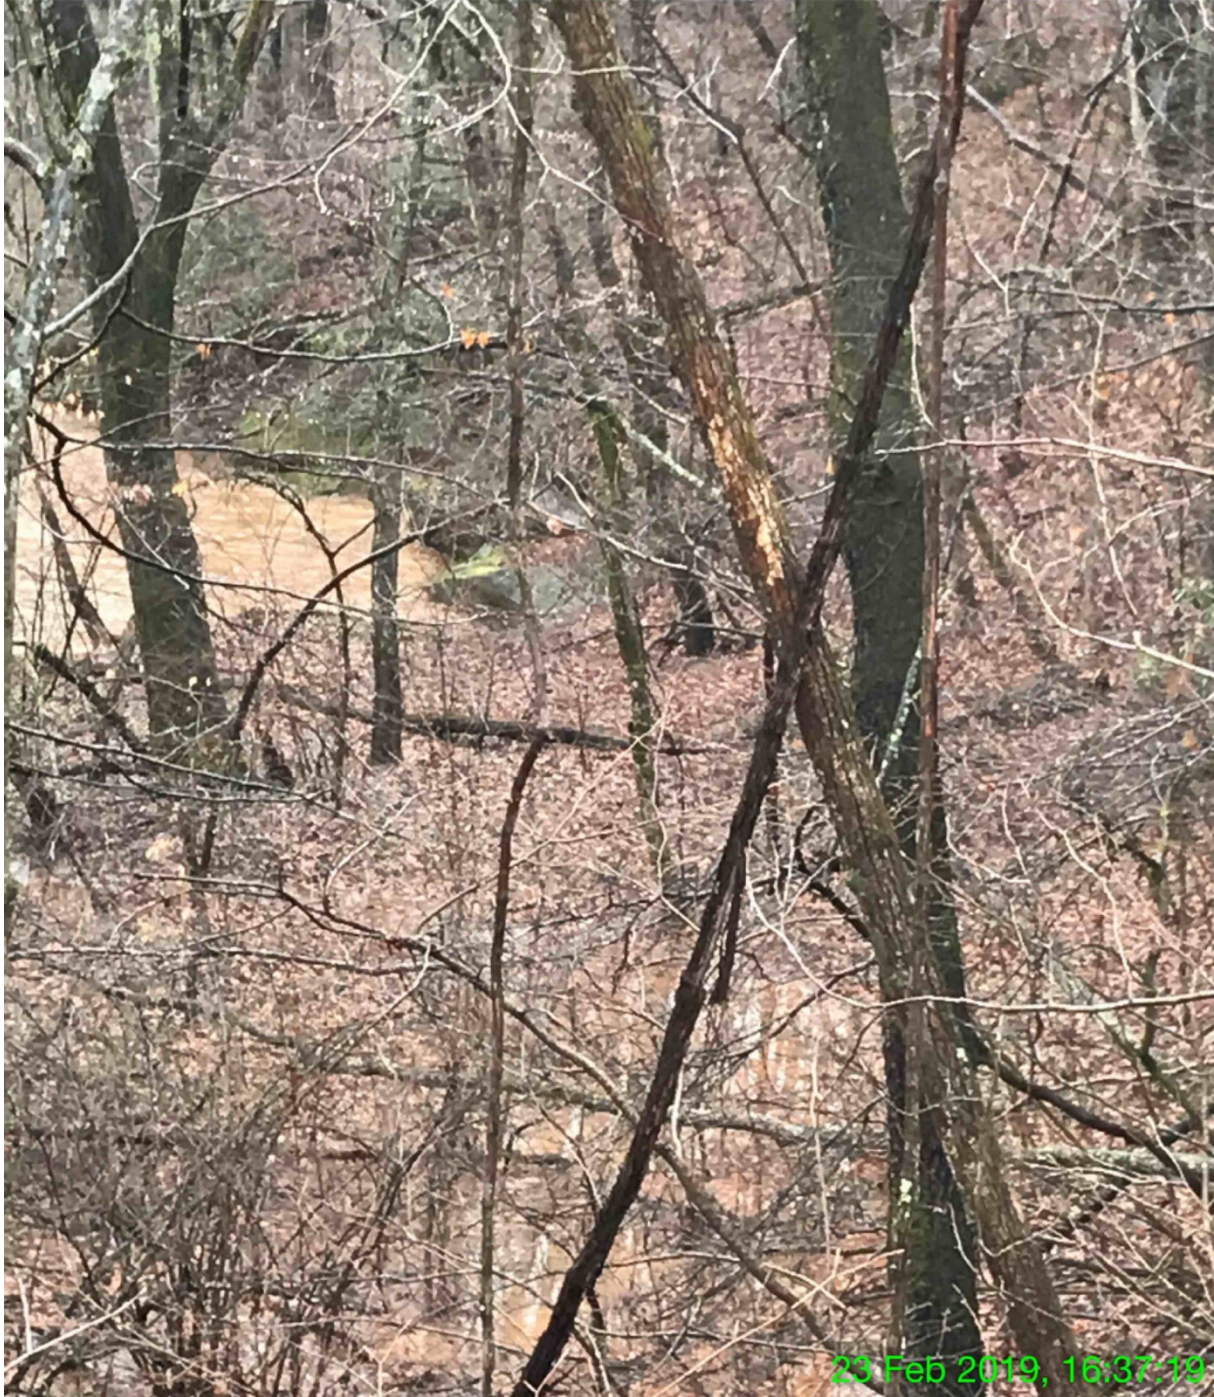
EXHIBIT P – Sediment-laden runoff has flowed from the construction corridor.

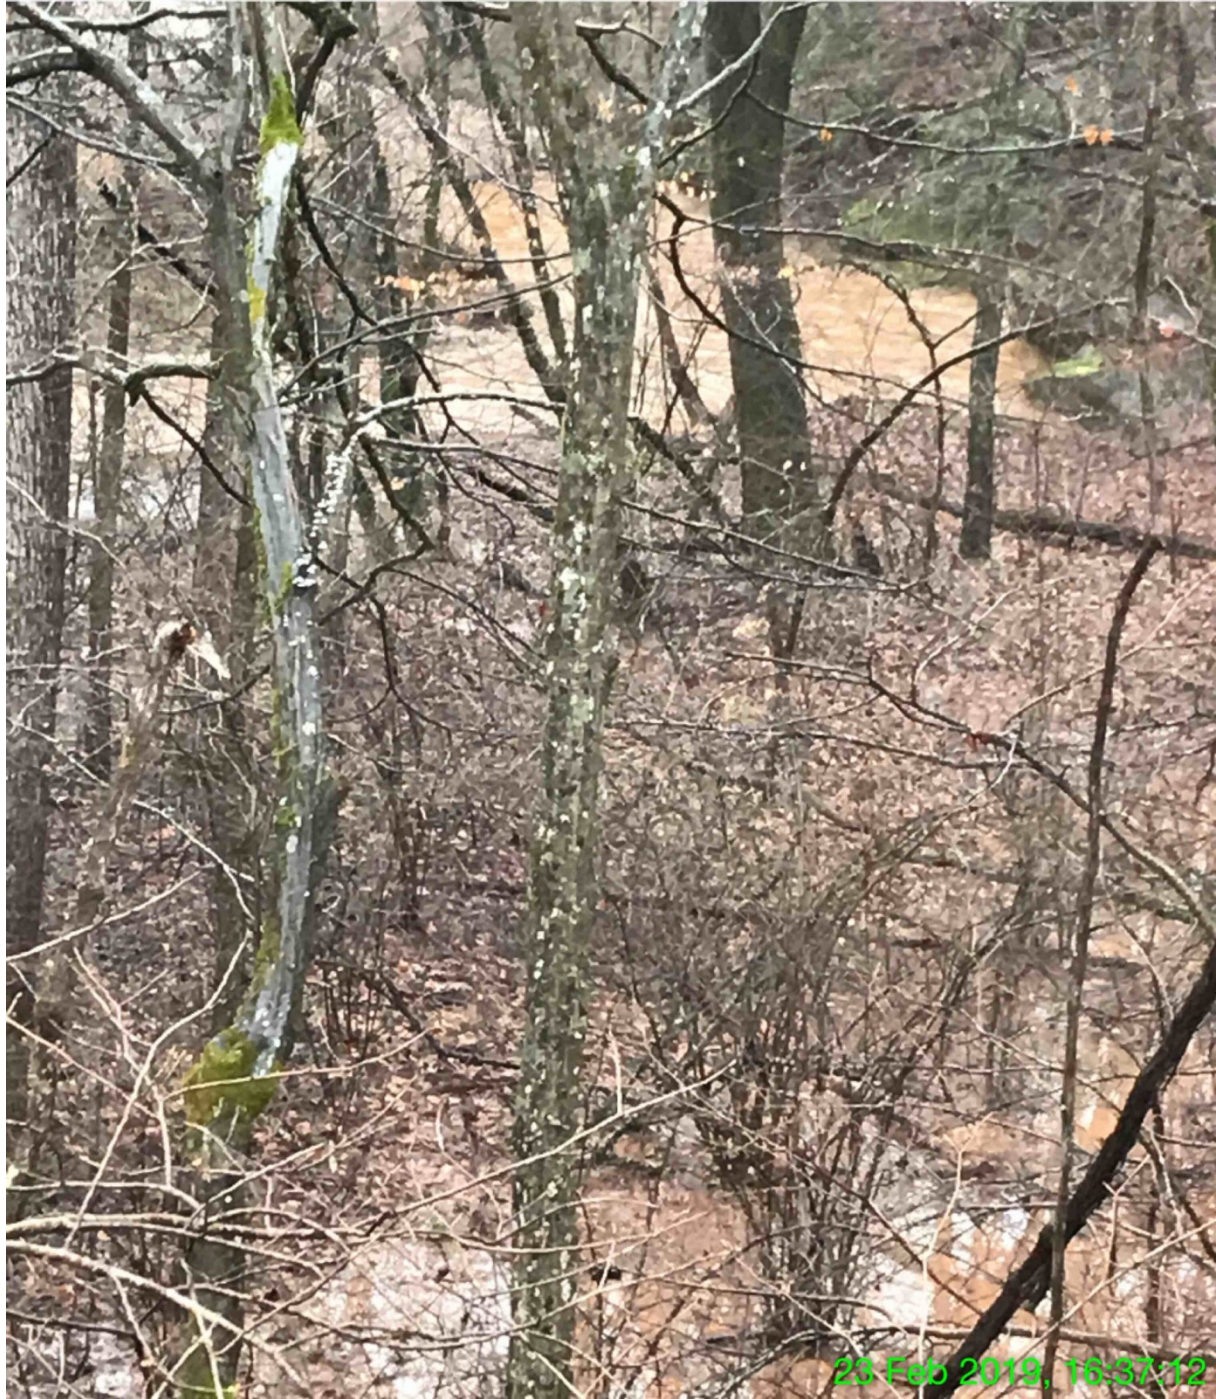
EXHIBIT Q – Sediment-laden runoff has flowed from the construction corridor.

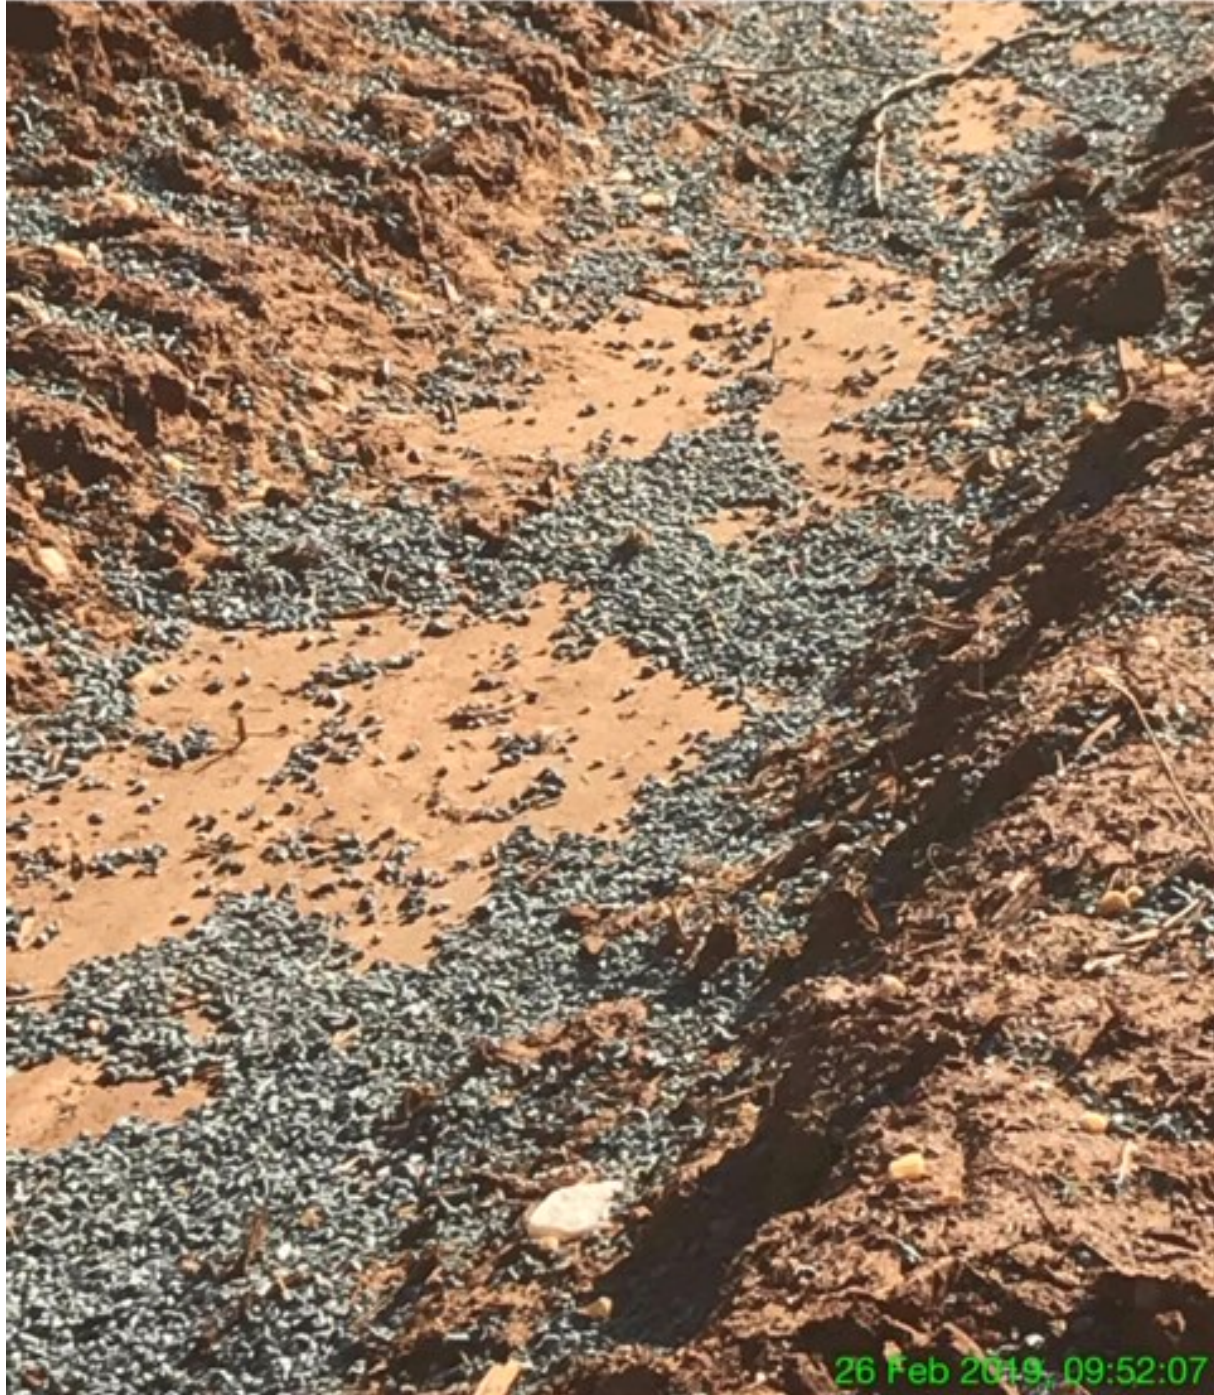
EXHIBIT U – Erosion control pellets.

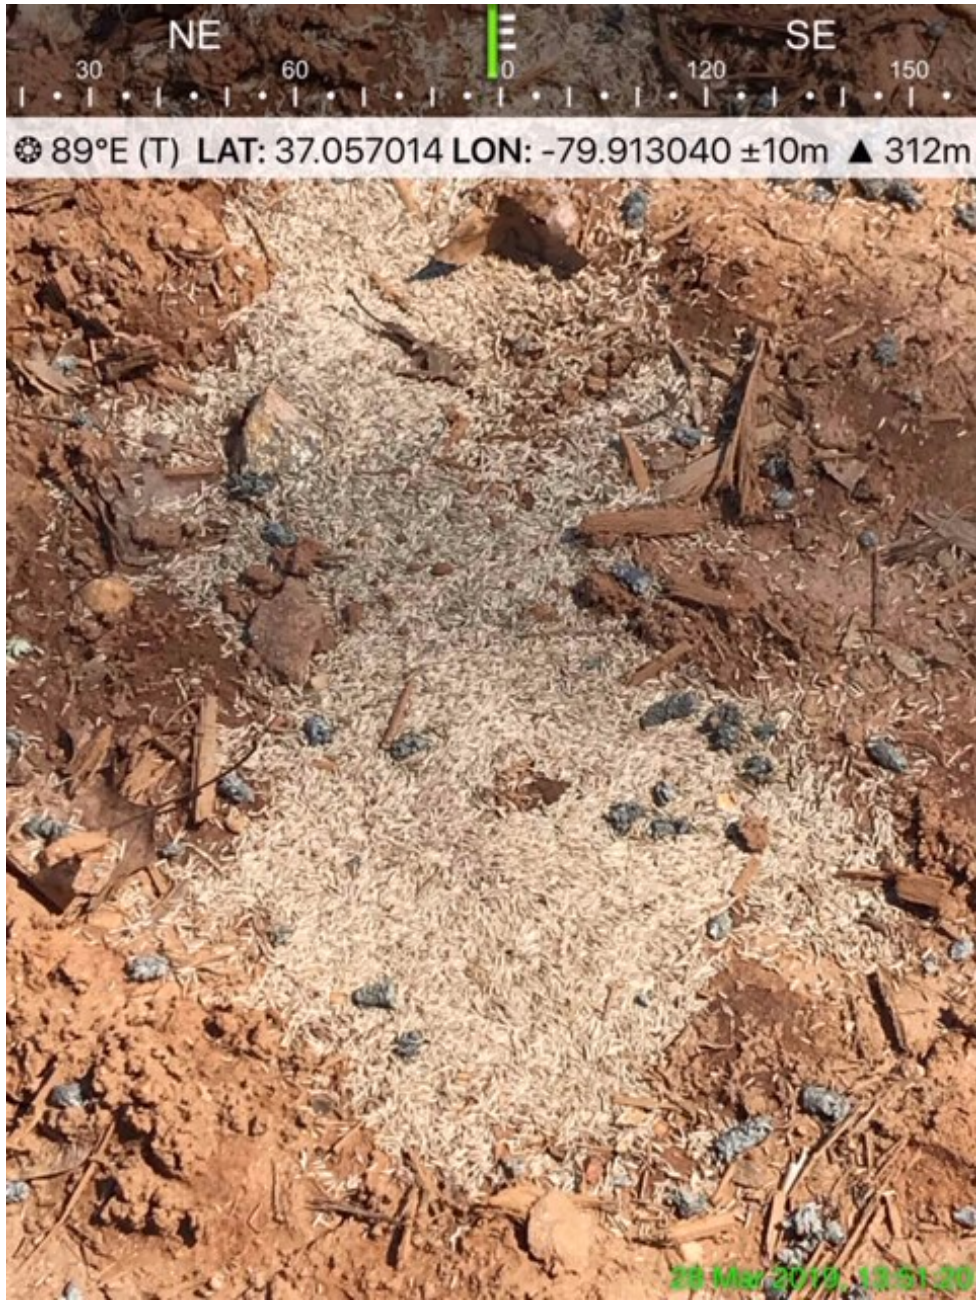
Exhibit X – Seed “spread” on ROW

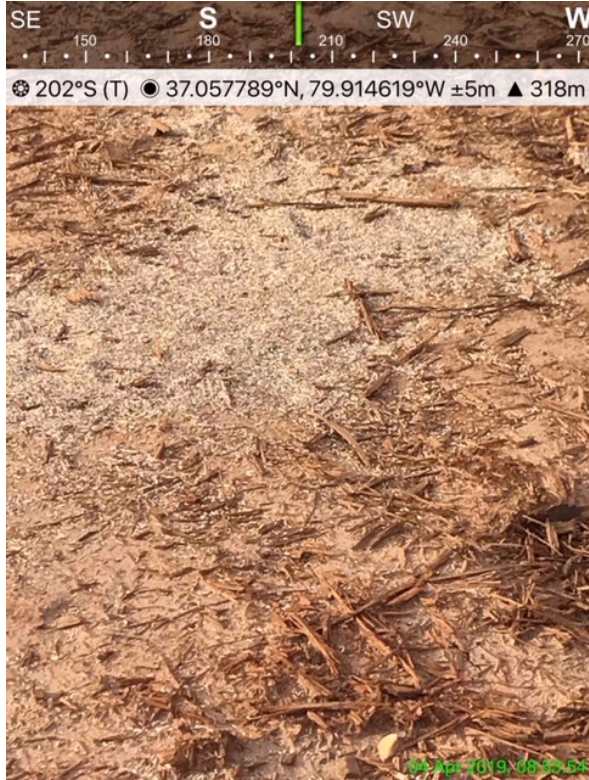
Exhibit Y – Seed sitting on ROW

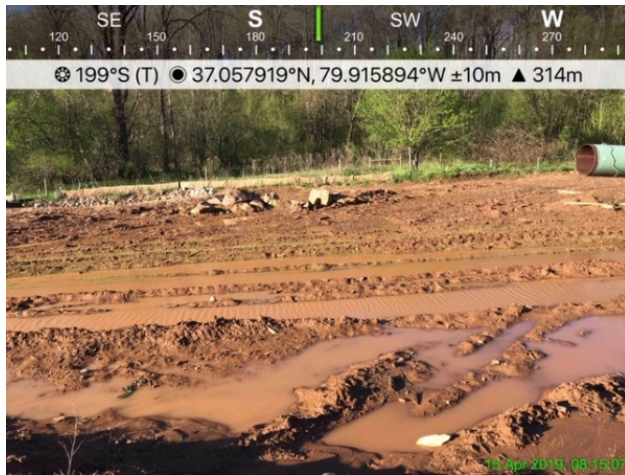
Exhibit Z – Seeded area of ROW

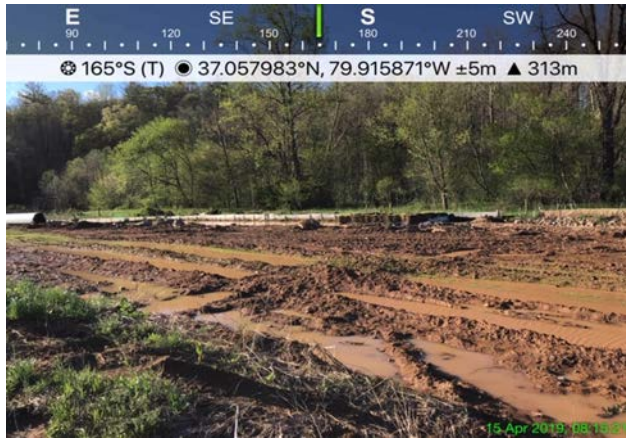
Exhibit AA – Seeded area of ROW

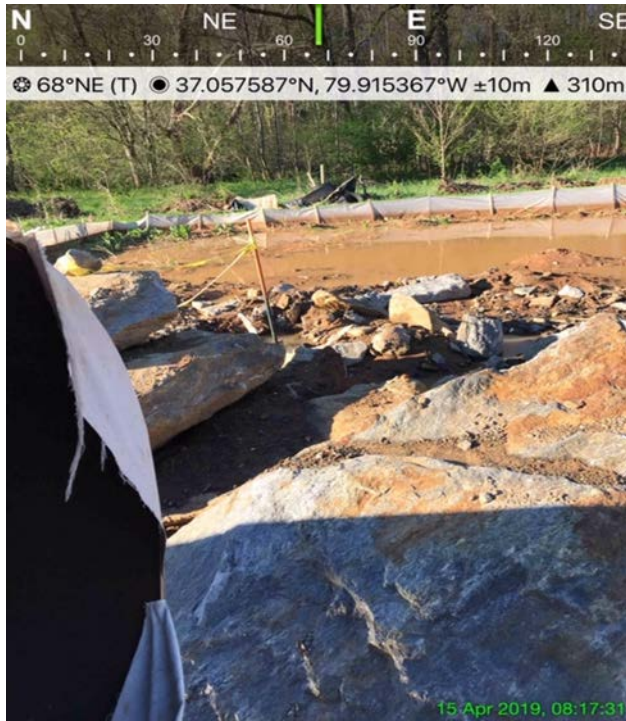
Exhibit BB – Seeded area of ROW

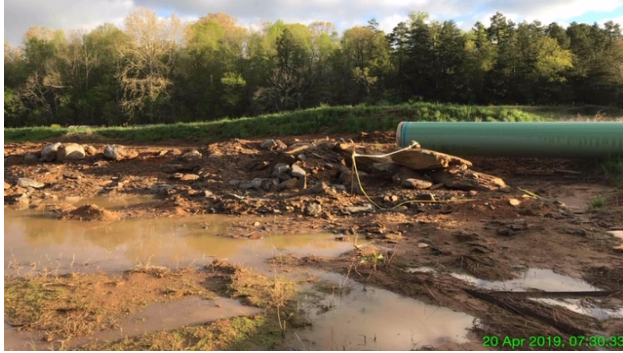
Exhibit CC – Sprouting grass on ROW?

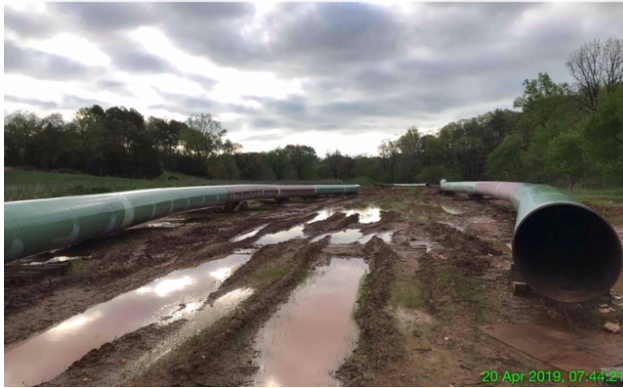
Exhibit DD – Sprouted Grass on ROW?

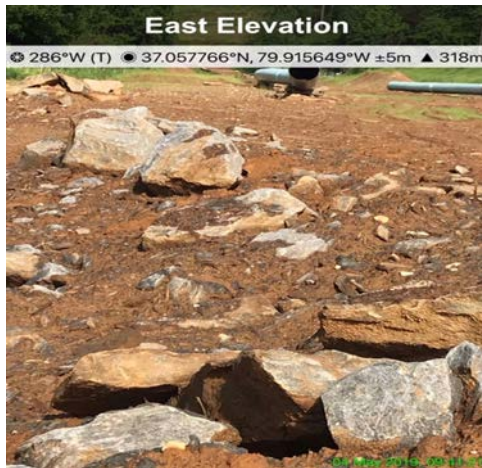
Exhibits FF & GG – Sprouted grass on ROW

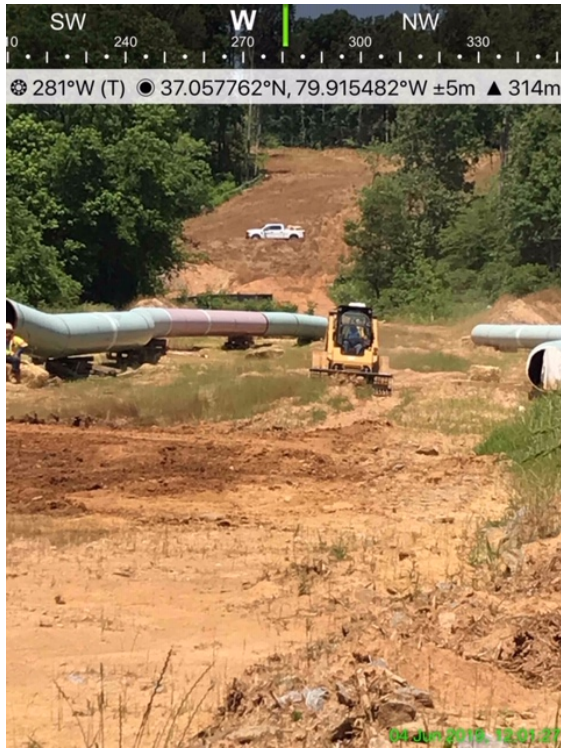
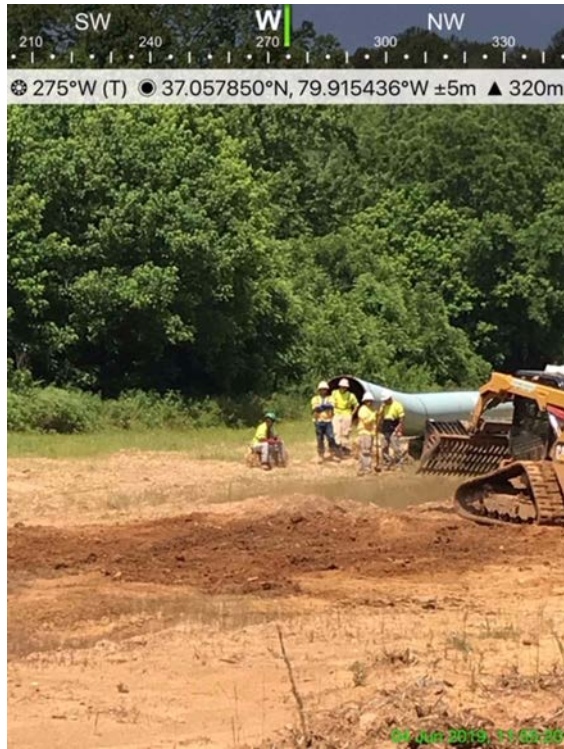
Exhibits JJ & KK -- MVP attempting to smooth over and re-seed by hand, also put down straw.

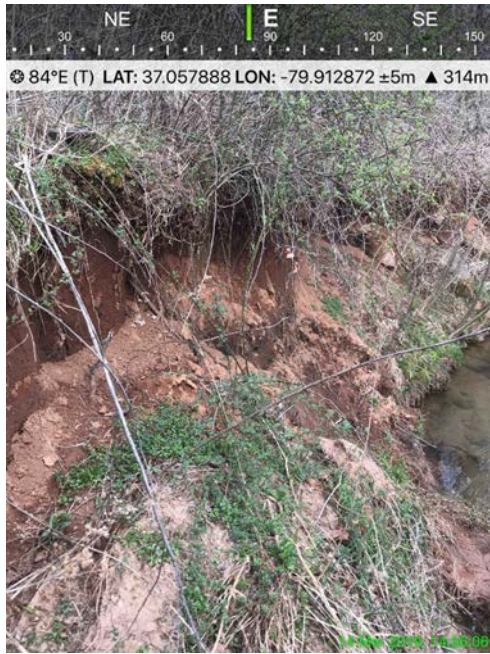
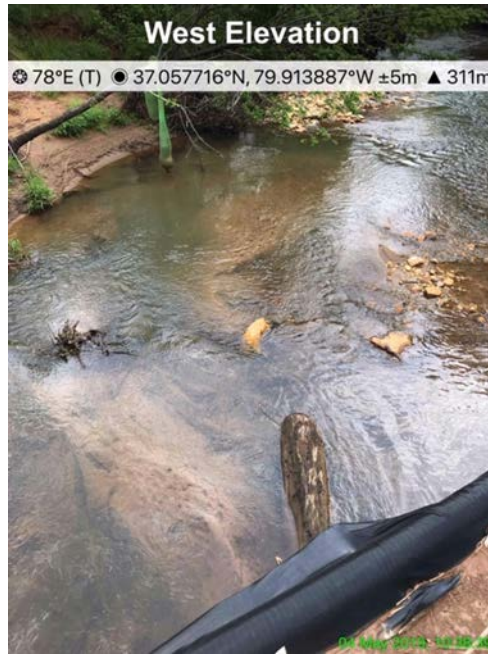
Exhibits MM & NN - Erosion and sediment in creek next to MVP bridge over Little Creek

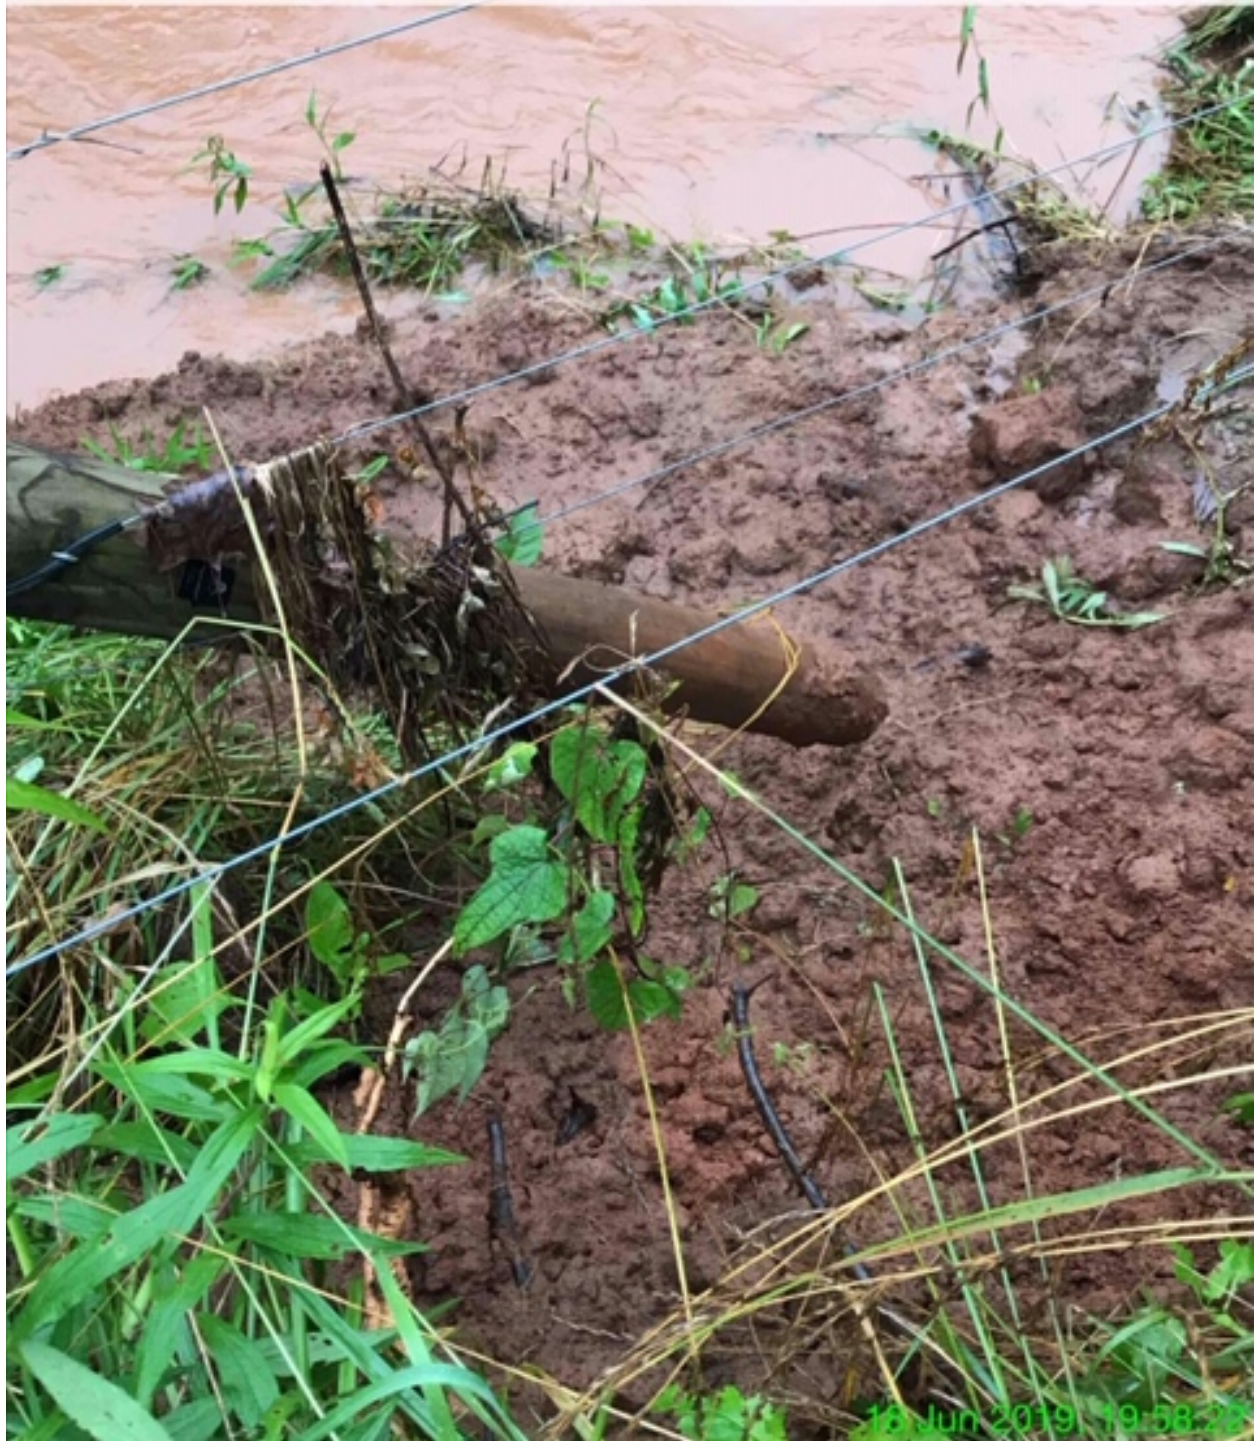
Exhibit PP – By June 18, 2019, the creek bank has eroded several feet beyond a fencepost that was at least six feet from the creek bank before construction started.

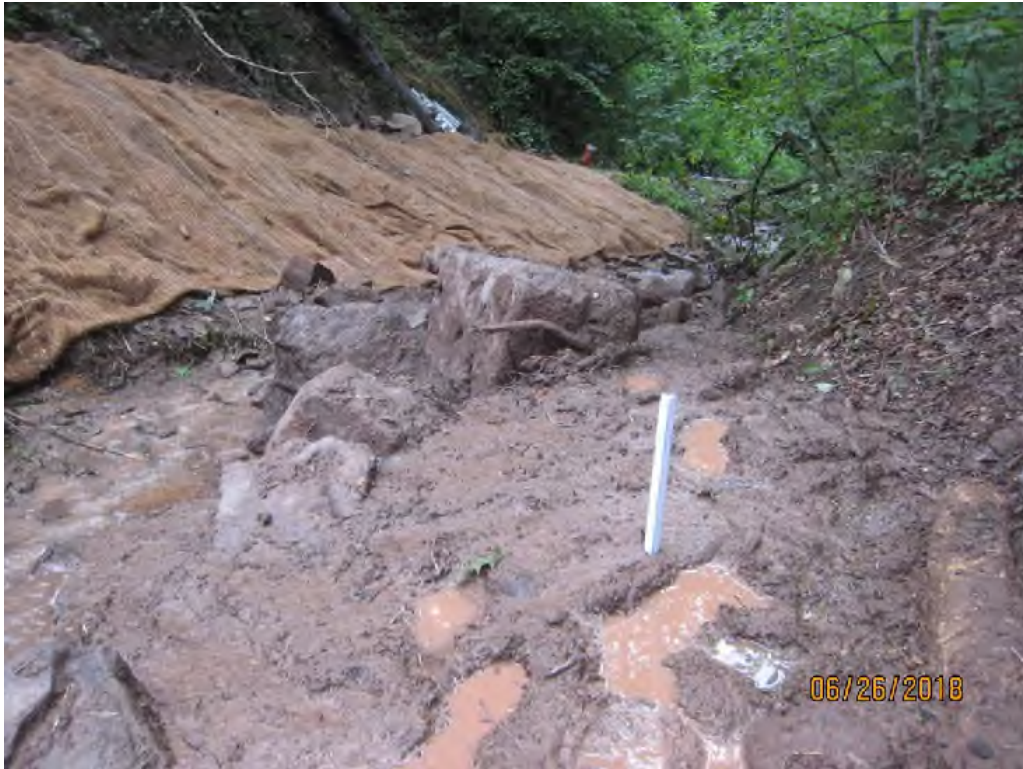
Photo 1: Sedimentation within "Stream 39" ~25' downstream of LOD

1. Repair erosion and sediment controls in areas where needed;
2. Stabilize all slopes above and below perimeter controls;
3. Remove sediment from impacted stream channels using hand removal methods (buckets and shovels) and stabilize with appropriate seed mix where applicable.

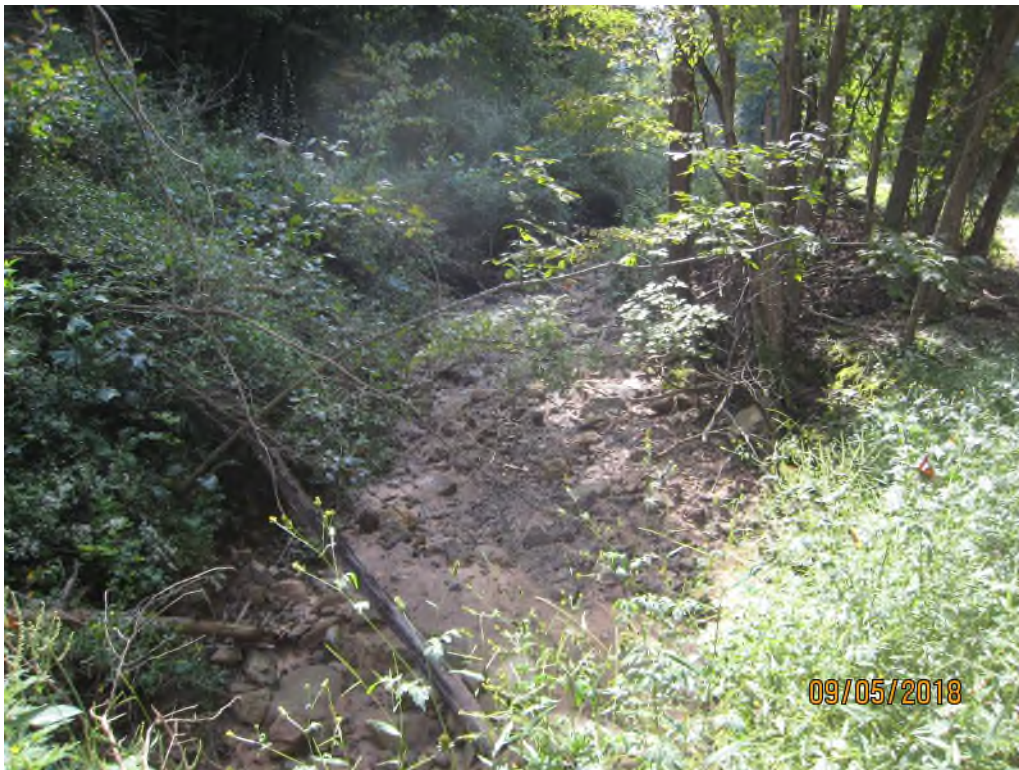
Photo 6: Sedimentation in channel downstream of Rogers Road culverts; no landowner permission
Orientation: Downstream

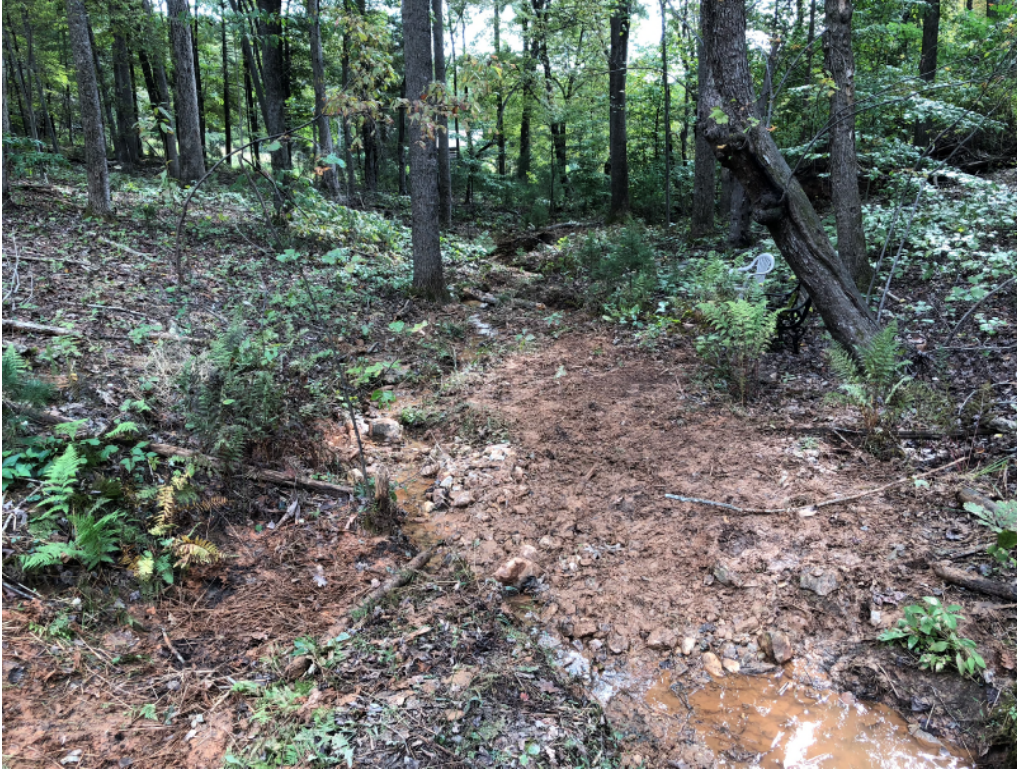
Photo 3: Sediment in stream and on banks at edge of RoW; Depth = 0.5-2"
Orientation: Downstream

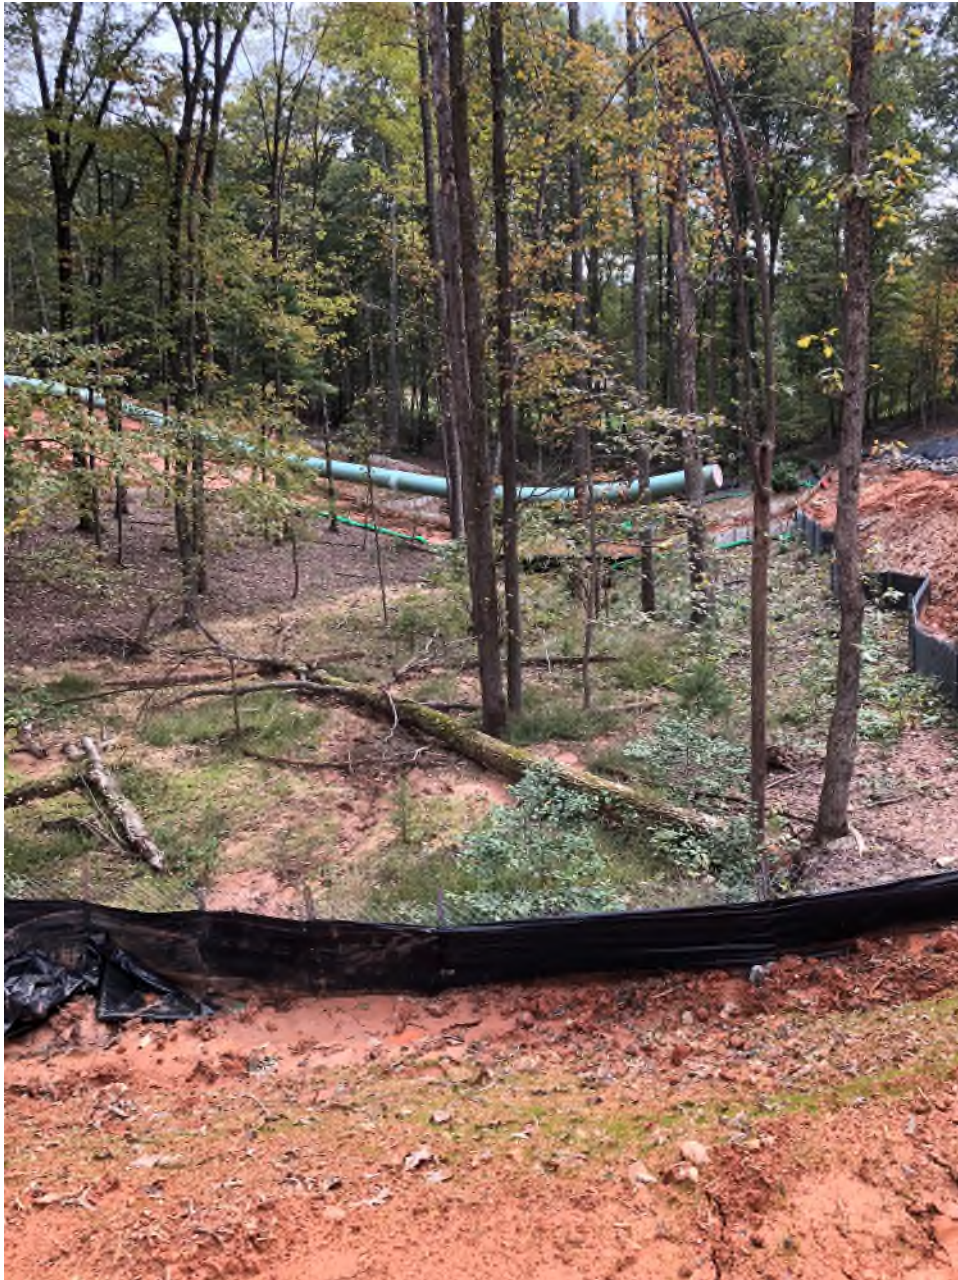
Photo 4: Overview of stream crossing and sediment within forested buffer
Orientation: SE

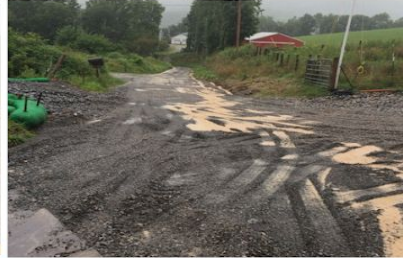
Ineffective gravel placement – now protecting stream crossing to left, but sediment is being channeled to the right side of the road into a recently dug ditch to move it offsite. No BMPs in place here to reduce sediment load within the ditch

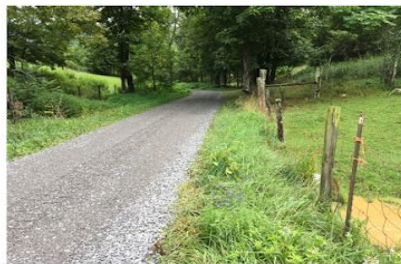
Where does it go from here? Sediment laden water crosses under SGT just beyond mailbox in the distance, then back under SGT through a culvert

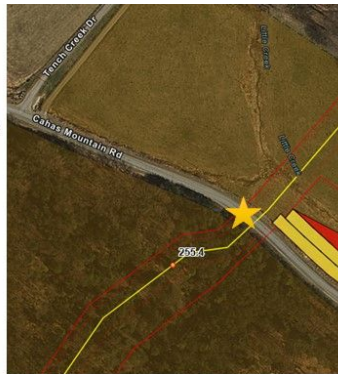
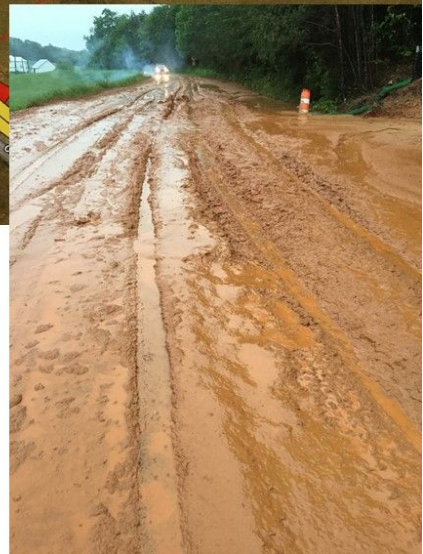
Figure 11: Potential violation reported - May 18, 2018

Erosion gullies, Bare soil - no mulch, Failing slopes, Failed BMPs, Sediment discharge outside construction area

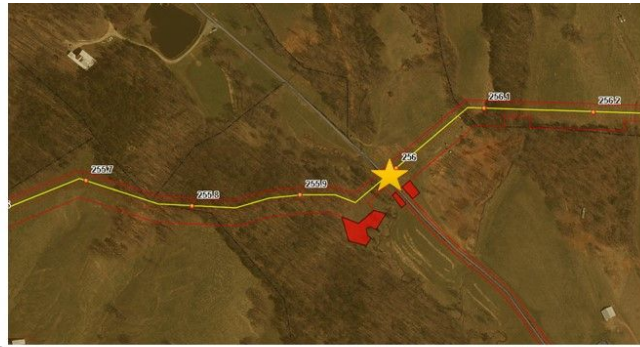
Figure 16: Potential violations reported May 18, 2018

Bare soil - no mulch , Failed BMPs , Sediment discharge outside construction area

Location Notes: 580 Wildwood Rd, Boones Mill, VA

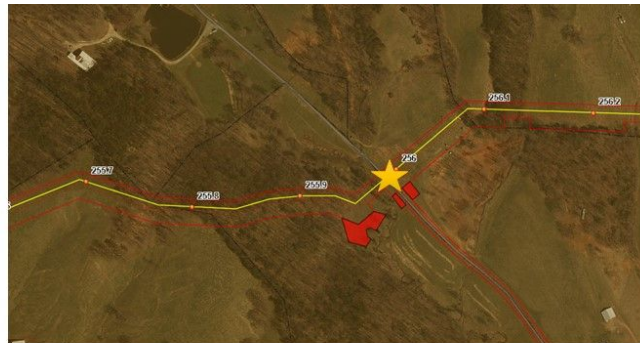
Figure 17: Potential violations reported May 28, 2018

Bare soil - no mulch , Failed BMPs , Sediment discharge outside construction area

Location Notes: 580 Wildwood Rd, Boones Mill, VA

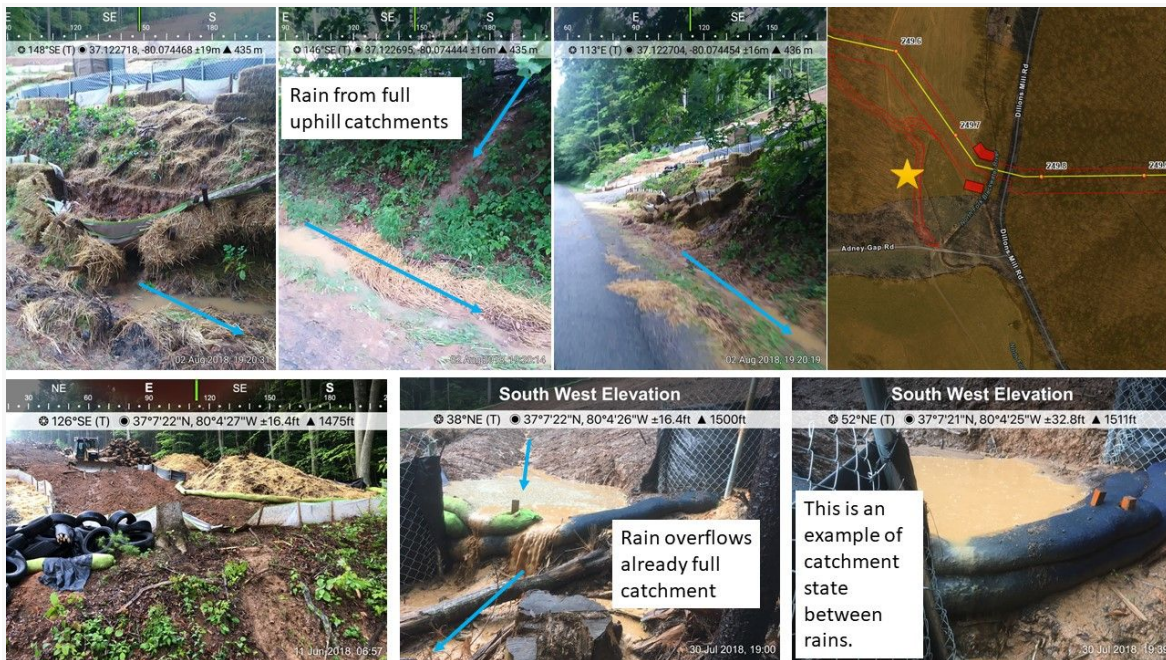
Figure 19: Violations reported - June 10, 2018 and August 3, 2018

Temporary right-of-way diversions (RWD) were not properly installed. Per Std & Spec 3.11 of the Virginia Erosion Control Handbook. Violation reported - June 10, 2018

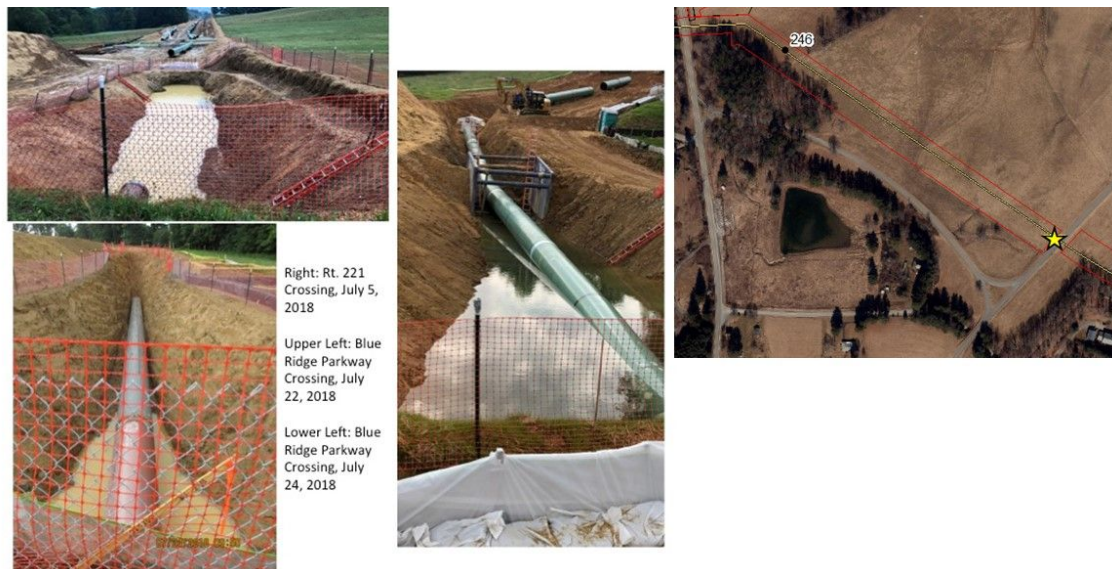
Figure 20: Images from Rt. 221 and Blue Ridge Parkway crossings in Roanoke County in July 2018

The perched aquifer has been breached at the Blue Ridge Parkway crossing. During both rain events and dry periods, the pipe beneath Route 221 and the Blue Ridge Parkway has been submerged in groundwater that continues to pool in the trench. This perched aquifer is the groundwater for the Bent Mountain community, and feeds residents' wells — their only source of drinking water. Pamela Dodds, an expert hydrogeologist, prepared a report on the perched aquifer of Bent Mountain in which she stated that "deforestation, soil compaction, and dewatering [during pipeline construction] will permanently deplete groundwater flow, especially groundwater flow through perched aquifers in the Mill Creek watershed to seeps and springs that provide water to wetlands, headwater areas, stream baseflow, and residential wells, and will permanently reduce the groundwater hydraulic gradient." (Dodds, P.C. 2017) See figures 20 and 21 for location of the Blue Ridge Parkway crossing, pictures of groundwater in the trench, and an aerial photo showing sedimentation of source water point for Mill Creek.
