A REPORT BY WILD VIRGINIA

FEBRUARY 2023

MOUNTAIN VALLEY PIPELINE POLLUTION IN VIRGINIA WATERSHEDS

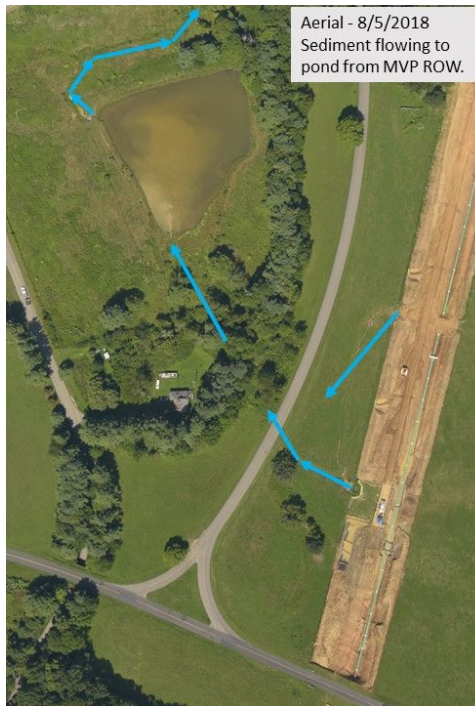
Figure 21: Aerial image from 8/5/2018 (left) and a pre-construction aerial (right) show drainage and sediment impacts from MVP construction ROW to neighboring pond.

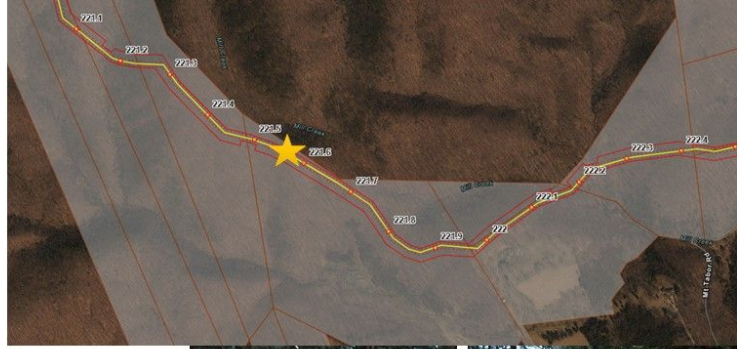
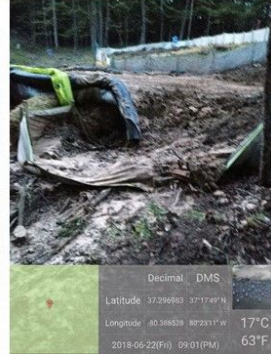
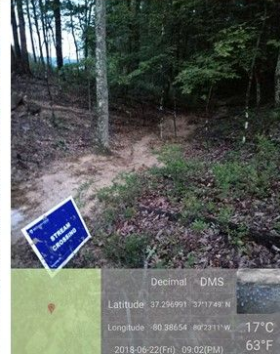
- evidence of sediment leaving the construction site
- evidence of flooding at the site
- evidence of structural damage at the site
- evidence of erosion at the site
- ROW diversions are not installed or functioning properly

- fence is damaged, collapsed, un-entrained or otherwise ineffective
- sediment has not been removed per maintenance requirements
- silt fence not properly located and installed

Figure 25: Images from incident reported on June 22, 2018. SMN-21 impacted.

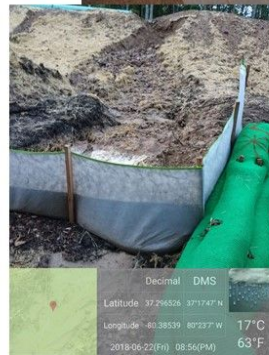
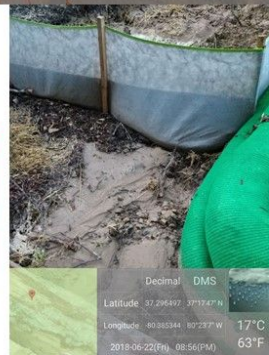
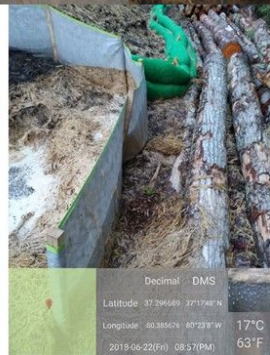
- fence is damaged, collapsed, un-entrained or otherwise ineffective
- sediment has not been removed per maintenance requirements
- silt fence not properly located and installed

Figure 26: Images from incident reported on June 22, 2018. SMN-21 impacted.

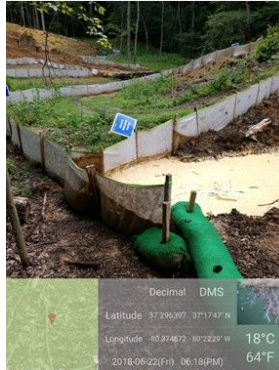
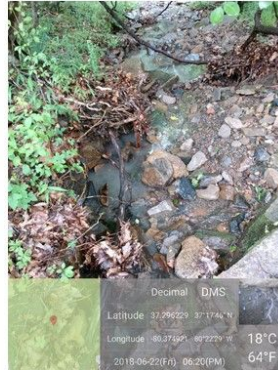
Figure 29: Photos from June 22, 2018 reported incident on Triplet property

- evidence of sediment leaving the construction site
- evidence of flooding at the site
- evidence of erosion at the site

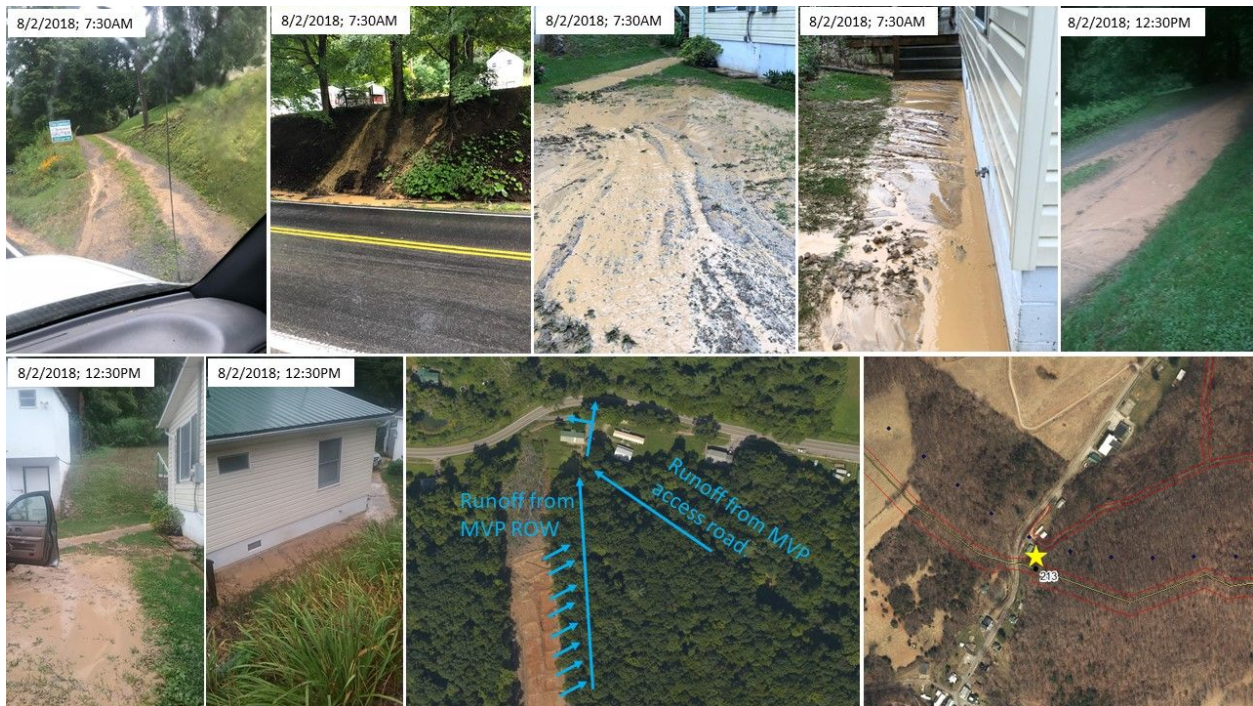
This is the first major failure observed in Historic Newport Virginia. This is the pattern for future rain events and impacts to Sinking Creek. See images of potential violation below. The drainage area for stormwater runoff includes a portion of an access road and a large area from the MVP right of way. Overwhelmed outlet structures at the discharge point of diversion bars cause rain water to create new runoff gullies adjacent to the ROW. Runoff from the access road combines with ROW runoff and result in the sedimentation shown in figure 32. A snapshot of the USGS water quality gauge, figure 33, located 1.71 miles downstream in Sinking Creek indicates a large spike in sediment loading on August 2, 2018.

Figure 32: Photos from August 2, 2018 reported incident in Historic Newport.

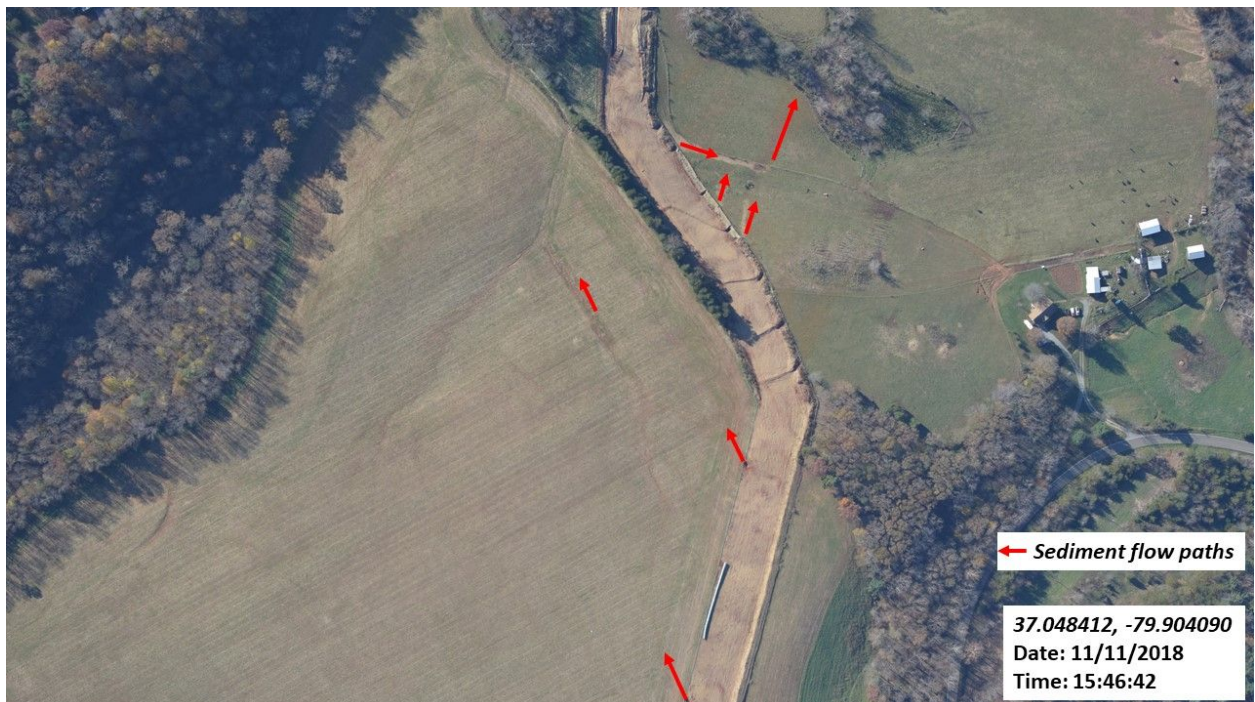
Figure 21: Sediment flowing into field from right of way diversions.

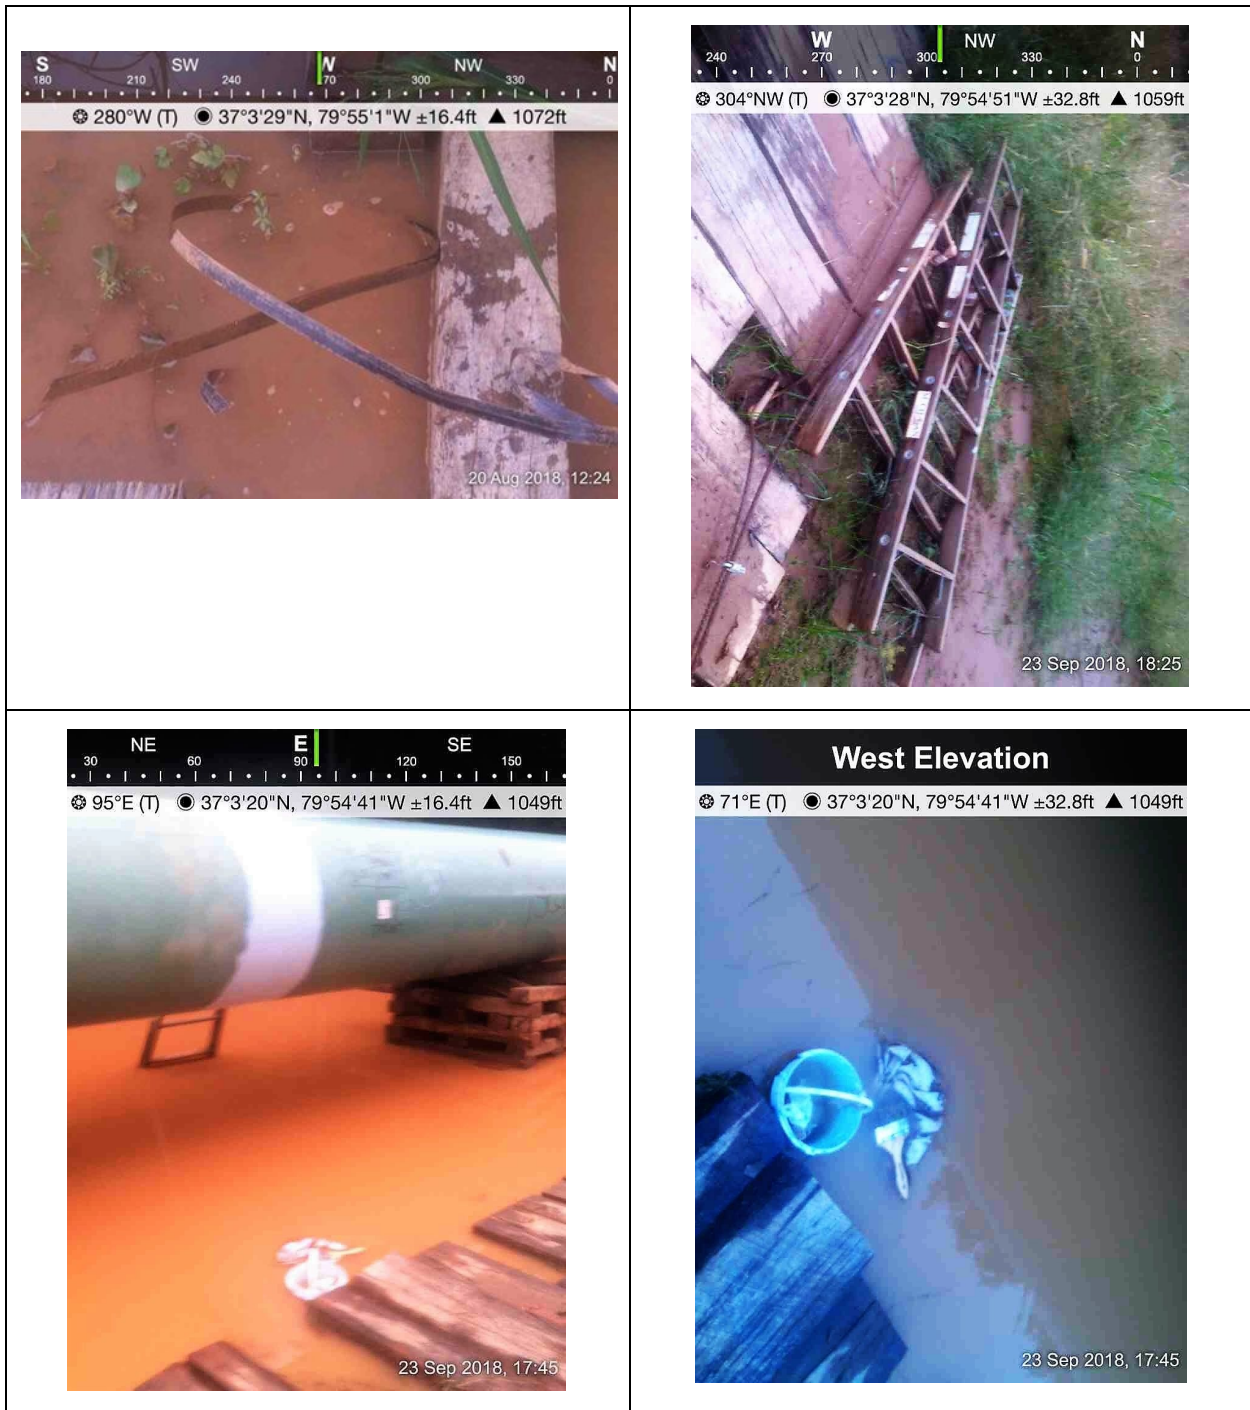
Table 1: Four Corners Farm flooding and poor MVP construction site management.

This photo is from 10/28/2018 at ~3:57pm.

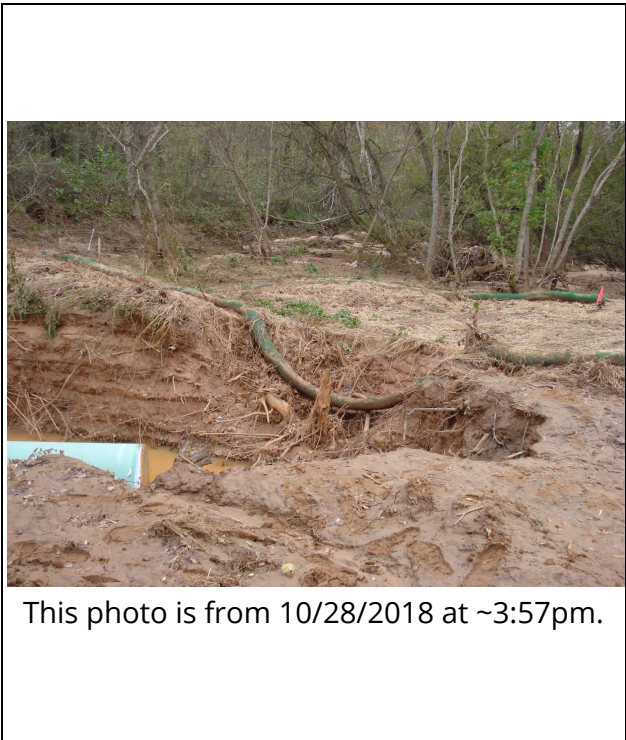
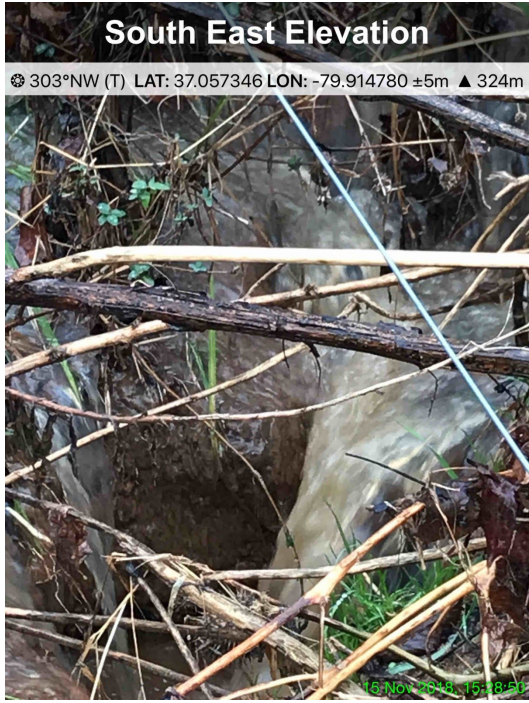
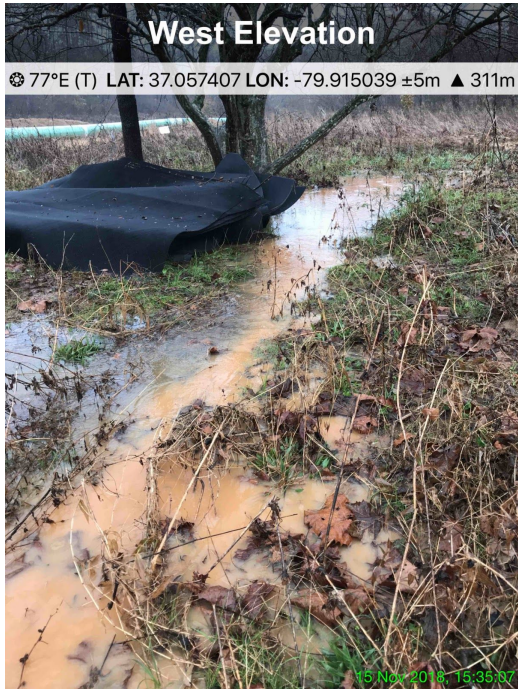
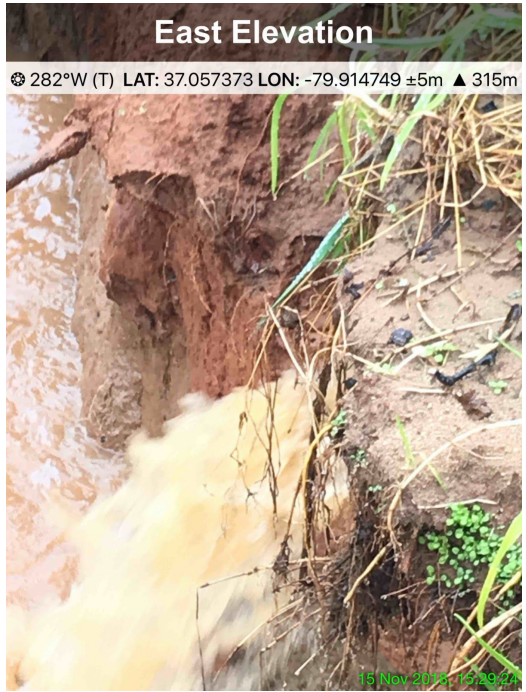
Table 2: Pictures of Four Corners Farm during a rain event showing sediment laden water piping through a cavity from LOD to creek.

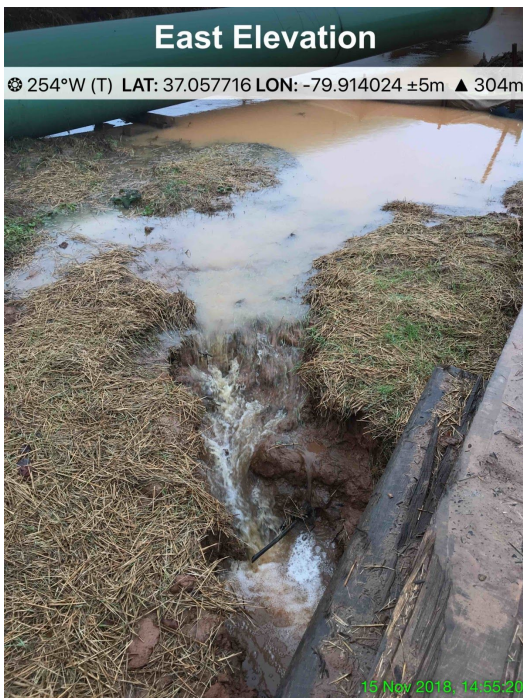
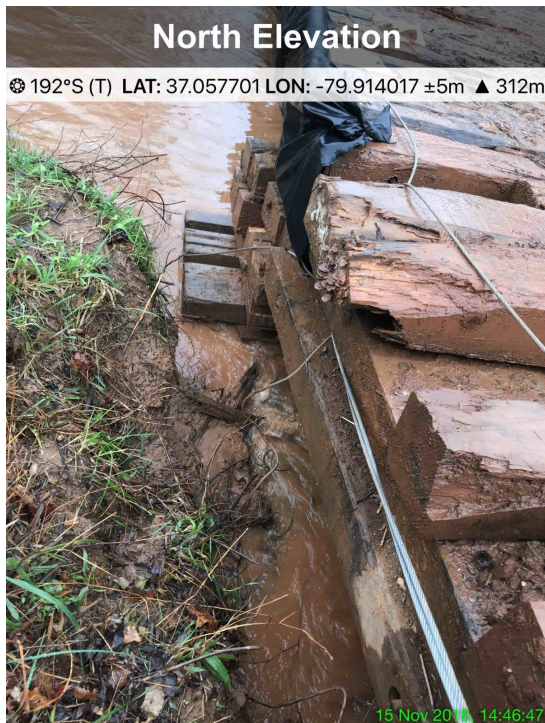
Table 3: Images from 11/15/2018, Four Corners Farm, Franklin County, Virginia.

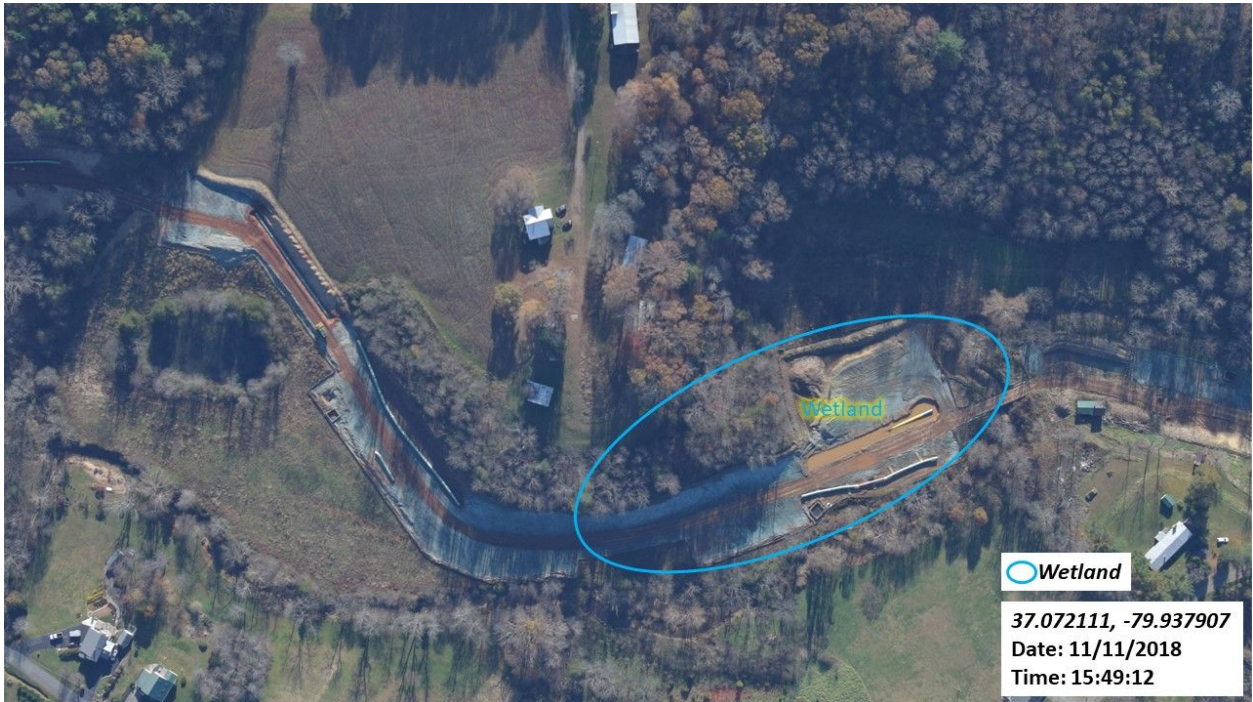
Figure 29: Sediment flowing into wetlands and adjacent stream.

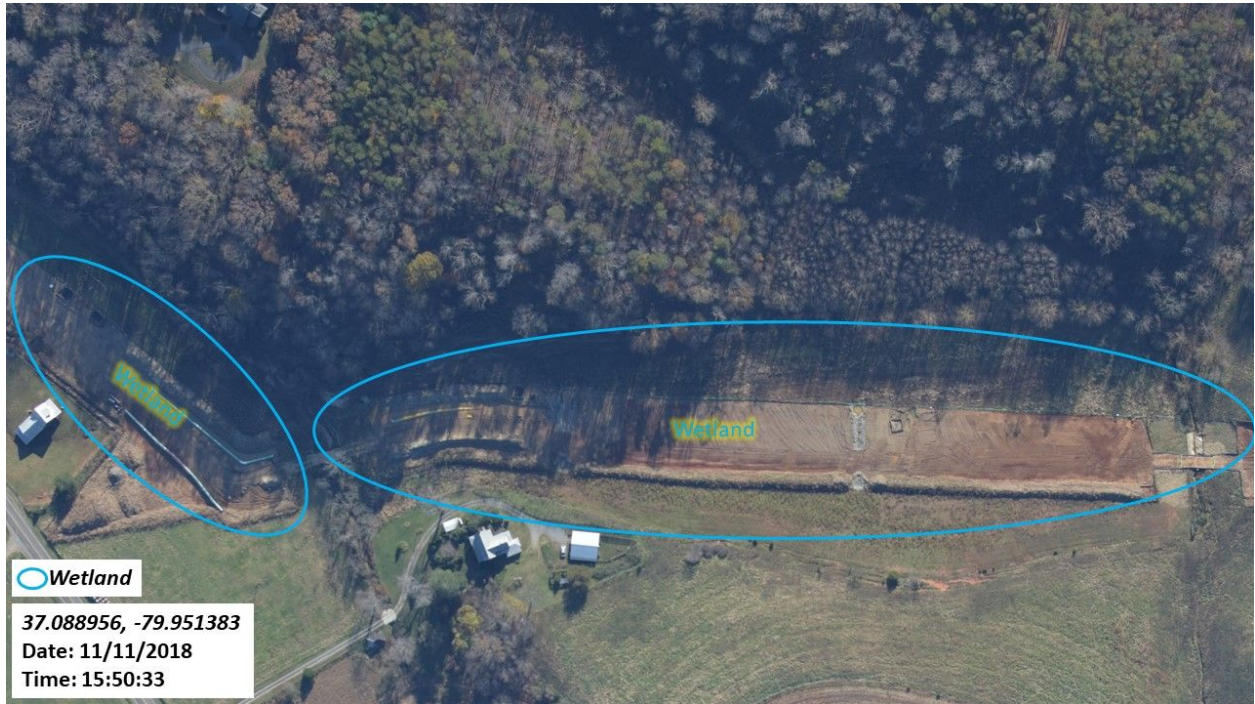
Figure 32: Wetlands area encroachment.

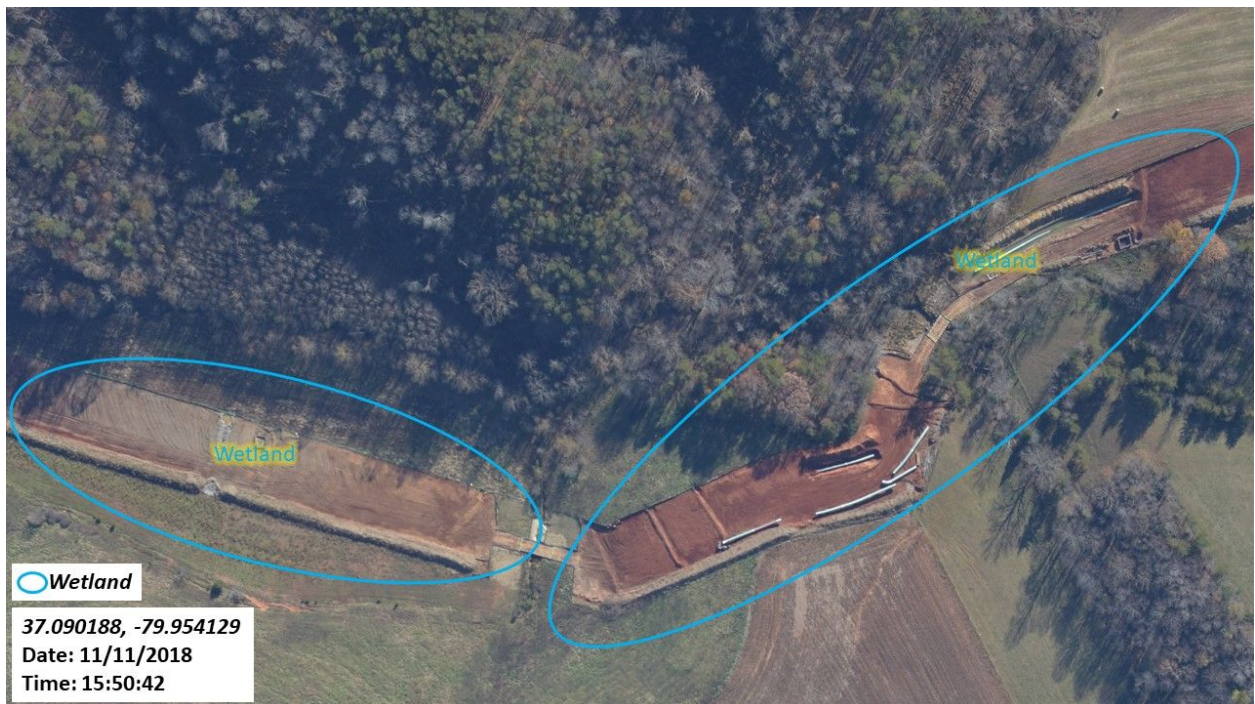
Figure 33: Wetlands area encroachment. Flooding occurred in these areas.
