**The Wilderness Society et al. Comments on the
U.S. Forest Service Mountain Valley Pipeline and
Equitrans Expansion Project Draft Supplemental
Environmental Impact Statement (#50036)**

EXHIBIT 12

**WEST VIRGINIA DEPARTMENT OF ENVIRONMENTAL PROTECTION
WV OIL AND GAS CONSTRUCTION STORMWATER PERMIT**

FACILITY NAME:	Mountain Valley Pipeline Project		REG. #	EXPIRE DATE:
PERMITTEE	MOUNTAIN VALLEY PIPELINE, LLC		WVR310667	5/13/2018 Extended: 12/31/2018
ADDRESS/PHONE:	Attn: MATTHEW HOOVER 625 LIBERTY AVE, ST 1700 PITTSBURG, PA 15222 7248733645			
LOCATION:	Harris Compressor Station		Entry Date/Time:	9/25/2018 1000
COUNTY:	Braxton		Exit Date/Time:	9/25/2018 1100
Site Representative /Phone	Brittany Dewitt (Lead EI)/330-987-1682, Matt Hoover MVP/ 412-258-5627 & Jason Hiles, Spread C Lead EI/740-334-7812		PHOTOS <input checked="" type="checkbox"/>	
CO-PERMITTEE:			ADDRESS:	
SITE OPERATOR:	MEC Construction LLC		ADDRESS:	19 RR Meadowbrook, WV 26404
PERMITTED ACREAGE	4311	WEATHER:	Cloudy	LAST INSPECTION: 8/21/2018
RECEIVING STREAM(S)	Trib of Elk/Kanawha R/ Ohio Rv			NOV: 1
Regular Mail <input type="checkbox"/> Certified Mail <input checked="" type="checkbox"/>	Tracking #			
OVERALL FACILITY R

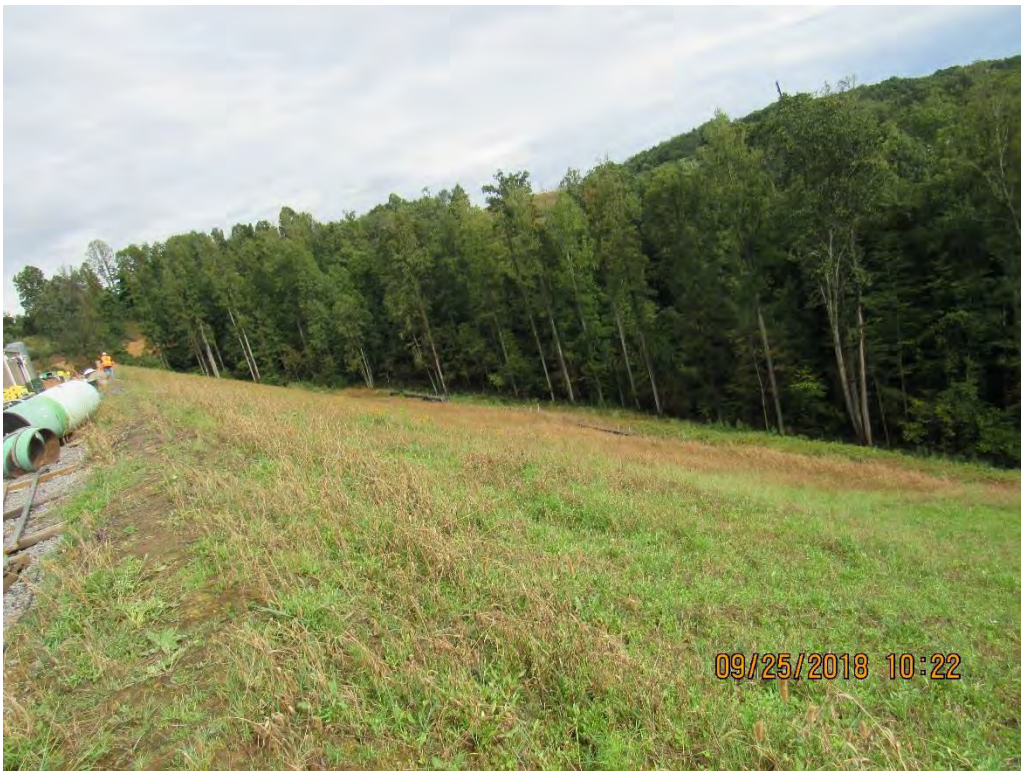
Photo 8: Re-vegetated slope on north eastern side of site abating NOV# W18-52-007-CP.

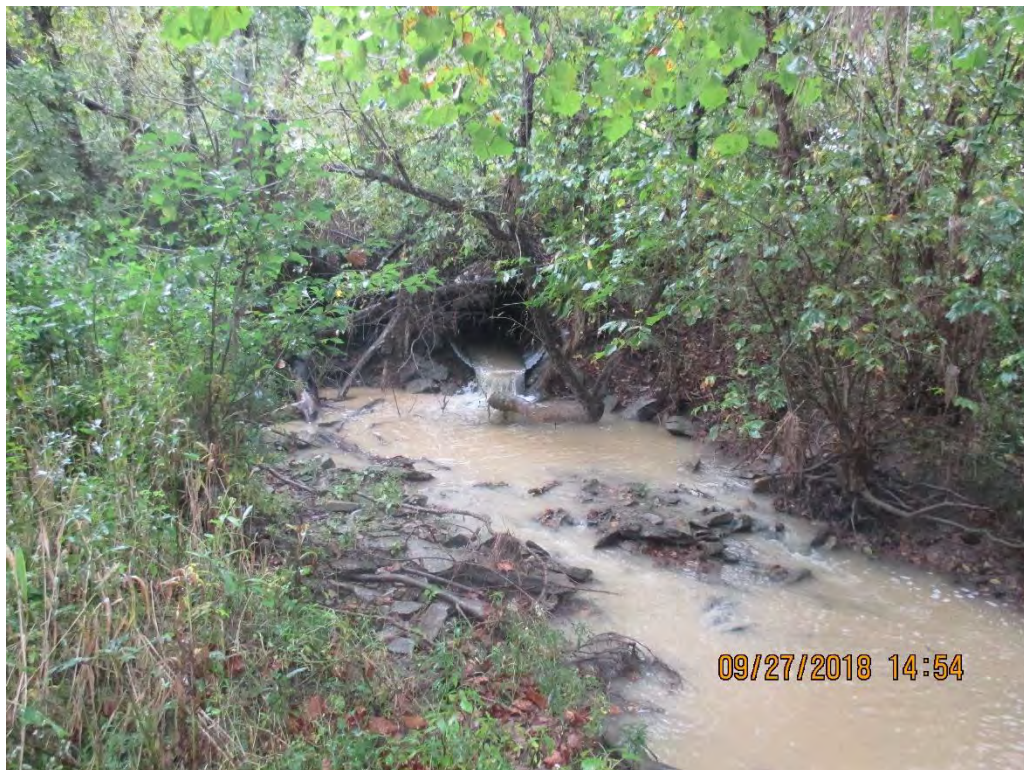
Location where SLW was entering stream S-A60.

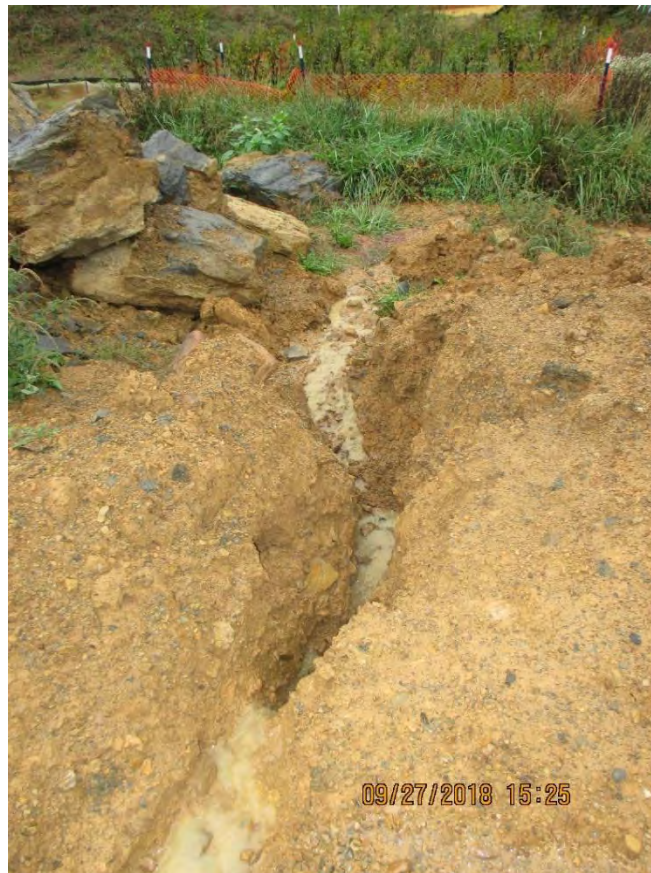
Water bar terminus leading to BMP. Erosion occurring due to channel not being stabilized.

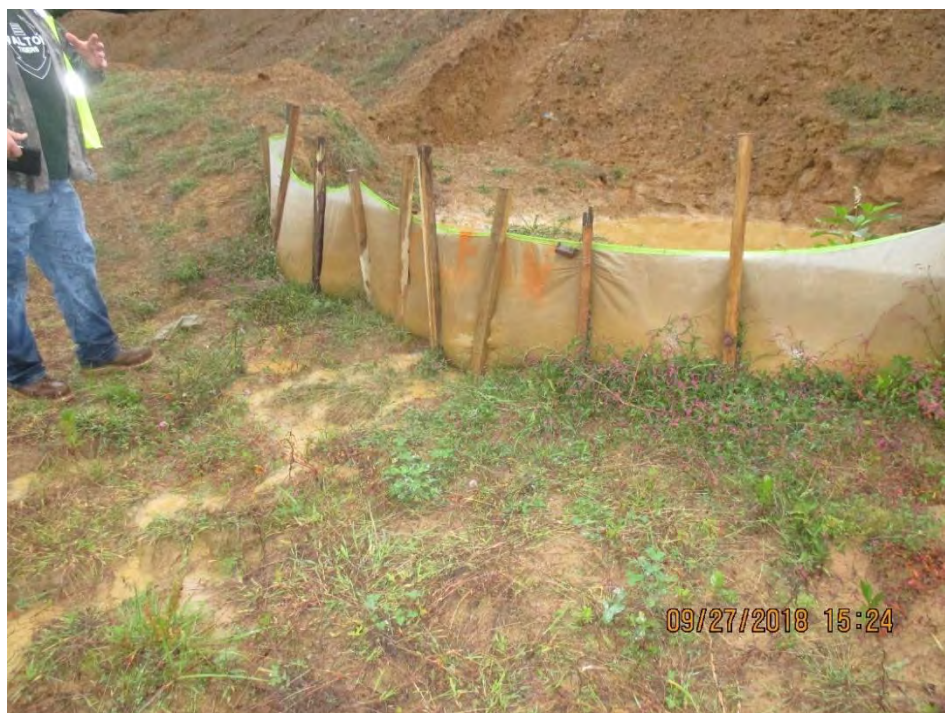
Sediment Laden water passing through/Under BMP.

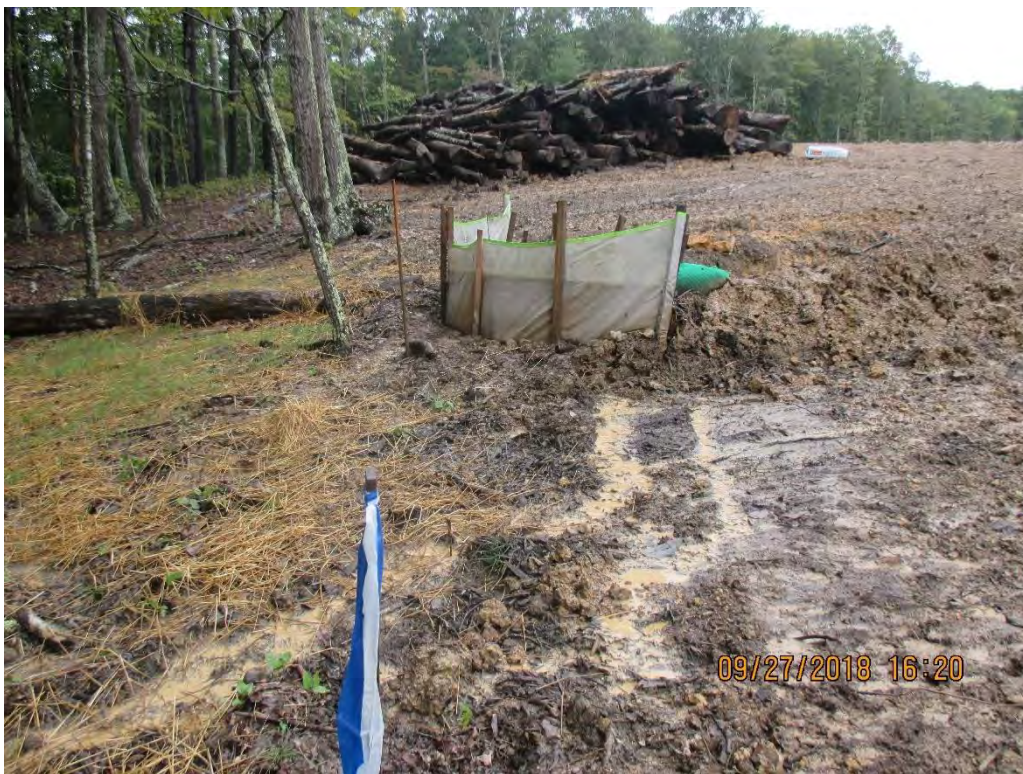
SLW flowing past BMP near Station #9417+75

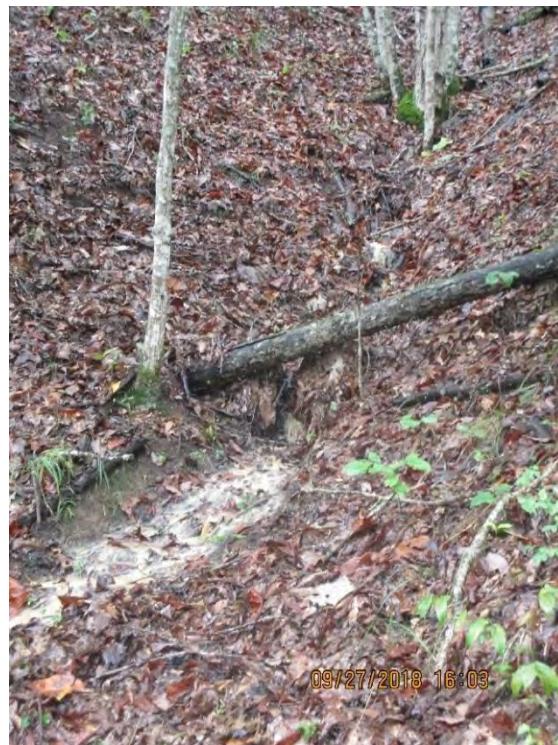
Spring/seep transporting SLW.

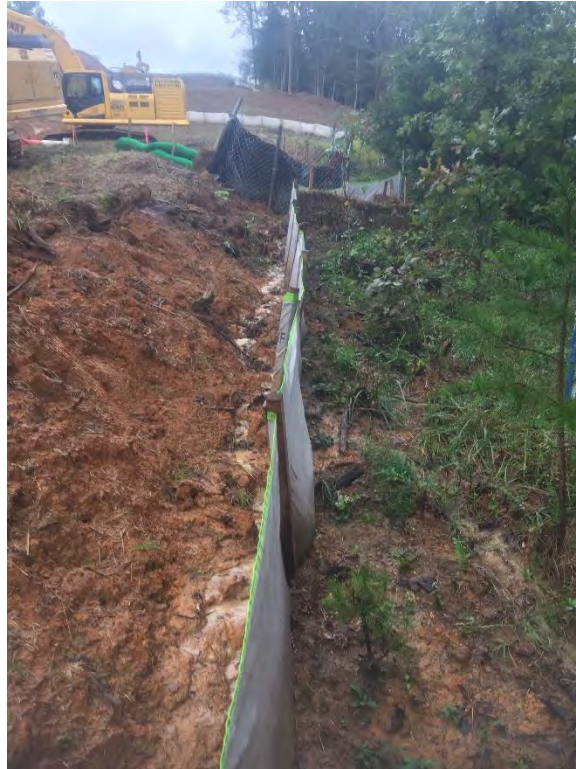
- 3.) (1, 6, 13, 19, 20) On 9/27/18 SLW was observed coming off hillsides on both sides off ROW at the Ellison Ridge road (CR 23/9) near station number 9783+00 and entering drainage ditches that flowed downhill through culverted stream crossings (S-Z5 and S-Z4). SLW was observed flowing downstream and was impacting a pond in line with stream S-Z4 approximately one-half mile down Ellison ridge road.

ROW near station numbers 9779+00 and 9778+00 where water bar outlets were being overwhelmed and SLW was passing through and under and being transported past LOD.

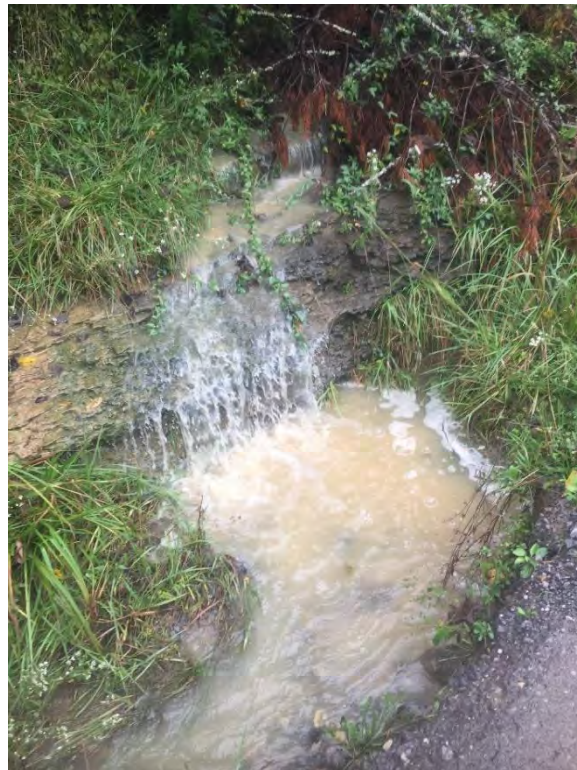
Ephemeral stream discharging into roadside ditch along Ellison Ridge Road.

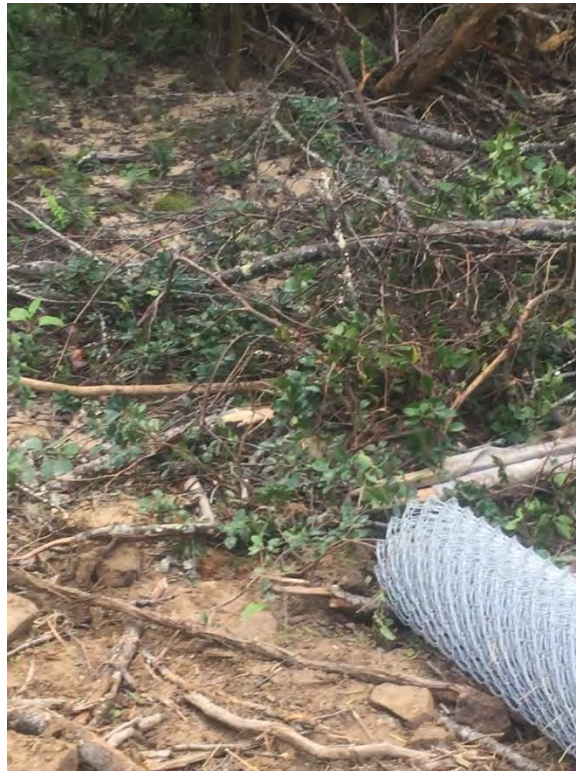
Close up of sediment that has been deposited past BMP.

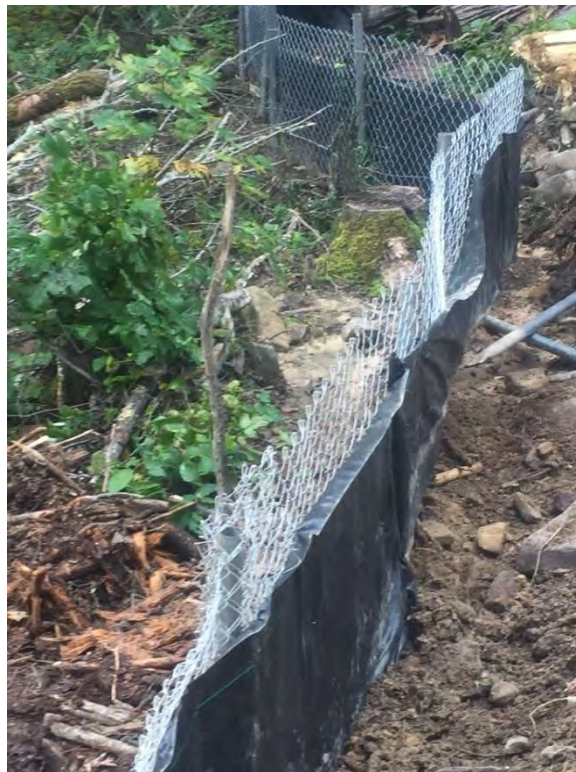
Area near station number 9907+00. Super silt fence had been undermined and damaged by logs.

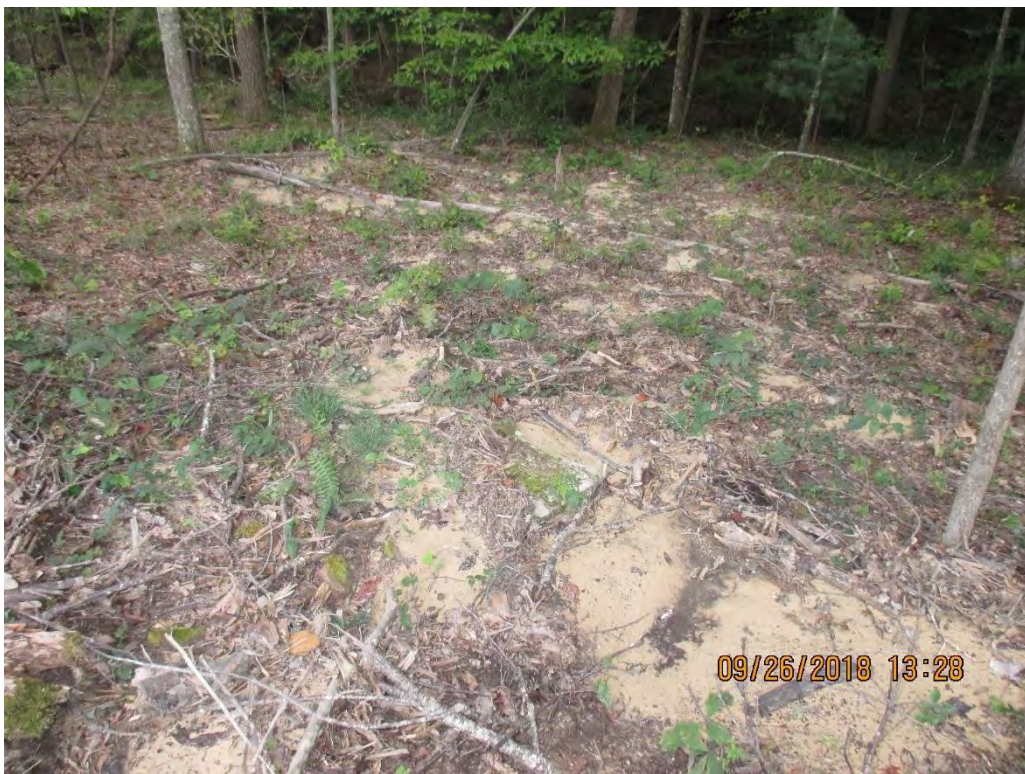
Off site sediment deposits located past LOD and being transported towards Streams S-H58 and TTWV-S-E58 near Station number 9899+00.

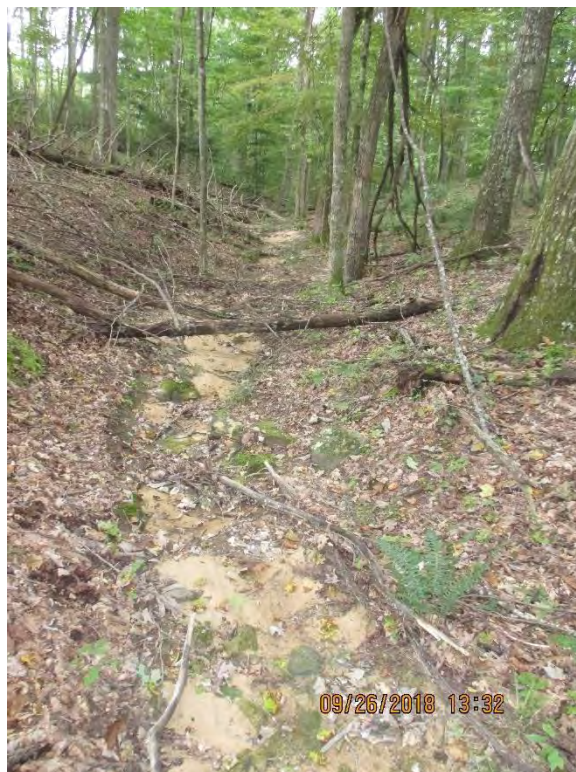
Stream S-H58/TTWV-S-E58 with sediment deposits heading towards Hans creek between Station number 9892+00 through 9899+00.

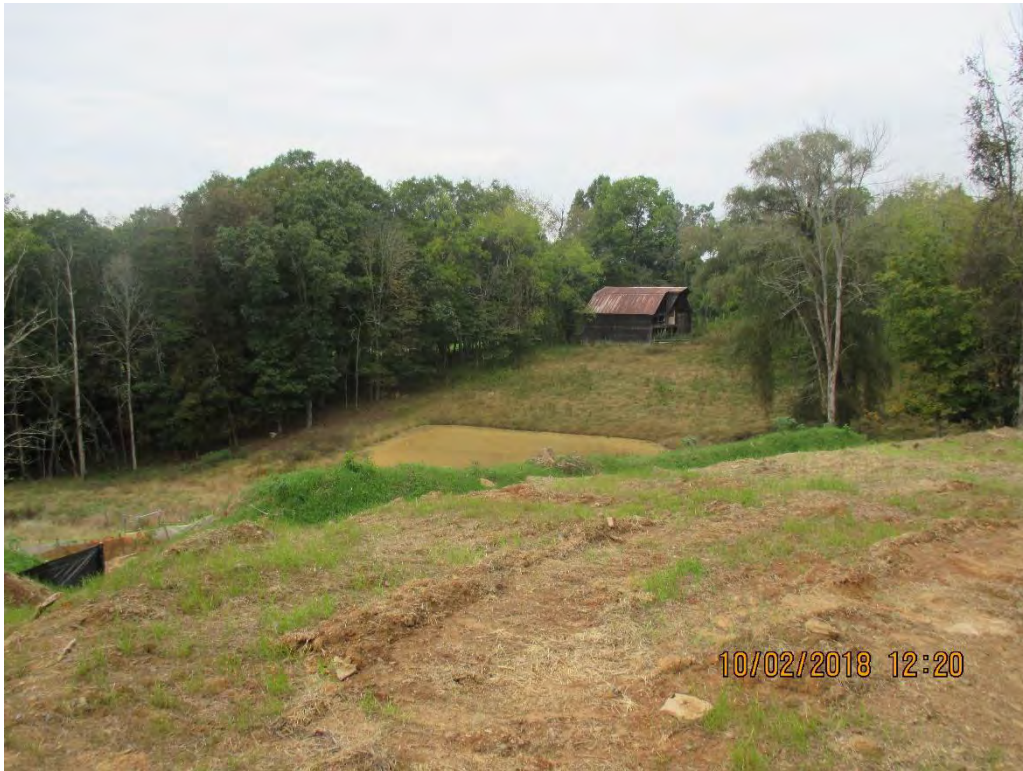
1.) (1, 6, 13, 14, 19, 20) Suspended sediment was observed in large pond (P-D1 on SWPPP) near station #9687 off MVP ROW. Near station #9687+00 run-on was entering the ROW from the uphill slope and causing erosion and BMP's to be overwhelmed downslope towards stream and pond. SLW had been transported past LOD, through Stream (S-D29), and failing BMP's that lead to the pond. Multiple BMP's were failing in this location on both sides of Stream S-D29 and sediment deposits were noted past the LOD. Fill slope protection and channel stabilization was lacking in several locations on both sides of the slopes that lead to the stream and pond. This was causing gully erosion to occur along portions of the slopes that lead to BMP's.

Pond (P-D1) impacted by visible settleable solids.

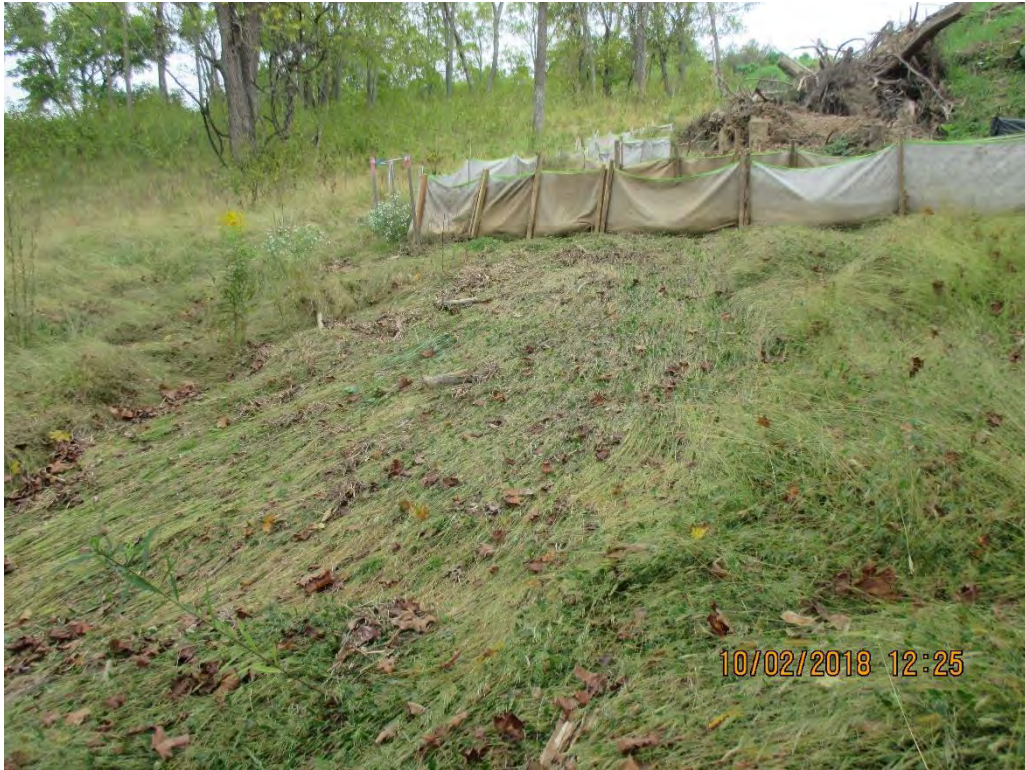
BMP above pond receiving concentrated flow.

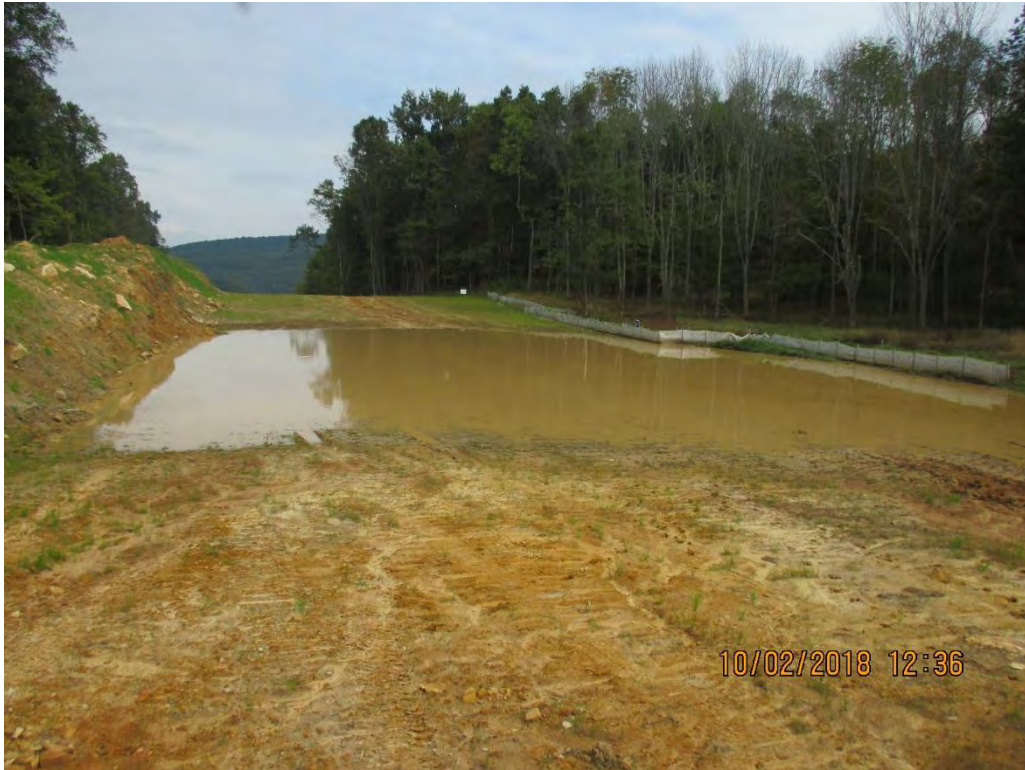
Pond (P-D2) near station number 9680.

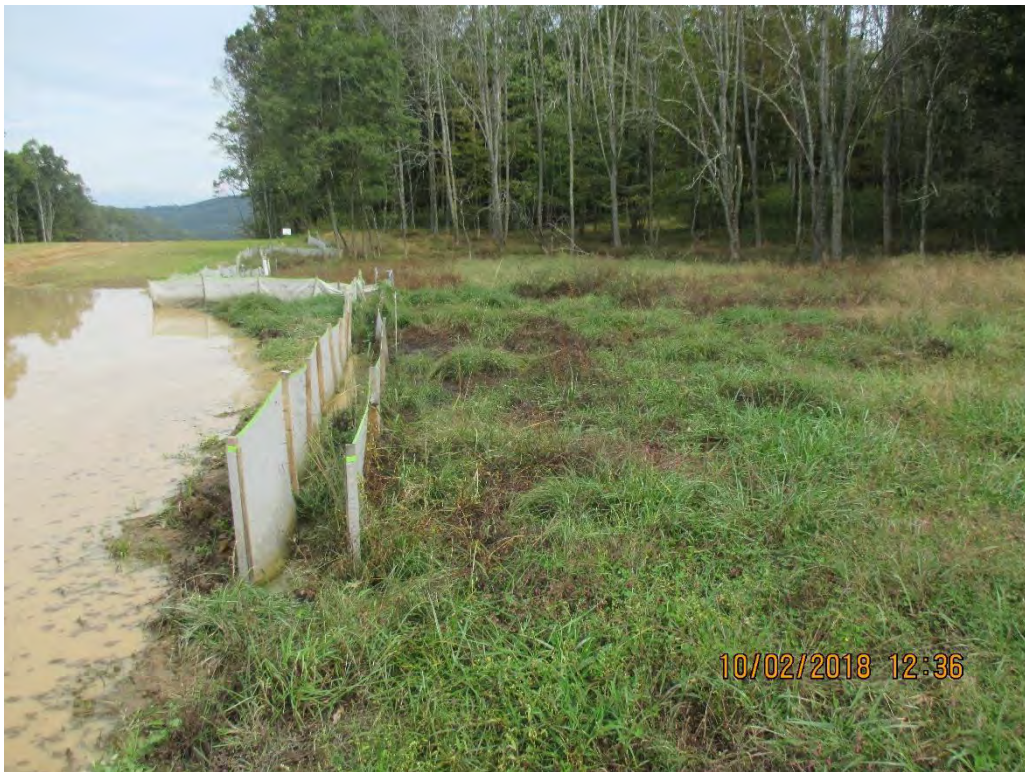
Edge of Pond (P-D2) near station number 9680.

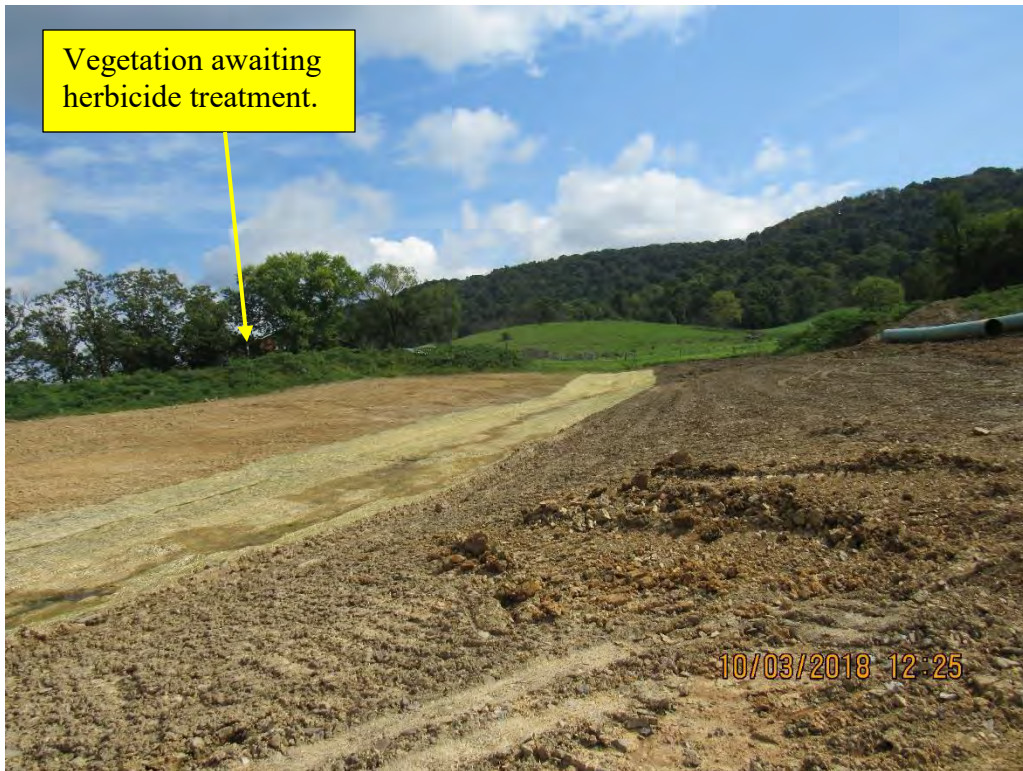
- 13. – Lindside Methodist Church (station 10116+49) continues to be an area of concern. Progress has been made with removal of matting and creation of bridge, as well as establishing a channel for run on water (photos 4 & 5). However, run on water lacks an established channel through site (photos 6 & 7). Per Megan Neylon, this area is waiting on approval for application of herbicide on topsoil vegetation prior to spreading and establishing permanent stabilization.

Photo 4: Lindsie Methodist Church station 10116+49- established channel for run-on created.

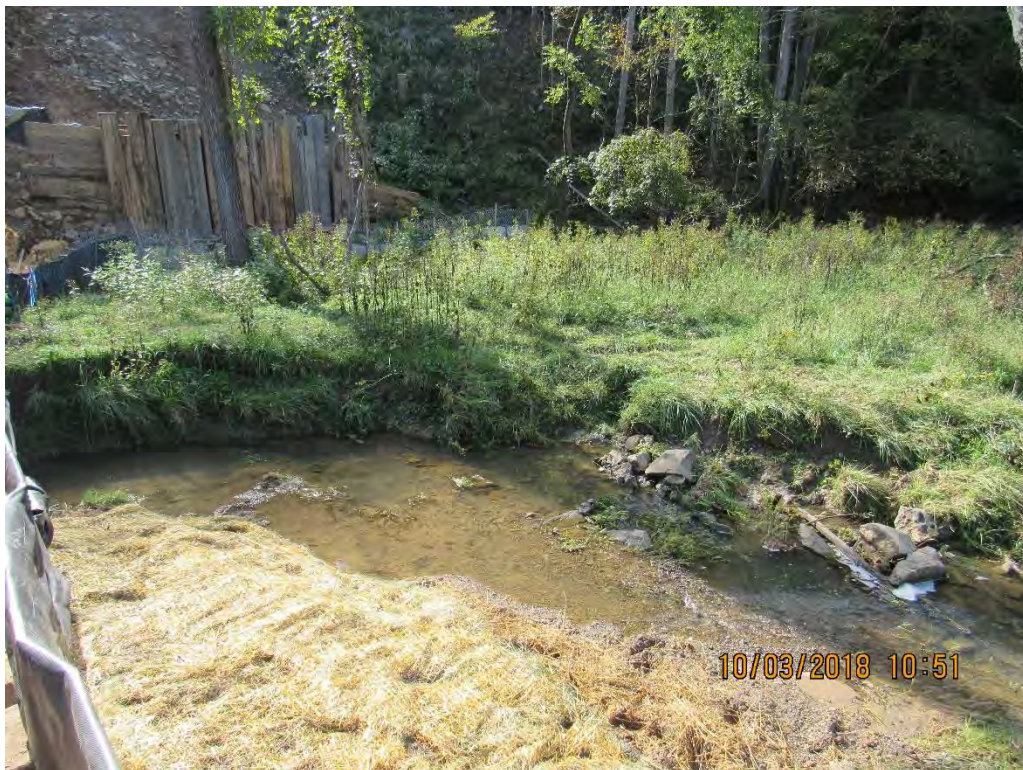
- The following locations were visited. No issues were observed.
 - Keller's Creek (station 9127)- location of equipment roll-over into creek. Clean-up and stabilization completed (photos 8 & 9)

Photo 8: Location of equipment roll-over into Keller's Creek station 9127 with clean-up completed.

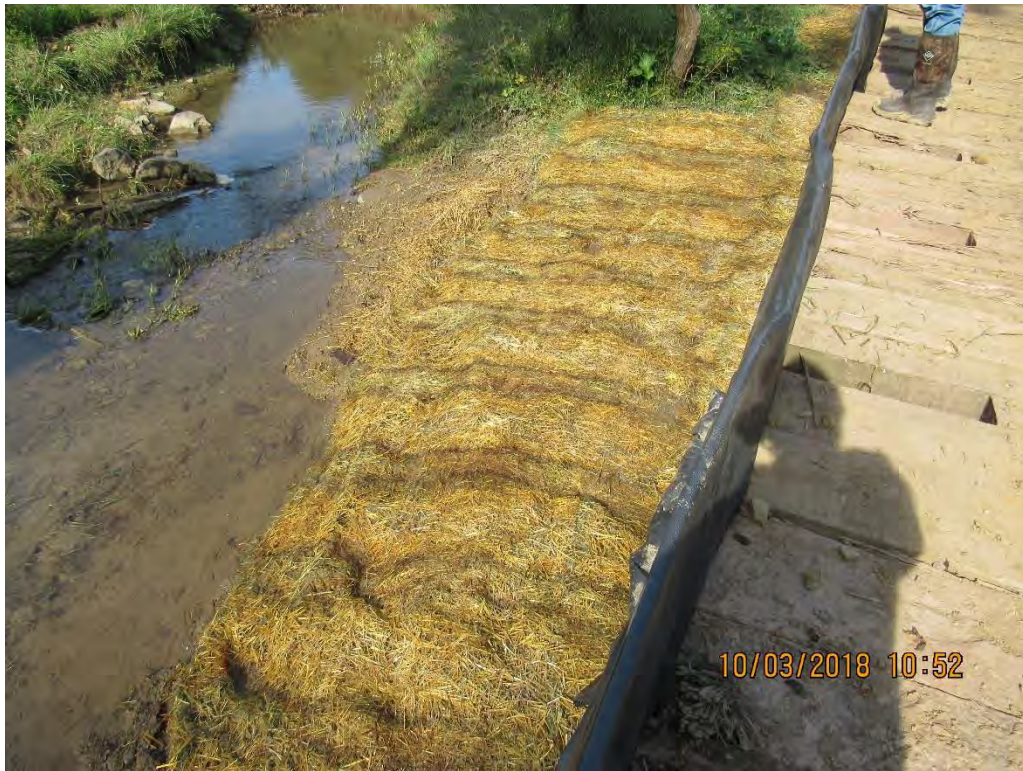
Photo 9: Location of equipment roll-over into Keller's Creek station 9127 with clean-up completed.

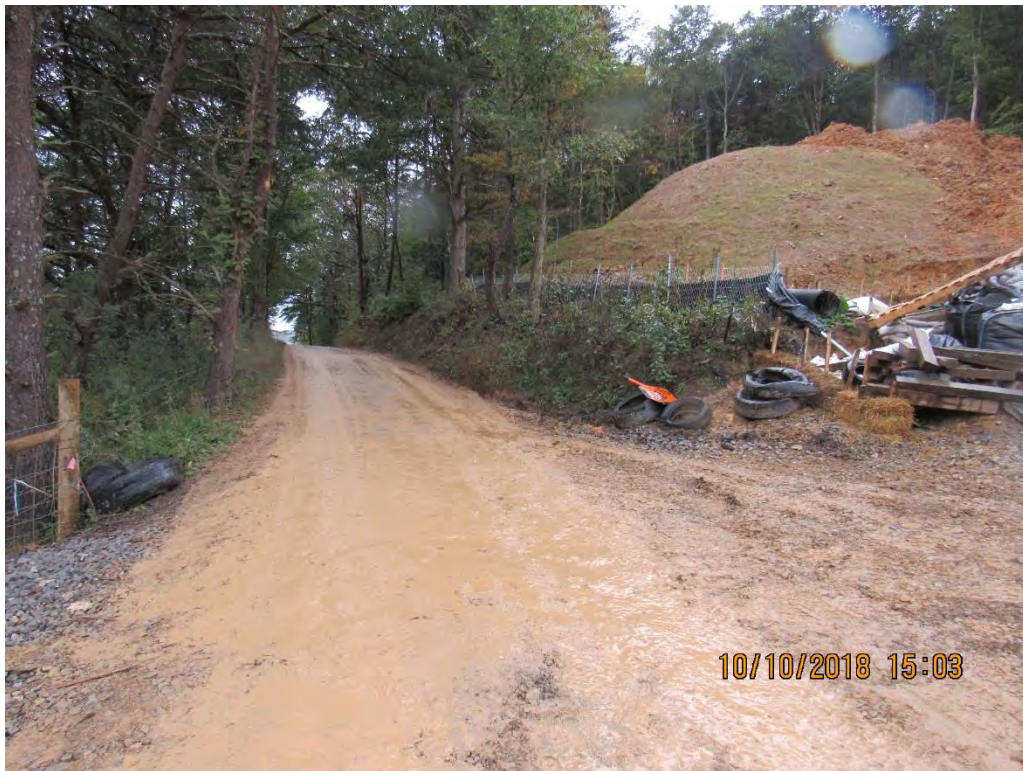
- 12. & 19. – AR 210 (photos 1-3) and Painters Run Road station 10270 (photos 4-6) had mud on roadway which was causing sediment laden water to leave site.
- Lowell Road station 9087 continues to serve as laydown/construction yard. Pipe laying and tie in is progressing south (going away) of this location. Minimal preparation for crossing Greenbrier River has occurred (just north of this location) (photos 7-8)
- Kellers Creek station 9127- location of equipment roll over several weeks ago. Area has been roughly graded and is awaiting finish grading and restoration (photo 9)
- Wayside/Talcott station 9466- rough grade completed. Awaiting final grade and restoration. Awaiting final decision on how much will be restored vs winter stabilized due to tie in required in wetland area and wetland/stream stay of USACE permits (photos 10-11).

Photo 4: Painter's Run Road station 10270 at access road crossing.

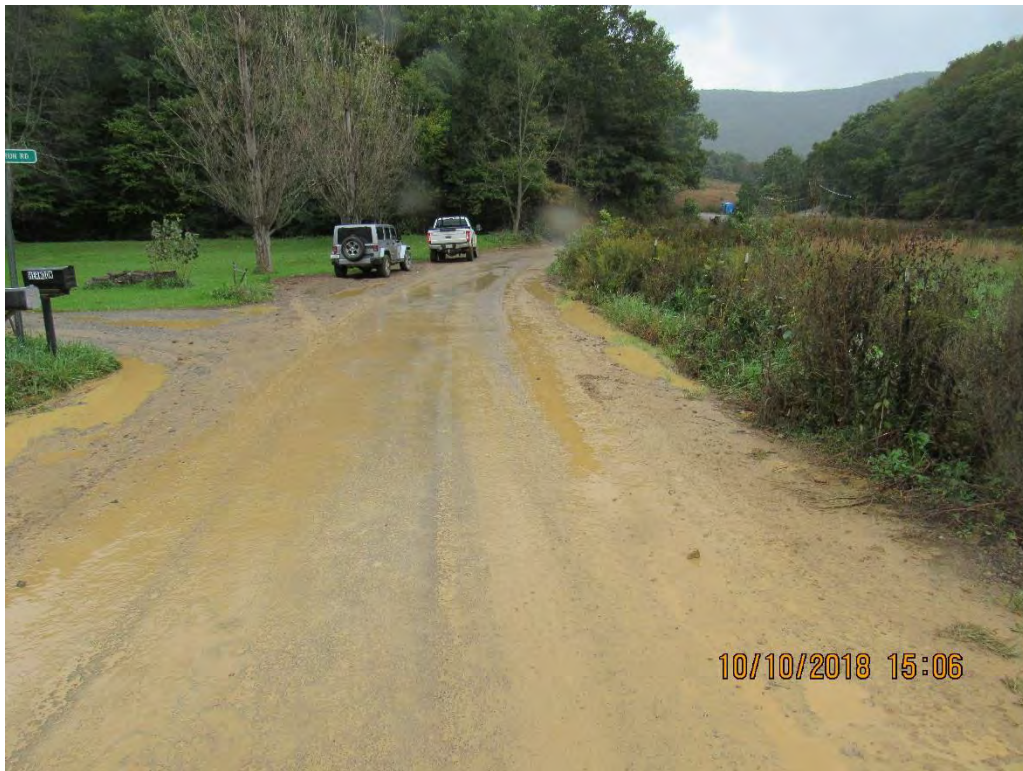
Photo 6: Painter's Run Road station 10270 down gradient of access road crossing.

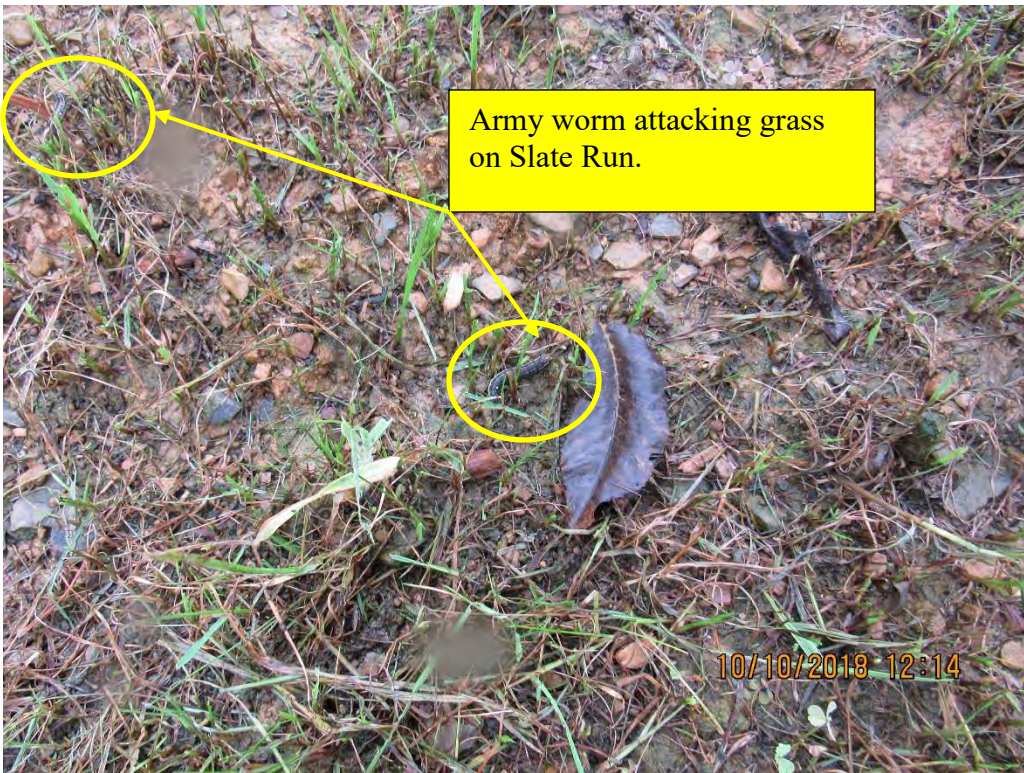
Photo 14: Army worm at Slate Run station 9624.

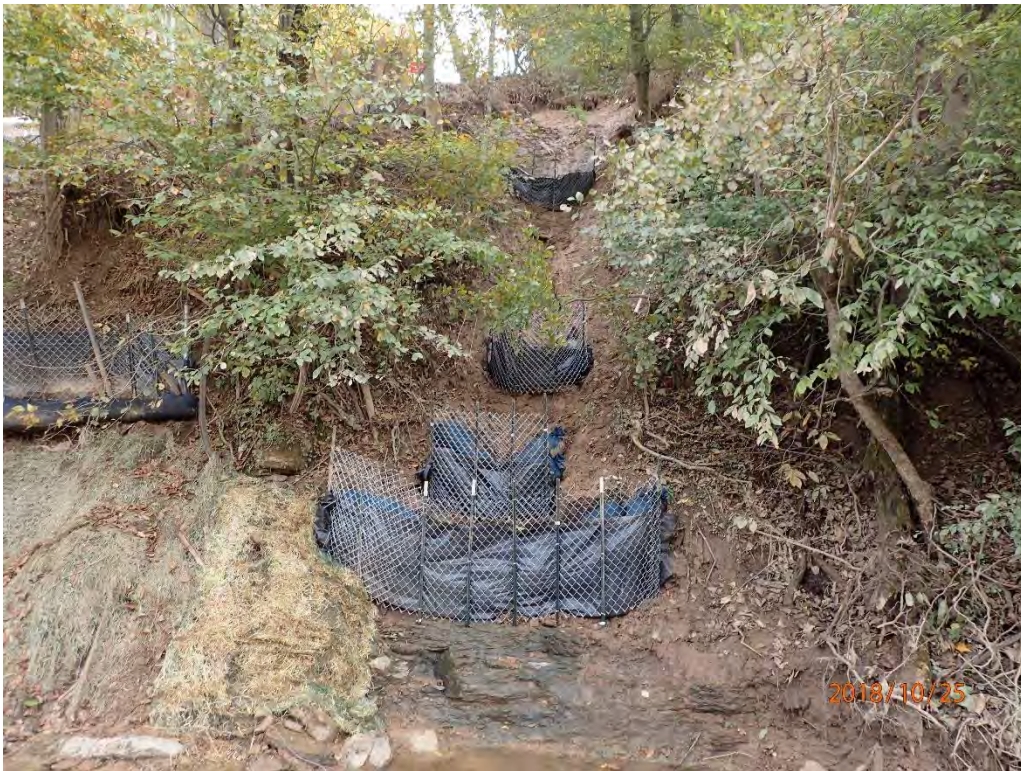
Slip off Sams Run with controls in place.

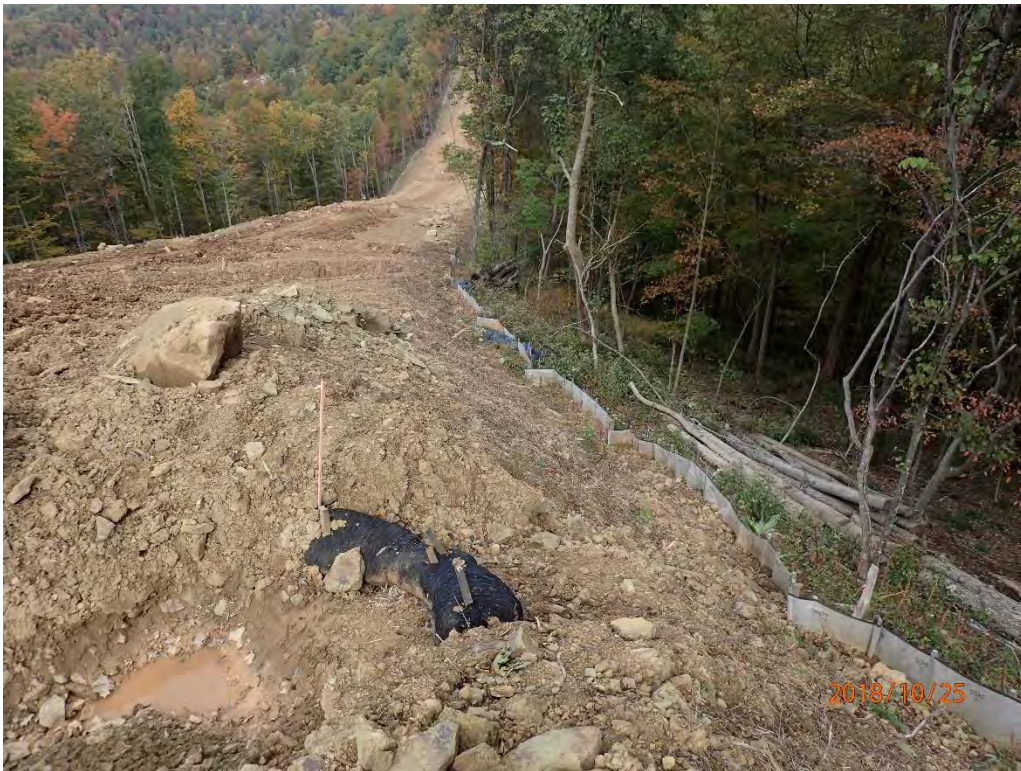
ROW near access road 18.

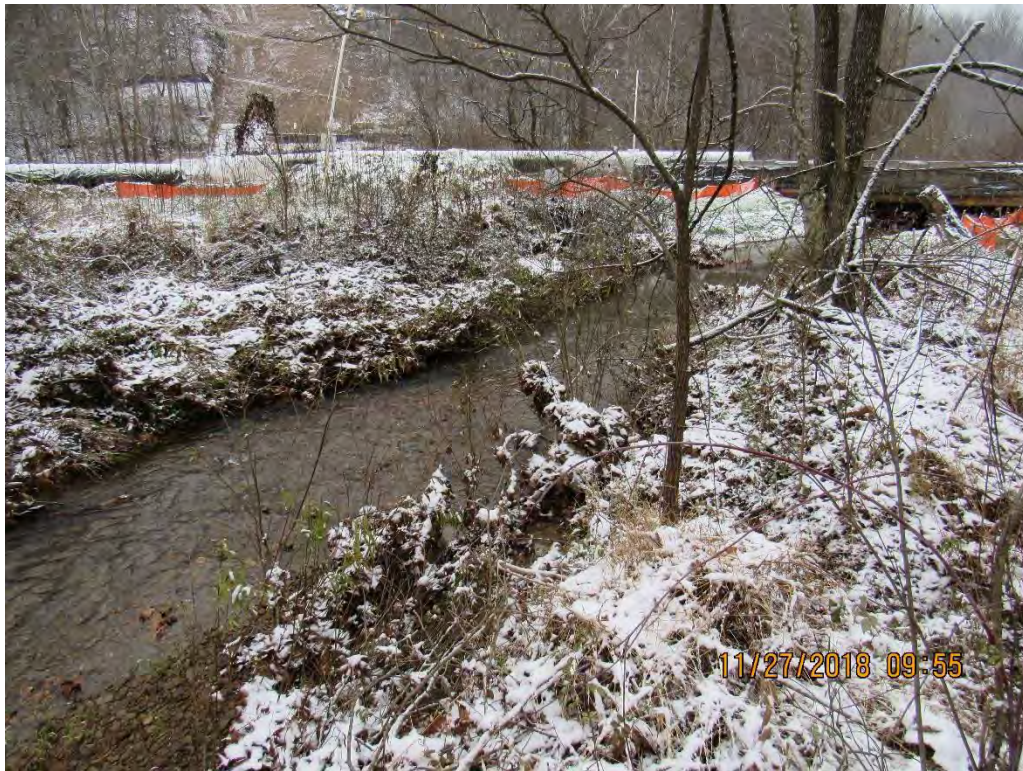
Photo 3: Downstream view of Knowl's Creek at location of convergence of UNT.

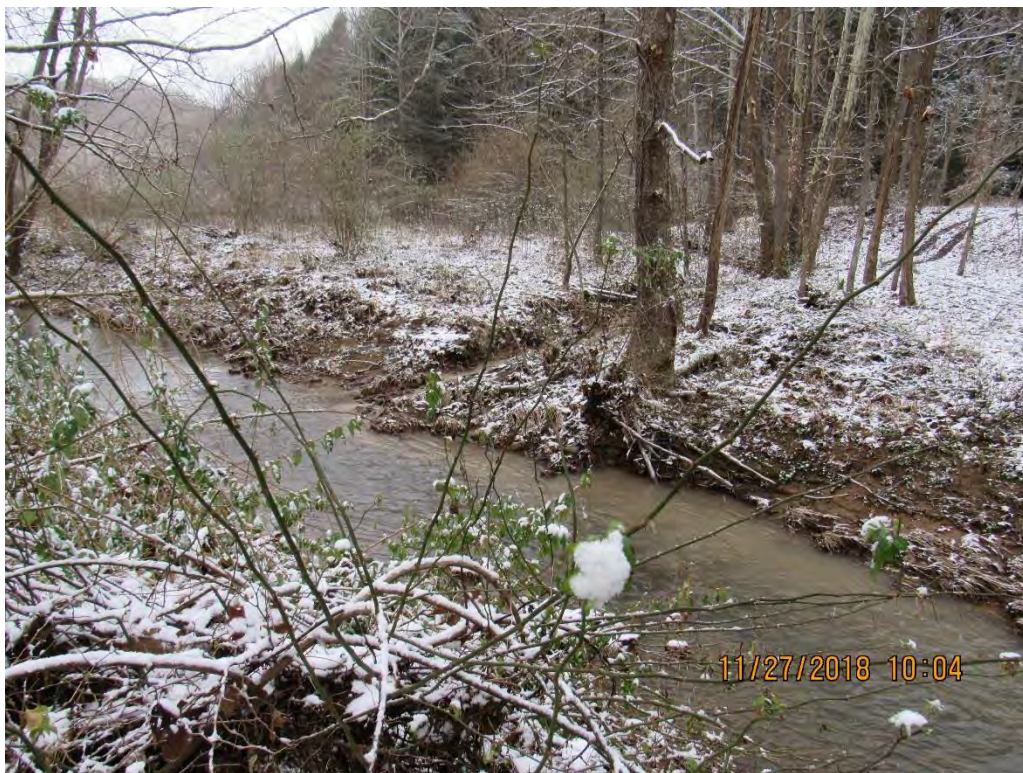
Photo 8: Slightly downstream of convergence point into Knawl's Creek below release point.

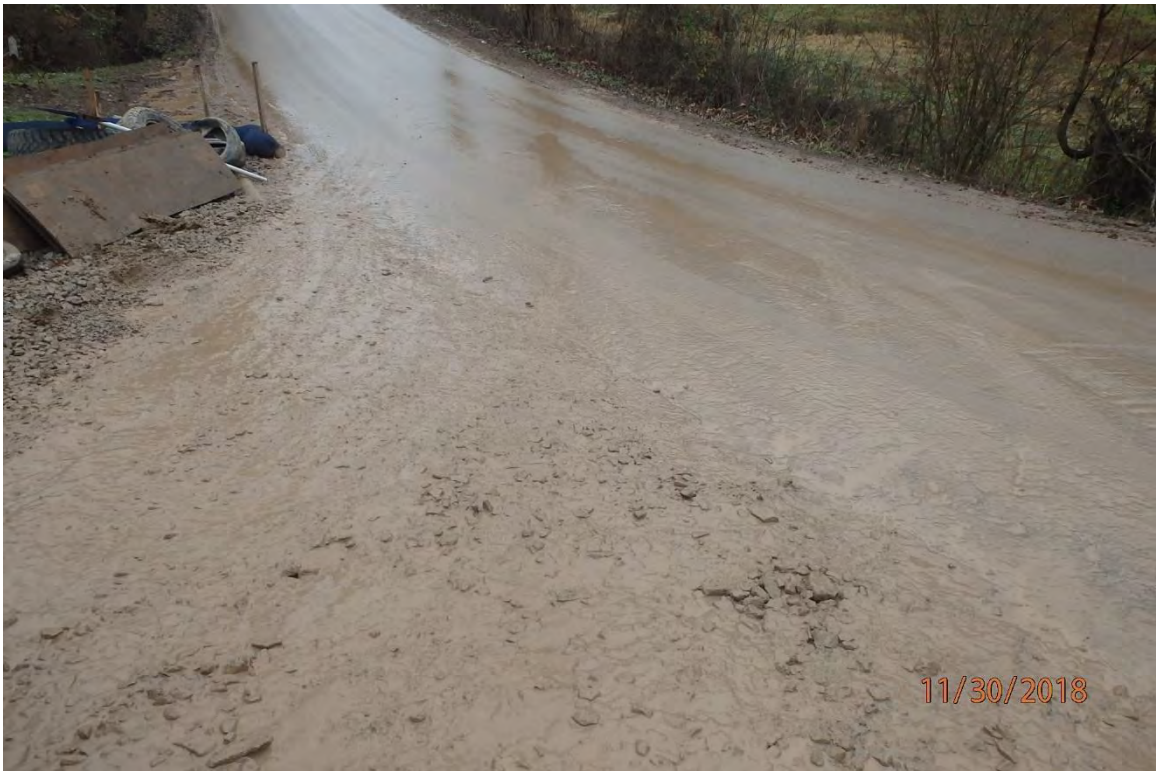
Access Road WV-HA – 31.1 off CR 50/4 showing the lack of an adequately stable construction entrance and the associated track out onto the public road.

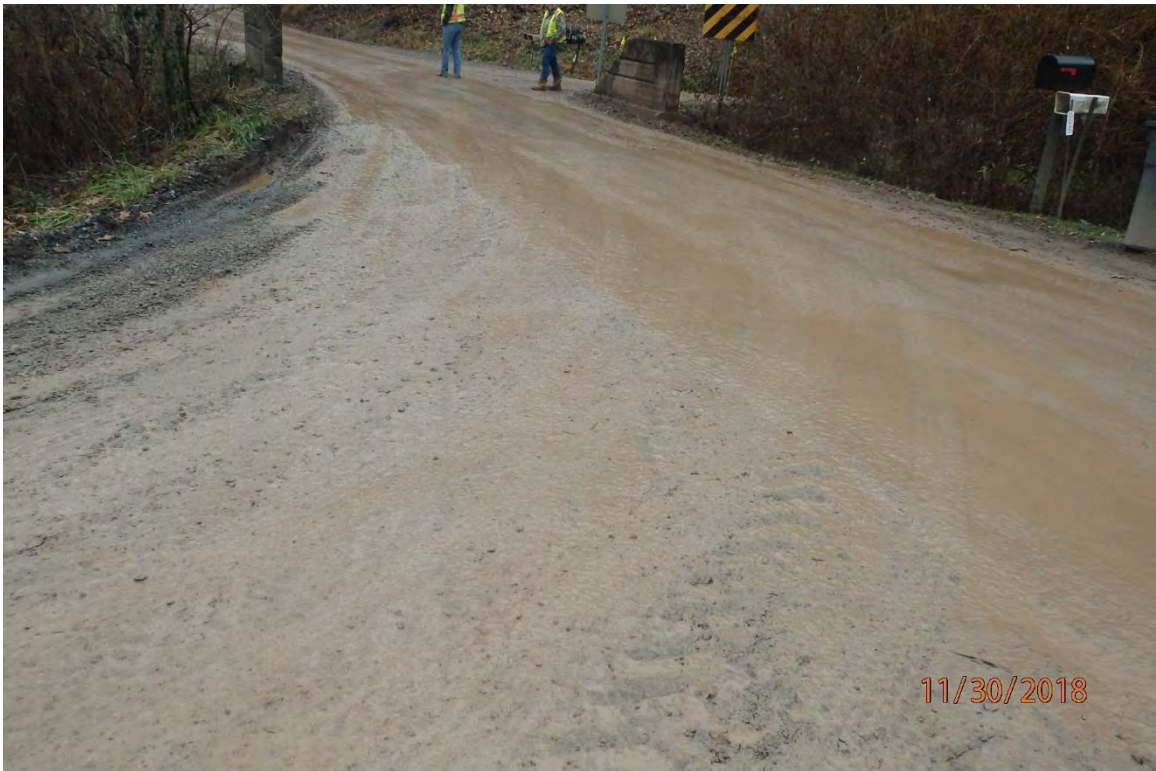
Access Road WV-HA - 29.04 off CR 50/5 showing the lack of an adequately stable construction entrance and the associated track out onto the public road.

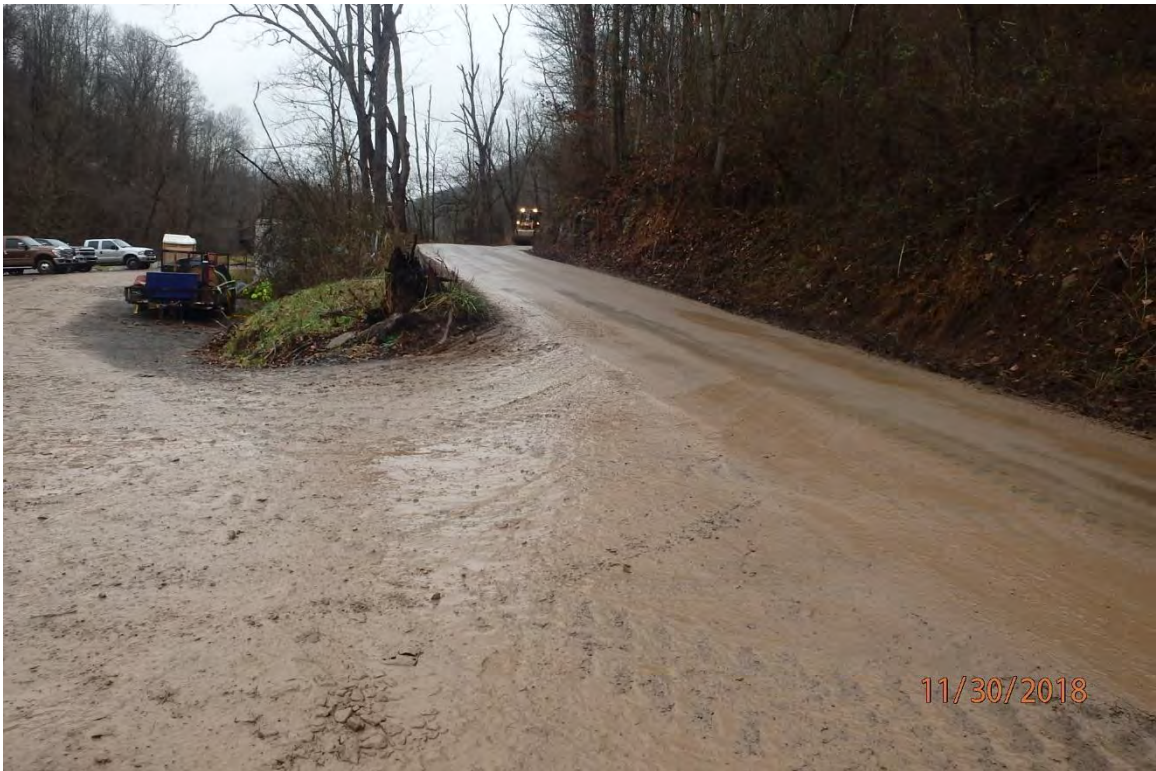
Access Road WV-HA - 29.5 off CR 50/5 showing the lack of an adequately stable construction entrance and the associated track out onto the public road.
