**The Wilderness Society et al. Comments on the
U.S. Forest Service Mountain Valley Pipeline and
Equitrans Expansion Project Draft Supplemental
Environmental Impact Statement (#50036)**

EXHIBIT 12

**WEST VIRGINIA DEPARTMENT OF ENVIRONMENTAL PROTECTION
WV OIL AND GAS CONSTRUCTION STORMWATER PERMIT**

FACILITY NAME:	Mountain Valley Pipeline Project		REG. #	EXPIRE DATE:
PERMITTEE	MOUNTAIN VALLEY PIPELINE, LLC		WVR310667	5/13/2018 Extended: 12/31/2018
ADDRESS/PHONE:	Attn: MATTHEW HOOVER 625 LIBERTY AVE, ST 1700 PITTSBURG, PA 15222 7248733645			
LOCATION:	Harris Compressor Station		Entry Date/Time:	9/25/2018 1000
COUNTY:	Braxton		Exit Date/Time:	9/25/2018 1100
Site Representative /Phone	Brittany Dewitt (Lead EI)/330-987-1682, Matt Hoover MVP/ 412-258-5627 & Jason Hiles, Spread C Lead EI/740-334-7812		PHOTOS <input checked="" type="checkbox"/>	
CO-PERMITTEE:			ADDRESS:	
SITE OPERATOR:	MEC Construction LLC		ADDRESS:	19 RR Meadowbrook, WV 26404
PERMITTED ACREAGE	4311	WEATHER:	Cloudy	LAST INSPECTION: 8/21/2018
RECEIVING STREAM(S)	Trib of Elk/Kanawha R/ Ohio Rv			NOV: 1
Regular Mail <input type="checkbox"/> Certified Mail <input checked="" type="checkbox"/>	Tracking #			
OVERALL FACILITY R

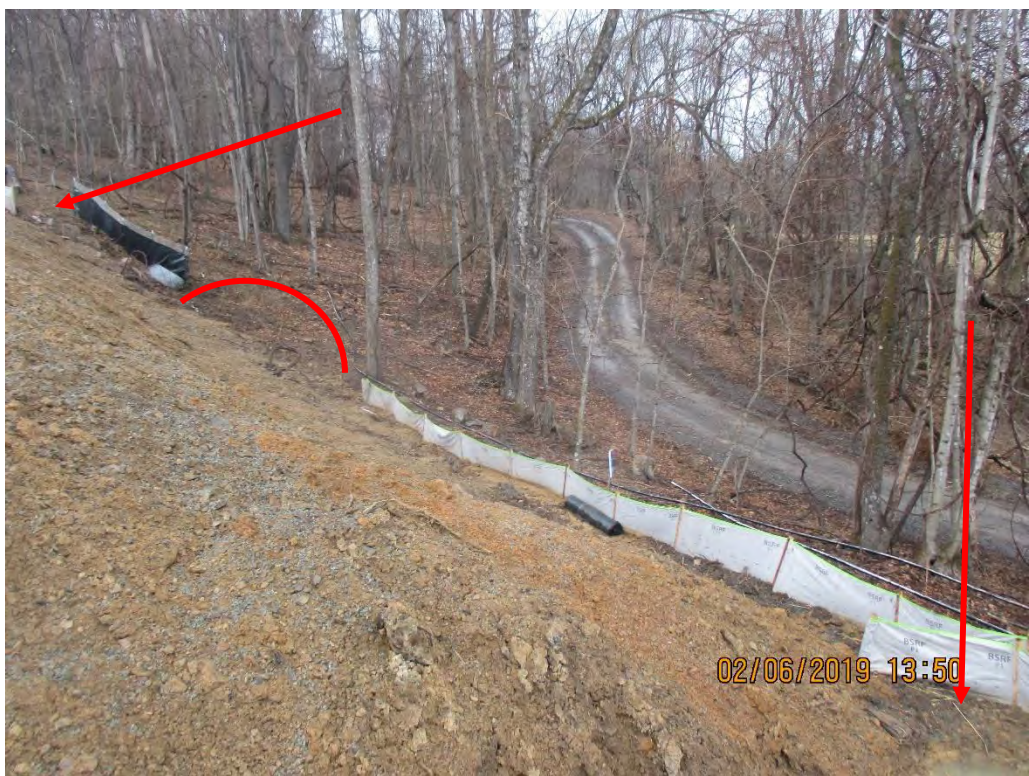
Section G.4. - Permittee has failed to comply with the General Permit and approved Storm Water Pollution Prevention Plan (SWPPP). Erosion control devices near station number 8816+00 are not in place as detailed by the SWPPP.

Waterbar outlets depicted with arrows near station number 8816+00. Area where temporary water diversion wasn't completely installed per SWPPP depicted with red line.

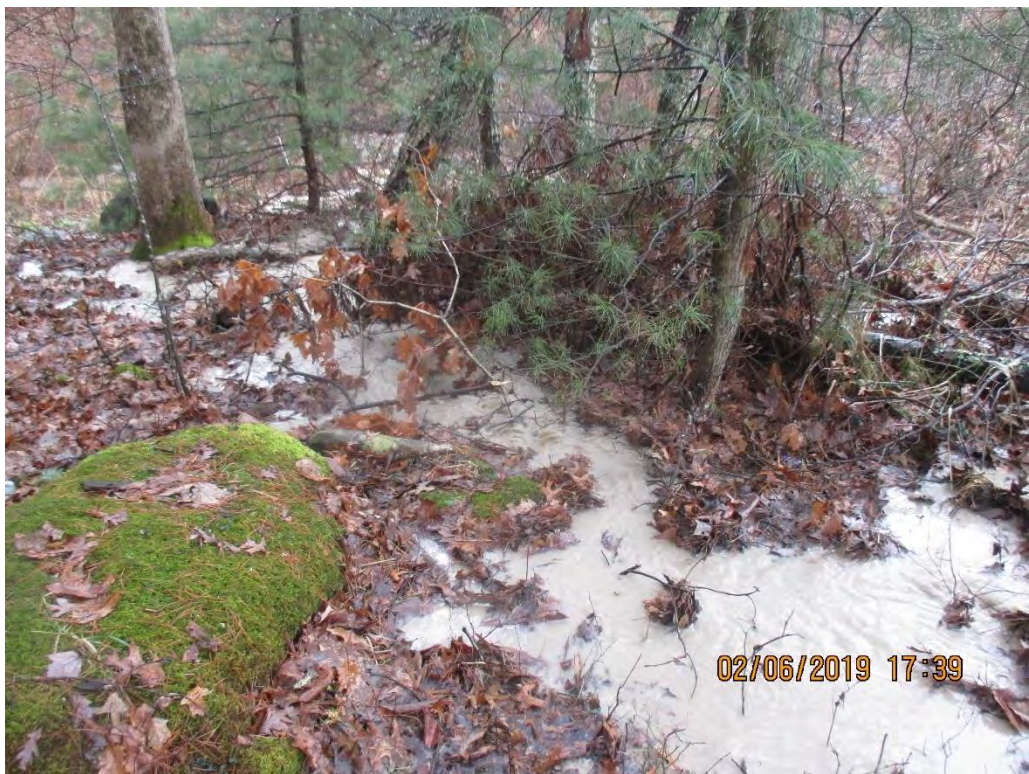
SLW flowing downslope towards UNT of Brammer Branch.

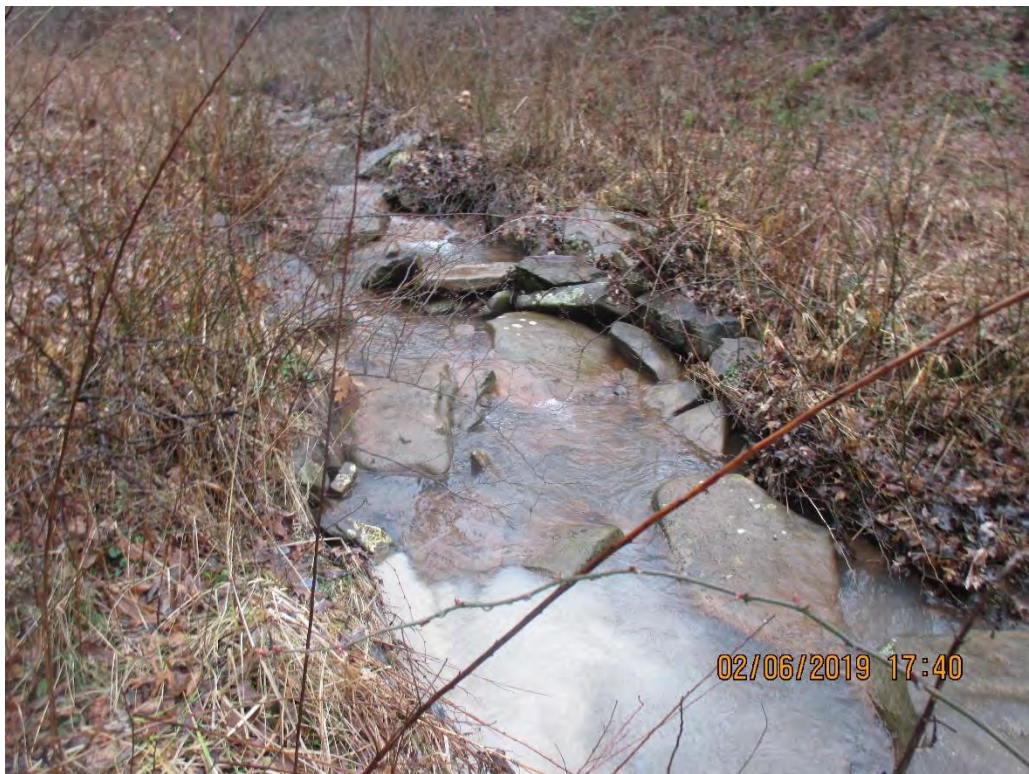
SLW entering UNT of Brammer Br. And traveling downstream towards larger culvert conveying under MVP construction yard entrance.

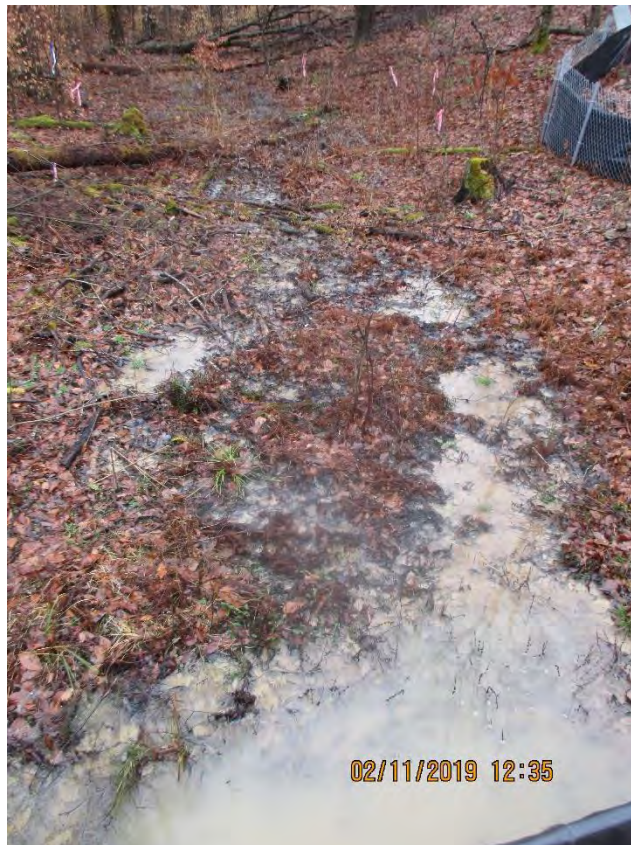
SLW present in Wetland W-IJ-55 migrating towards LOD

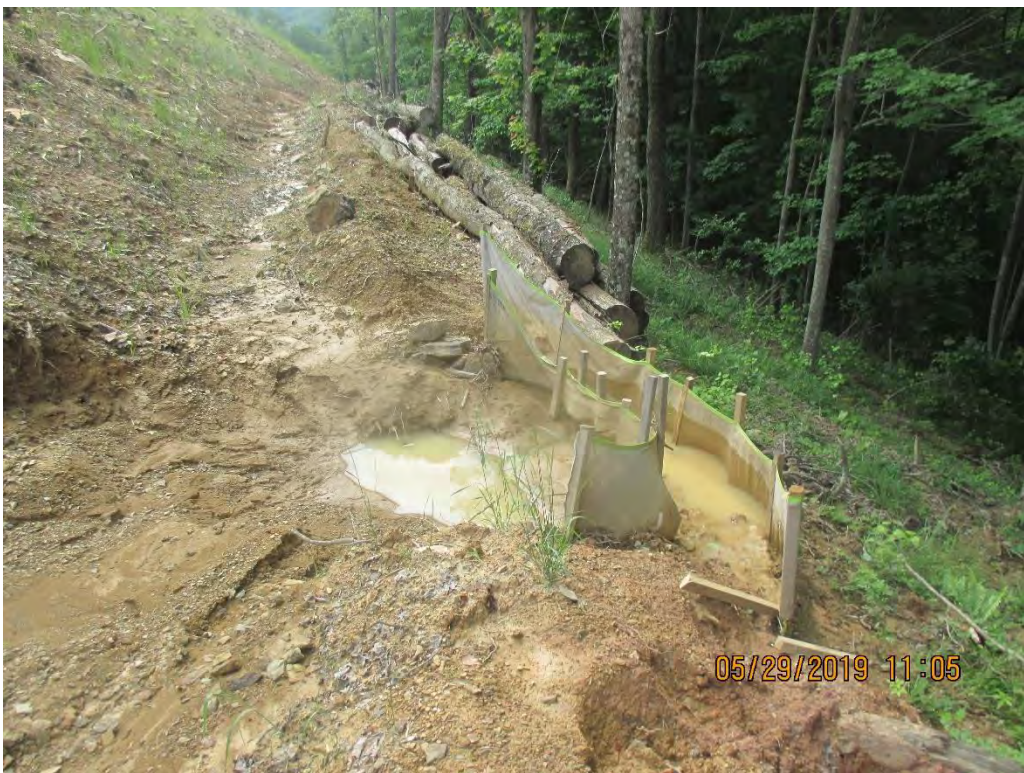
Diversion berm outlet No. 3. Sediment being deposited behind controls.

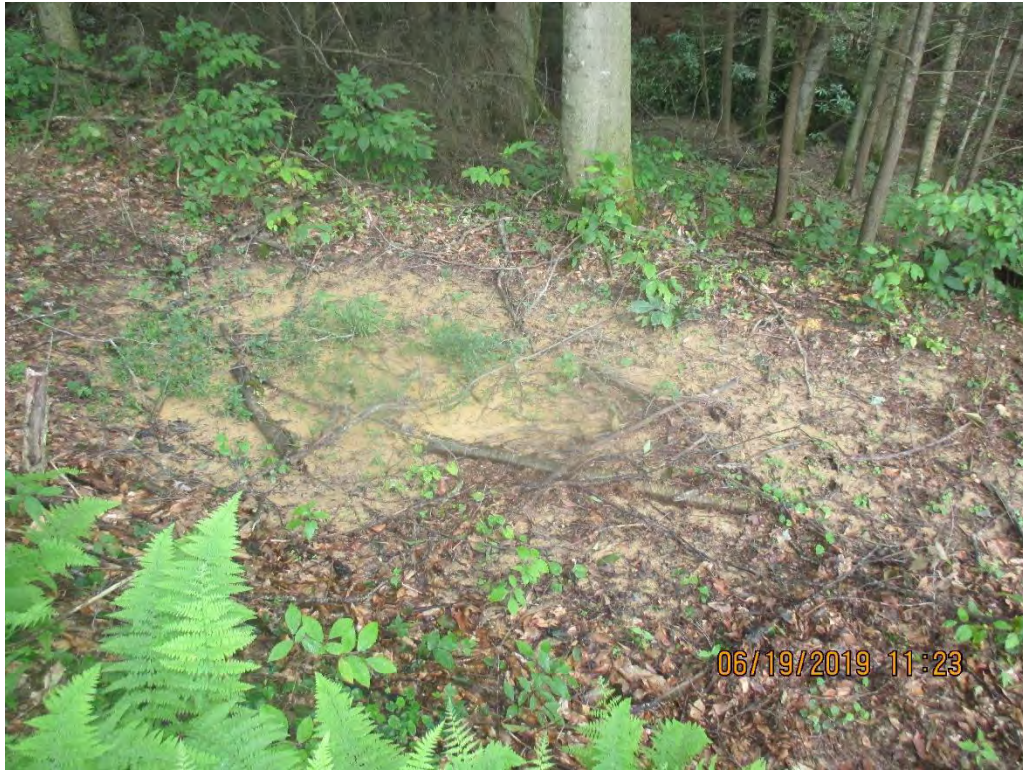
1. **(19)** Above stream S-L38 evidence was observed that sediment laden water (SLW) had left the site at station No. 6587+00. Sediment deposits were observed below these controls approximately 75 feet towards stream S-L38.

Sediment deposits present above Stream S-L38.

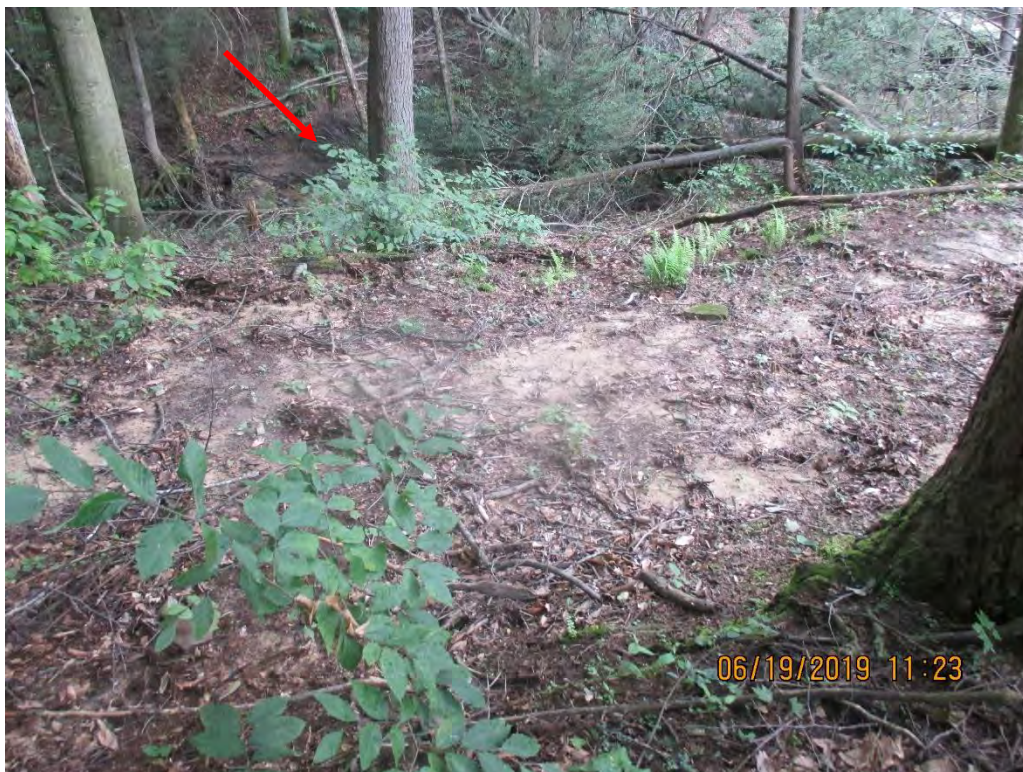
Sediment deposits above Stream S-L38. Arrow depicts stream location.
