**The Wilderness Society et al. Comments on the
U.S. Forest Service Mountain Valley Pipeline and
Equitrans Expansion Project Draft Supplemental
Environmental Impact Statement (#50036)**

**WEST VIRGINIA DEPARTMENT OF ENVIRONMENTAL PROTECTION
WV OIL AND GAS CONSTRUCTION STORMWATER PERMIT**

FACILITY NAME:	Mountain Valley Pipeline Project			REG. #	EXPIRE DATE:
PERMITTEE	MOUNTAIN VALLEY PIPELINE, LLC			WVR310667	5/13/2018
ADDRESS/PHONE:	Attn: Matt Hoover 625 LIBERTY AVE, ST 1700 PITTSBURGH, PA 15222				
LOCATION:	Wileyville, WV			Entry Date/Time:	4/3/18 8:30am
COUNTY:	Wetzel			Exit Date/Time:	4/3/18 1:37pm
Site Representative /Phone	Matt Hoover Sr. Environmental Coordinator (412) 258-5627			PHOTOS <input checked="" type="checkbox"/>	
CO-PERMITTEE:				ADDRESS:	
SITE OPERATOR:	Precision Pipeline			ADDRESS:	
PERMITTED ACREAGE	4214	WEATHER:	Rain	LAST INSPECTION:	N/A
RECEIVING STREAM(S)	Mobley Run > Ohio River				NOV: 1
Regular Mail <input type="checkbox"/> Certified Mail <input checked="" type="checkbox"/>	Tracking #				
OVERALL FACILITY RATING:	Unsatisfactory		COMPLIANCE OUTCOME	Not Immediately Corrected

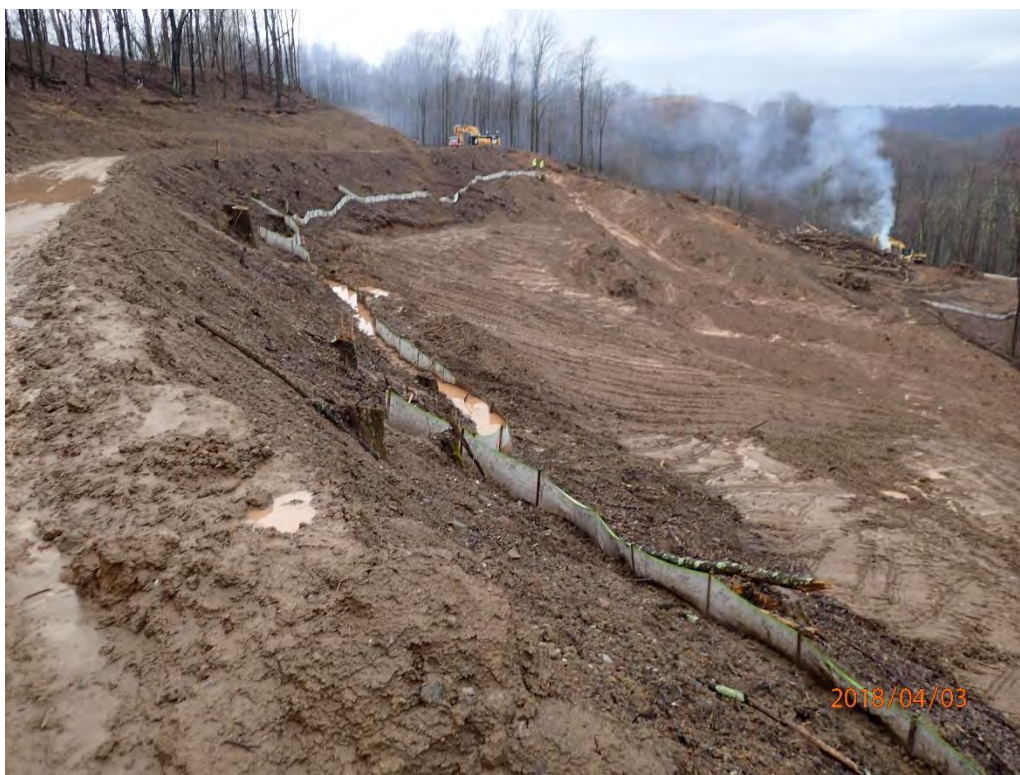
Hillside above slip near Bradshaw Compressor Station.

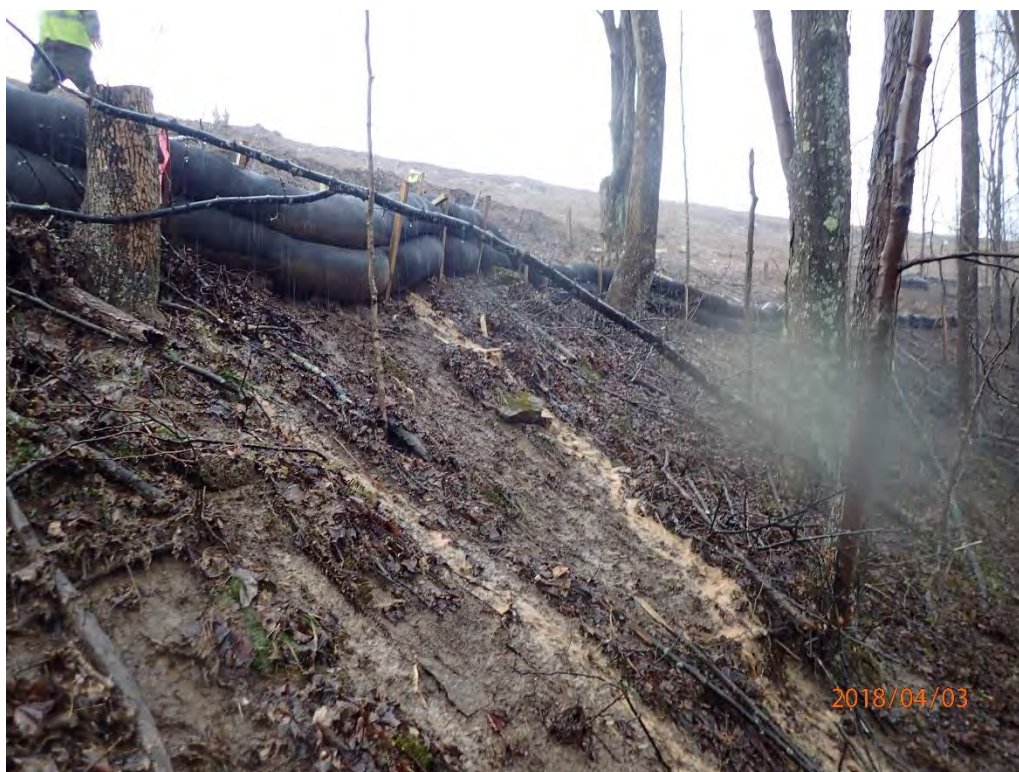
Sediment laden water leaving site at Bradshaw Compressor Station.

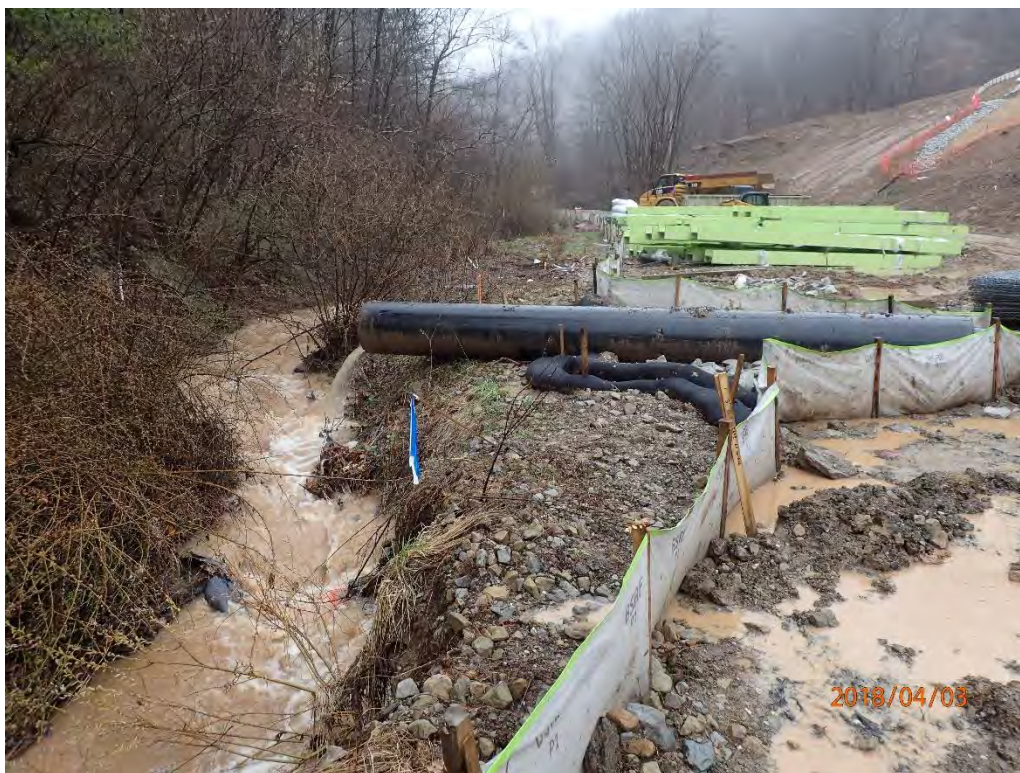
UT of Mobley Run near Mobley Compressor Station.

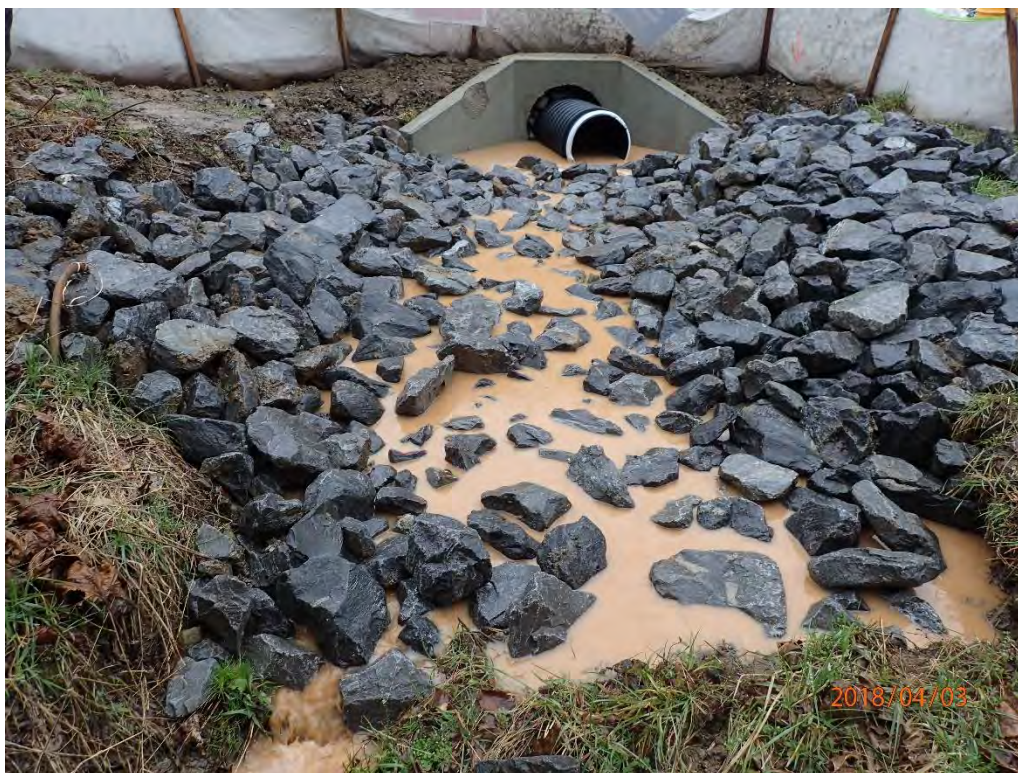
Sediment laden water leaving site into UT of Mobley Run.

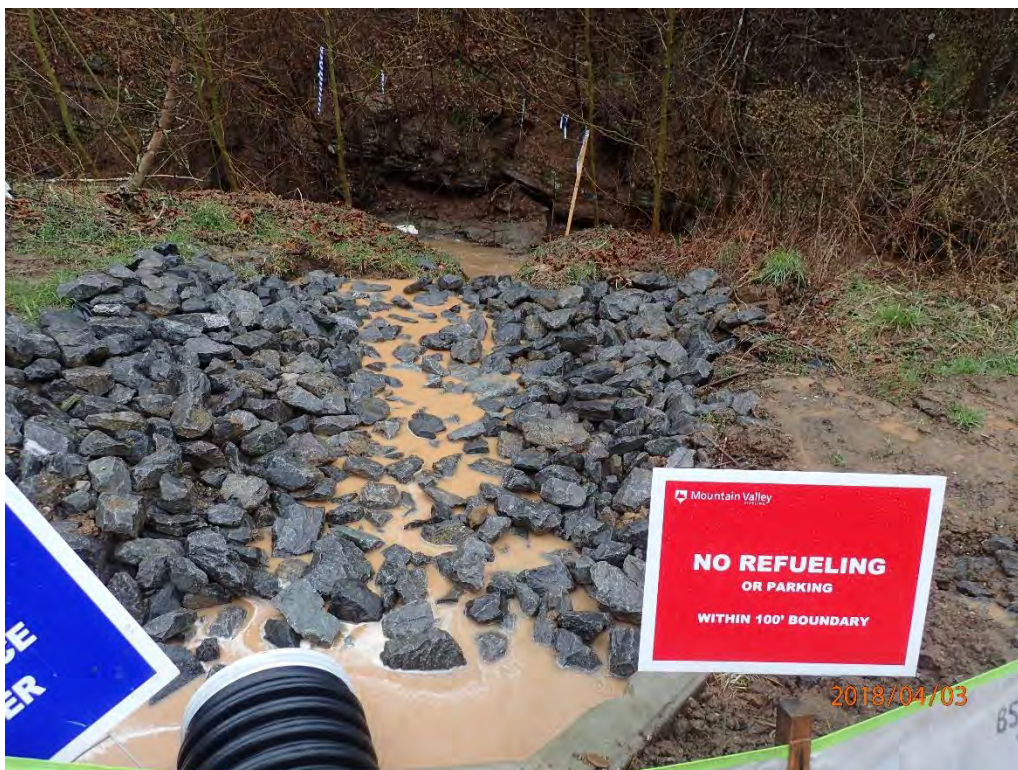
Sediment laden water leaving site into UT of Mobley Run.

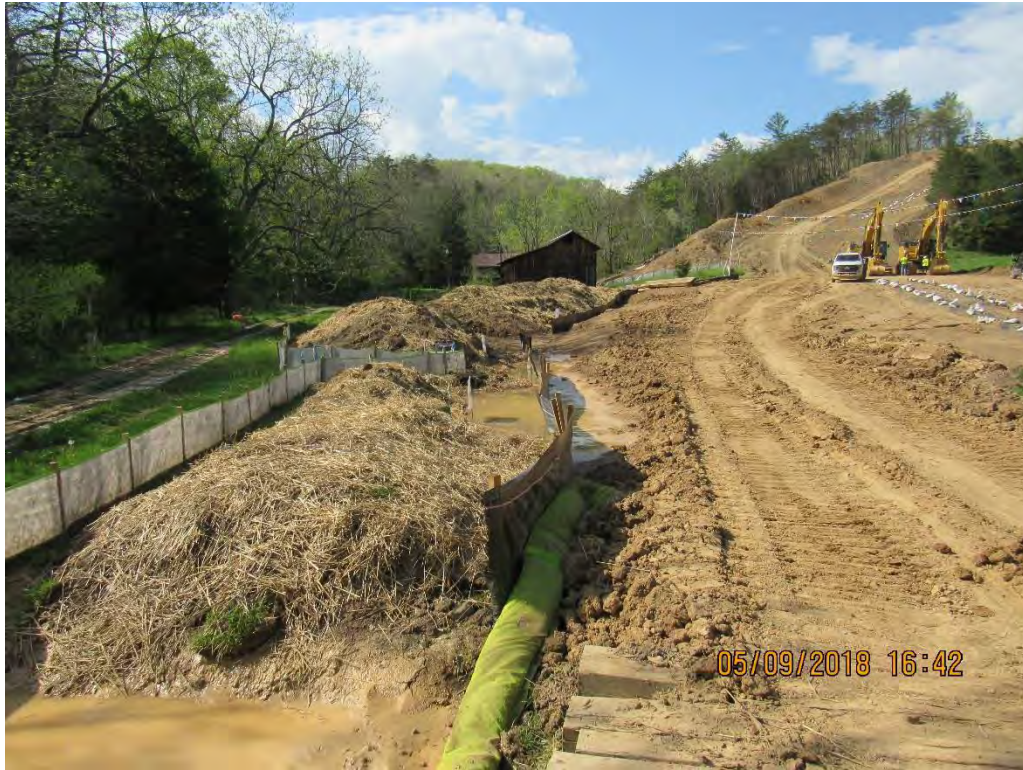
Photo 1: Delineation of topsoil stockpiles from subsoil with black silt fence and path to sump prior to stream.

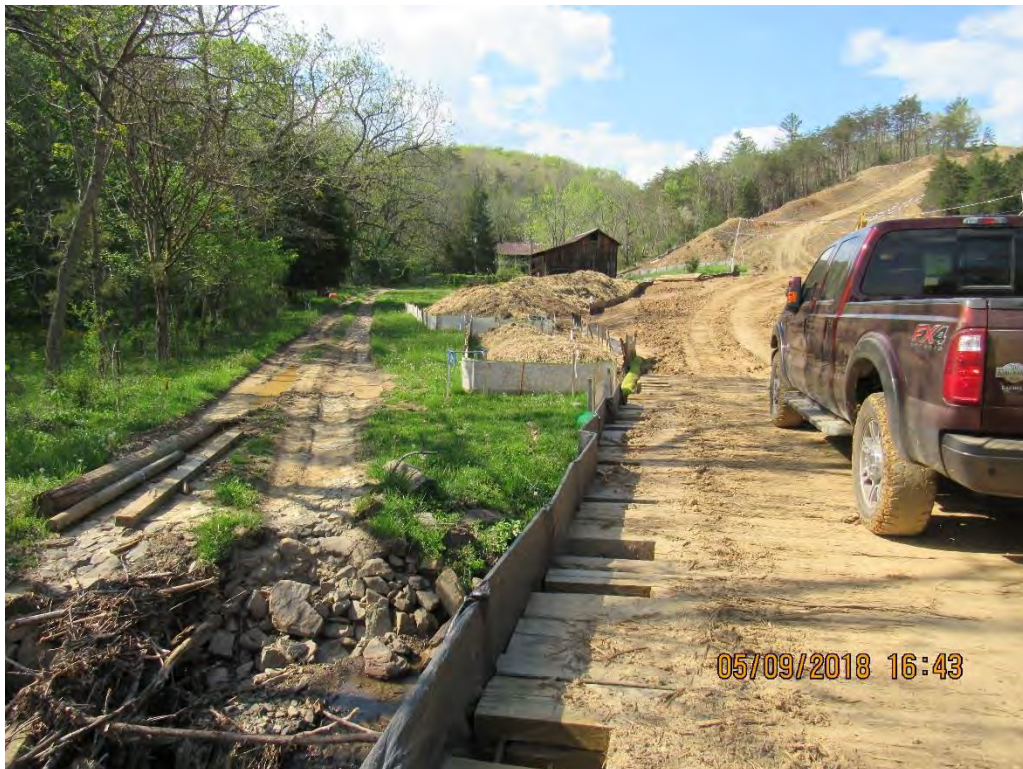
Photo 2: Topsoil delineation, sump, perimeter fencing and vegetative buffer prior to stream.

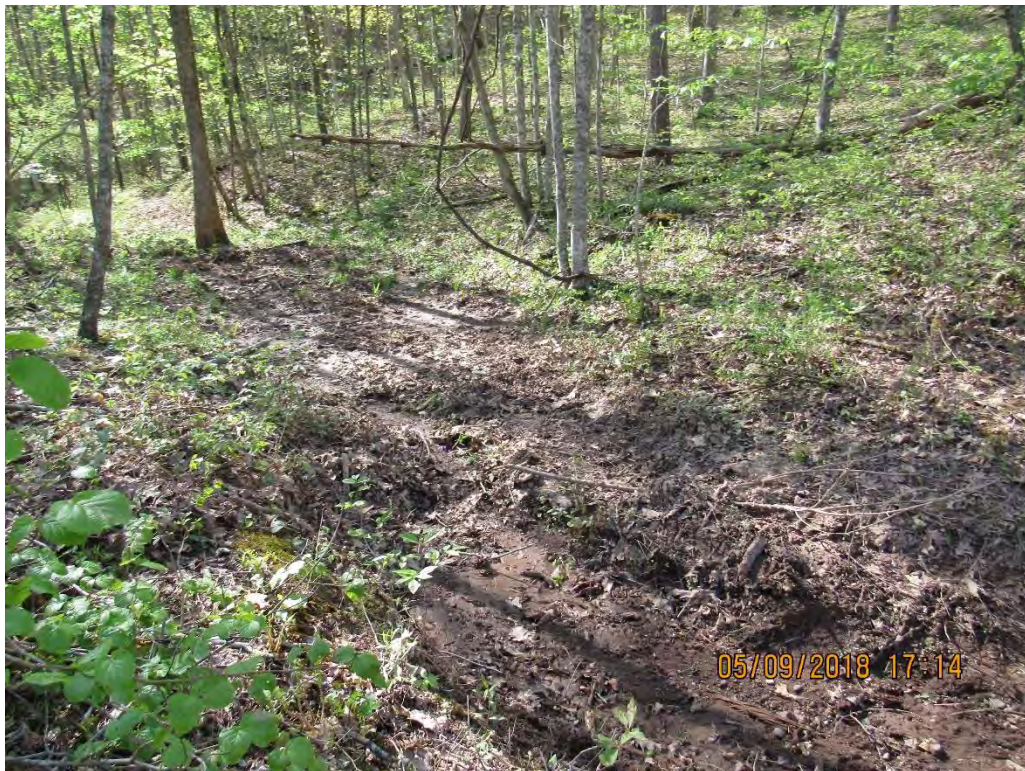
built, scheduled for next day. Sediment deposits were observed in stream causing conditions not allowable. (Photos 4-8)

Photo 8: Downstream view of sediment deposits in stream S-IJ65 creating conditions not allowable. (view west)

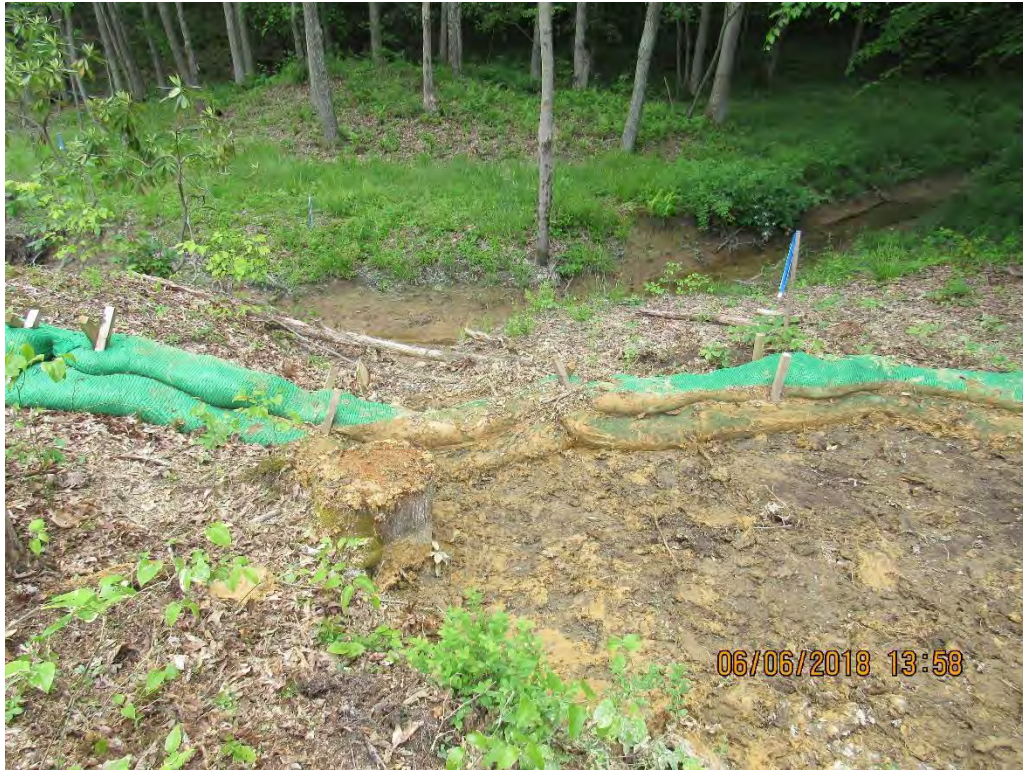
Photo 1: Station 6782+00 control failure repair but additional controls not added.

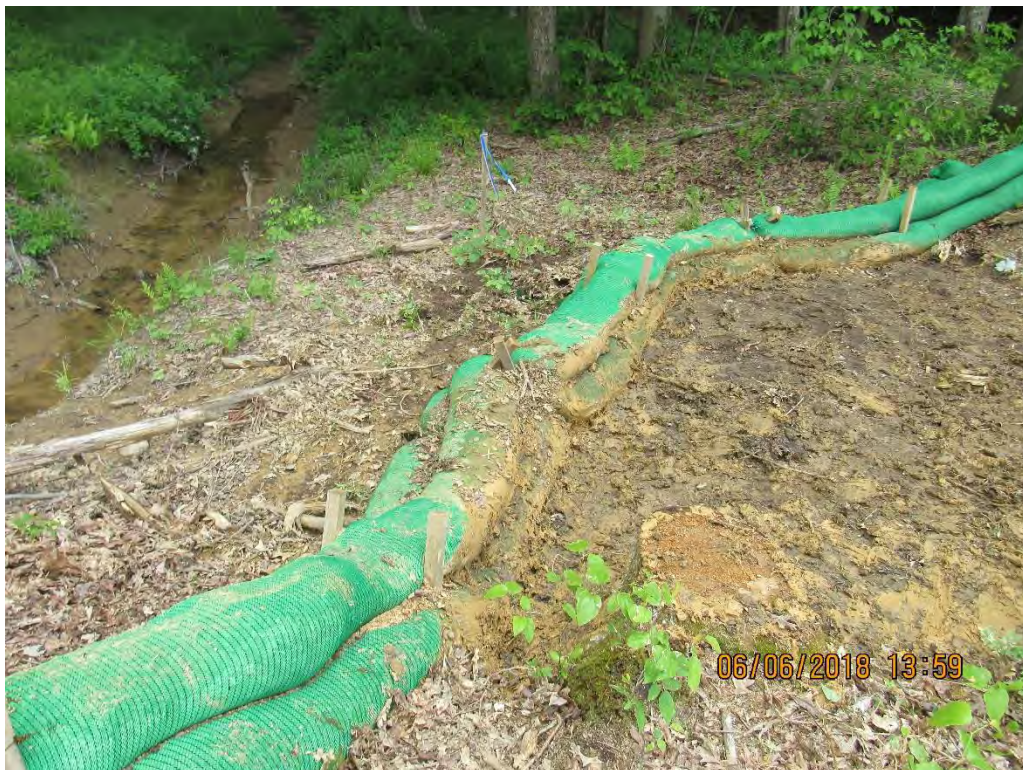
Photo 2: Station 6782+00 control failure repair but additional controls not added.

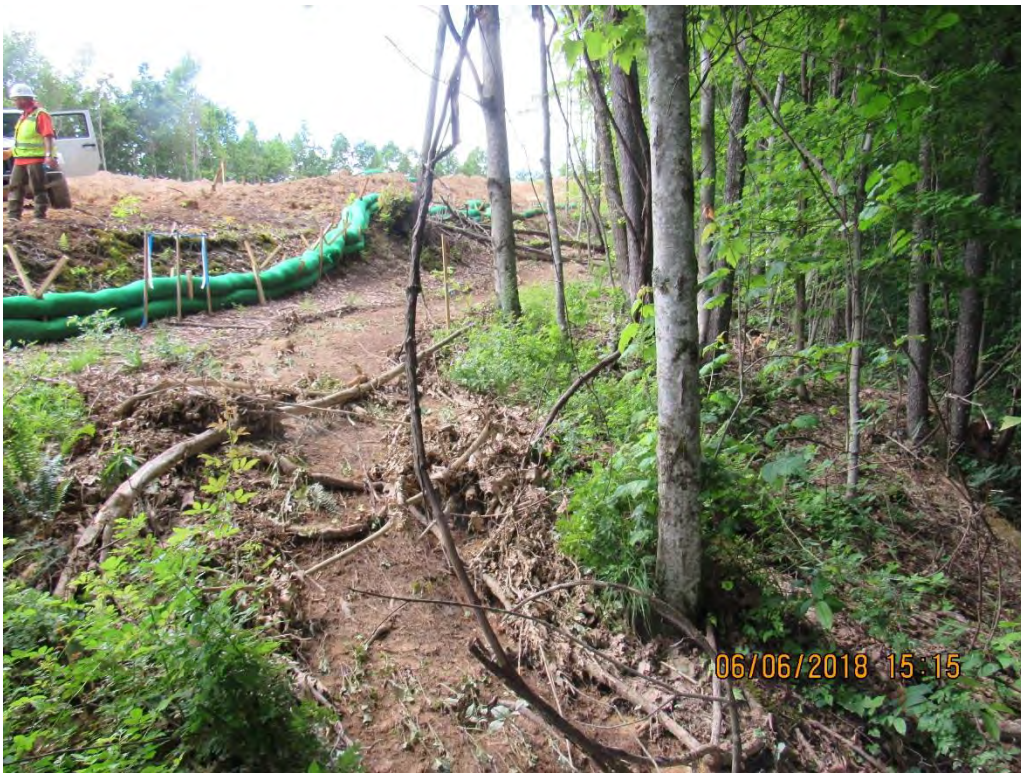
Photo 6: Continued scoured path from control failure at station 6812+58.

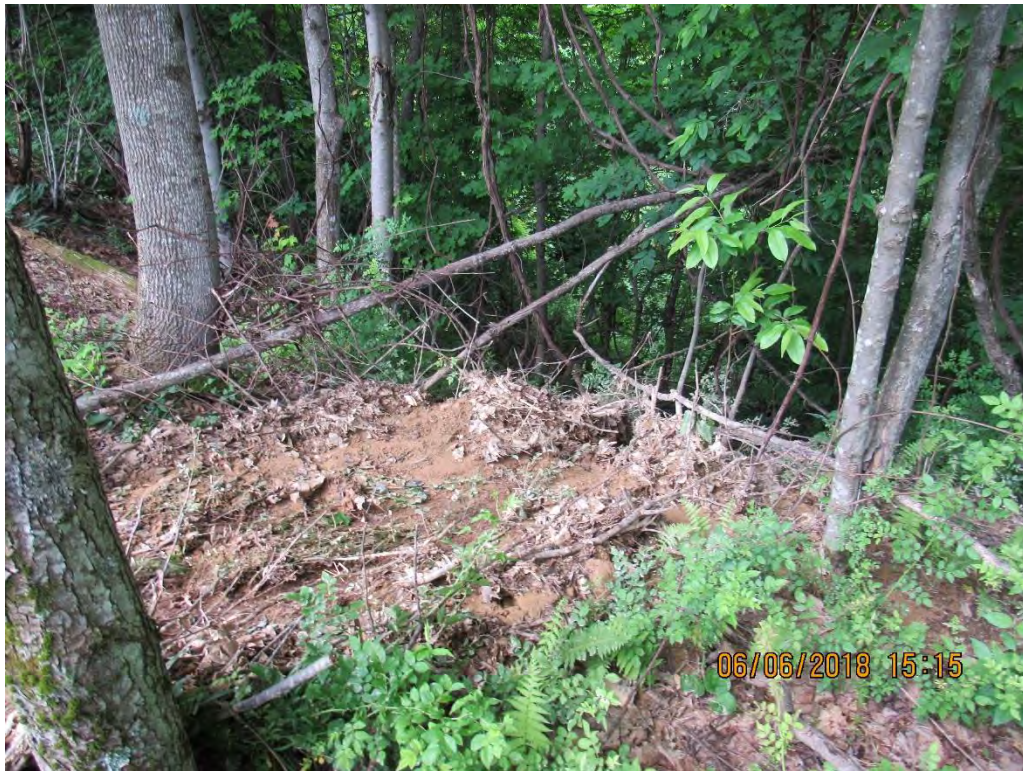
Photo 7: Water leaving the site from control failure at station 6812+58.

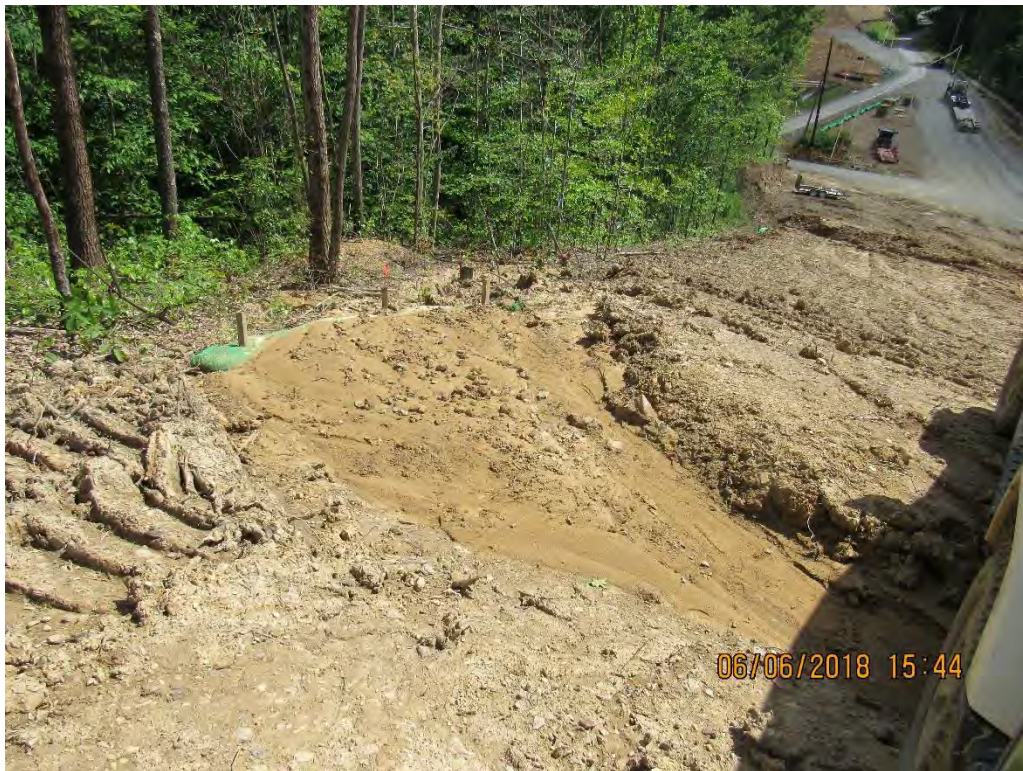
Photo 8: Control failure near station 6854+00 where sediment laden water left site.

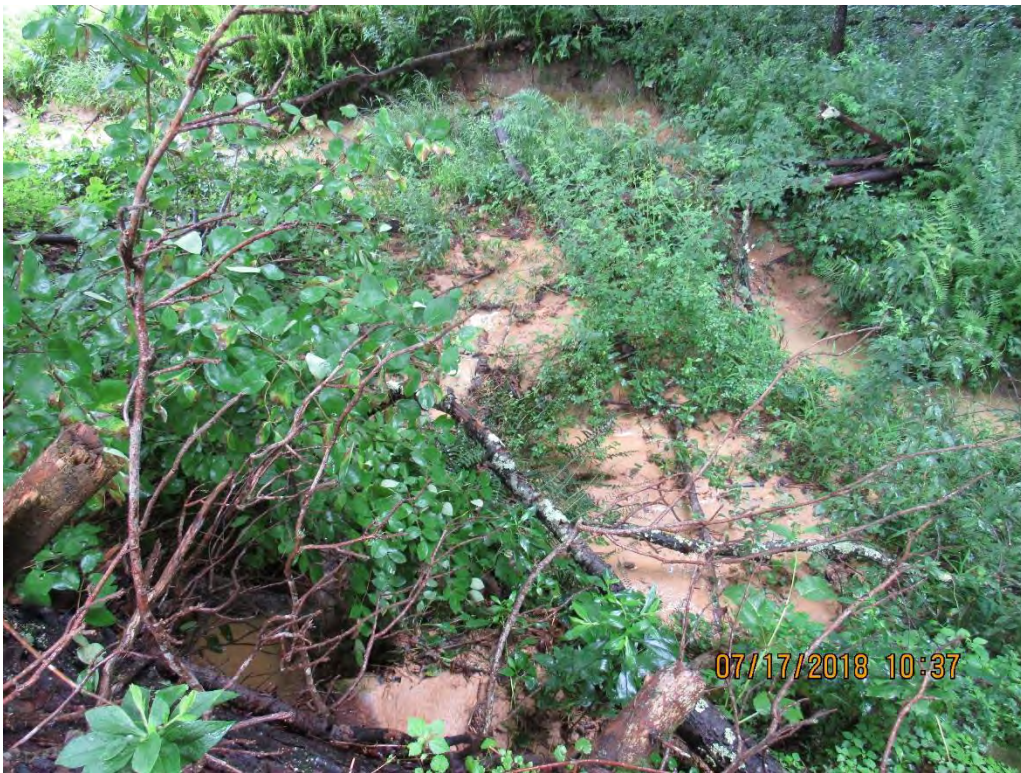
- 7., 19., & 20. – Water bar near station 5518+00 had failed- water had undercut and went around compost filter sock releasing sediment laden water off site and into UNT of Birch River (S-F34). (Photos 4-11) Sediment deposits were observed in stream (Photo 9) as well as stream was muddy downstream (Photo 11). GPS coordinates of control failure location: 38° 25.4570'N, 80° 34.2329'W

Photo 8: Sediment deposits below temporary tree dam.

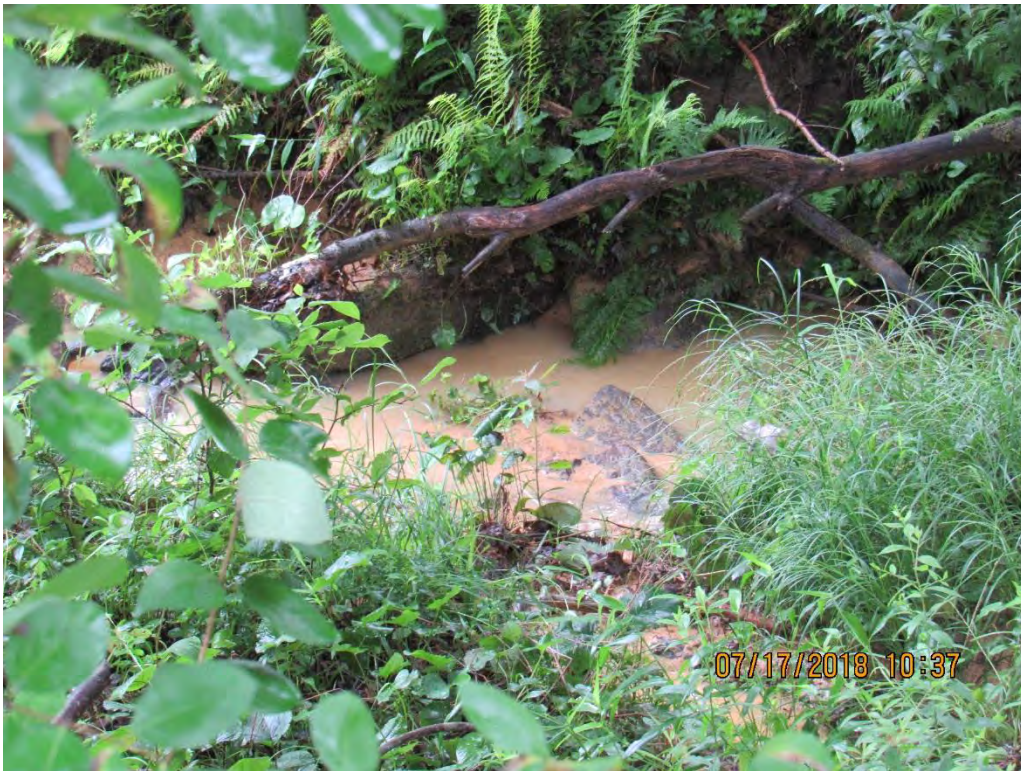
Photo 9: Sediment deposits in UNT of Birch River (S-F34)

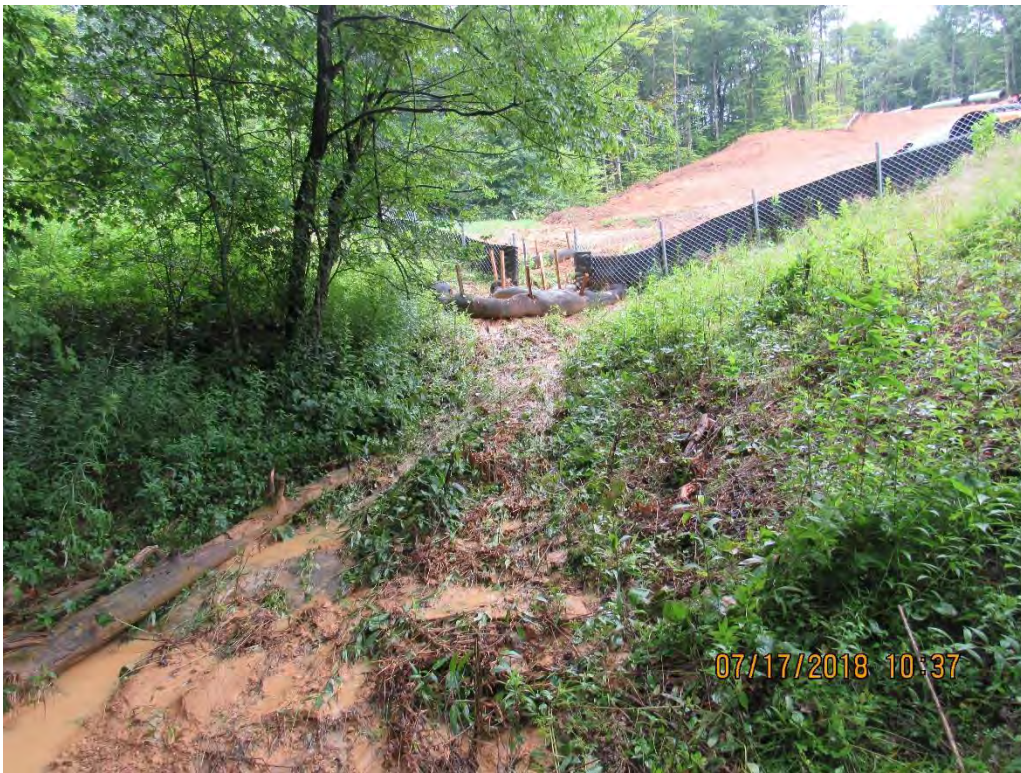
Photo 10: Upslope view of sediment deposits from control failure.

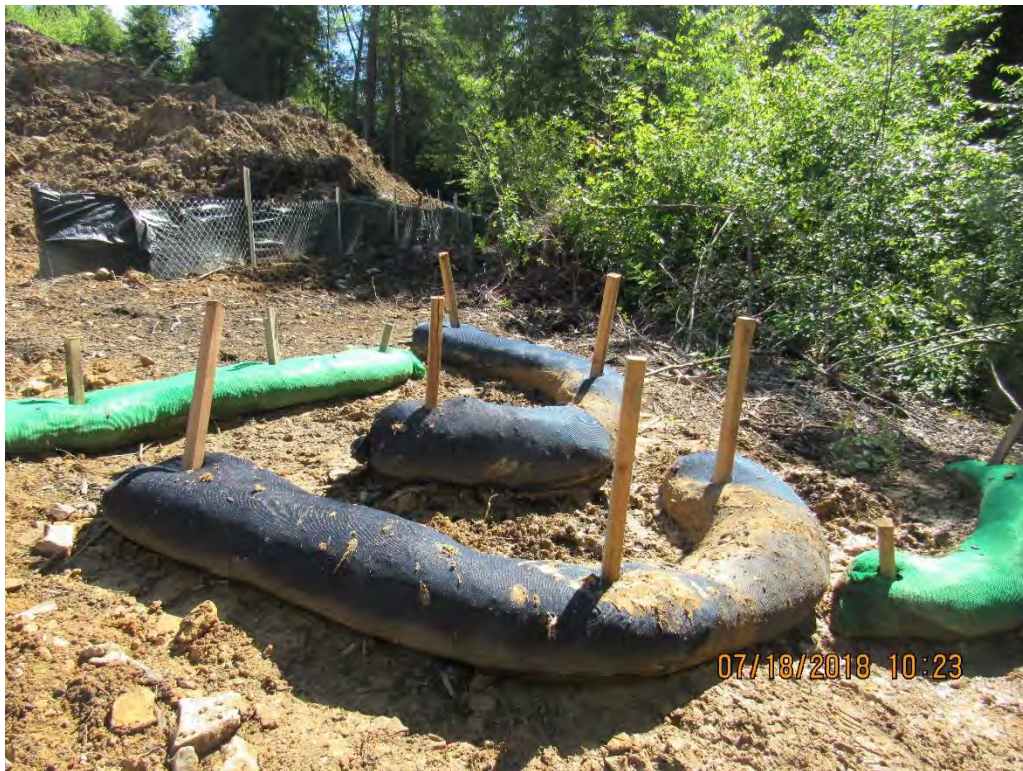
Photo 2: Controls at end of water bar were over topped at station 6898+59.

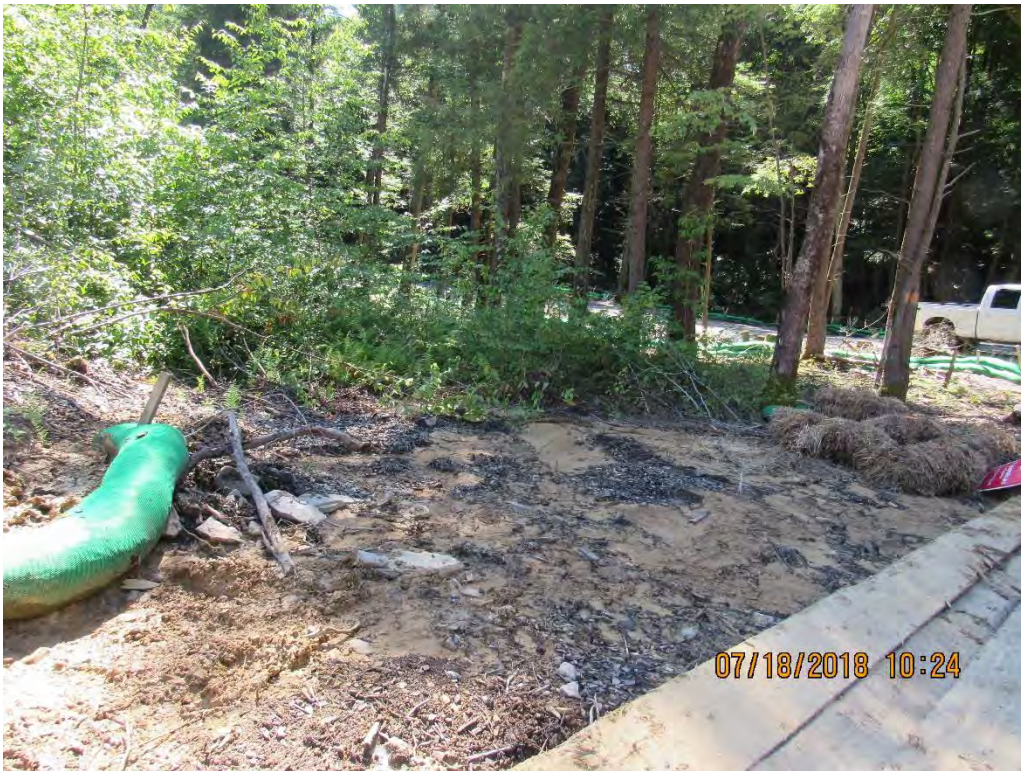
Photo 3: Down gradient of over topped water bar control at station 6898+59.

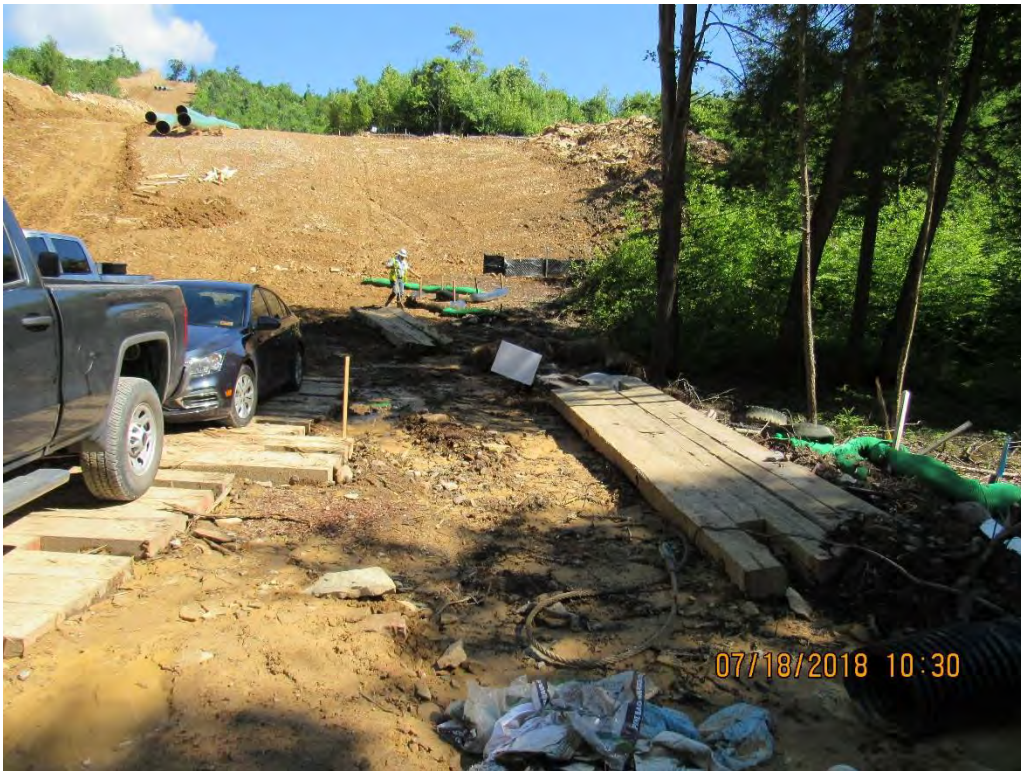
Photo 5: Upslope view of station 6898+59.

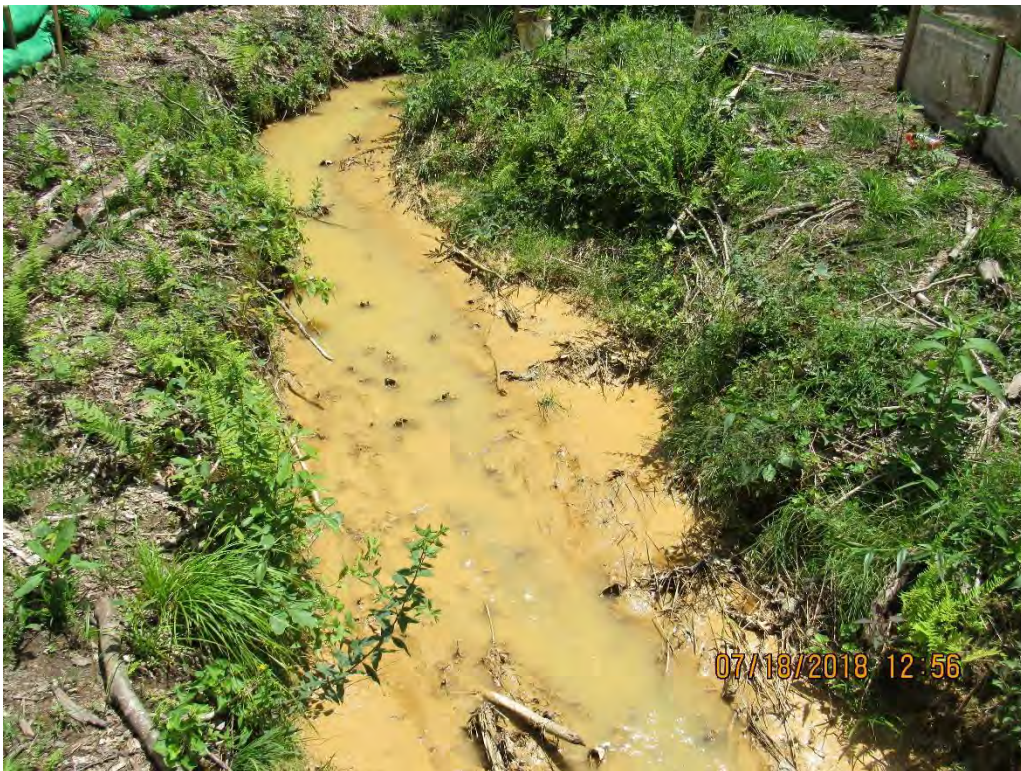
- Station 6788+00 (kick off for Spread E- Wahoo Road) has water bar and control failures in several locations allowing sediment laden water to enter UNT of Hominy Creek. (Photos 6- 18)

- 19., & 20. – Several water bars & controls adjacent to UNT of Hominy Creek between MP 128.3 and 128.5 have failed allowing sediment laden water to enter stream and depositing sediment on bottom and on banks of stream. (Photos 6-8)

Photo 6: Sediment deposits in UNT of Harmony Creek at bridge near station 6781+87

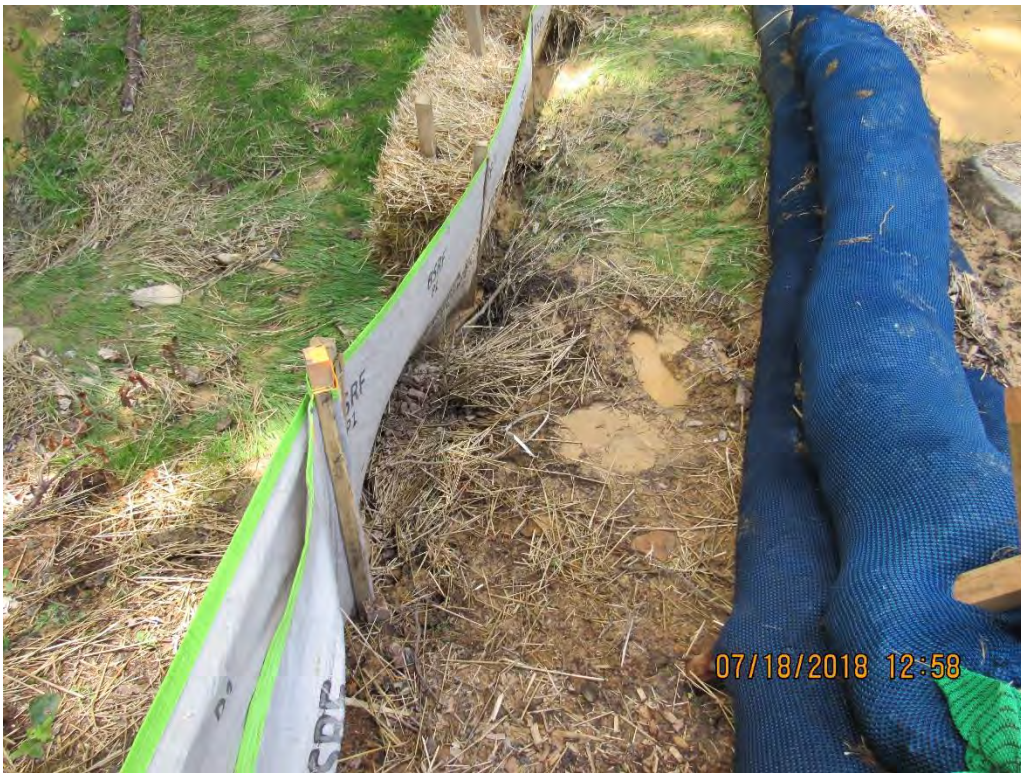
Photo 10: Last control in sequence allowing sediment laden water to leave site.

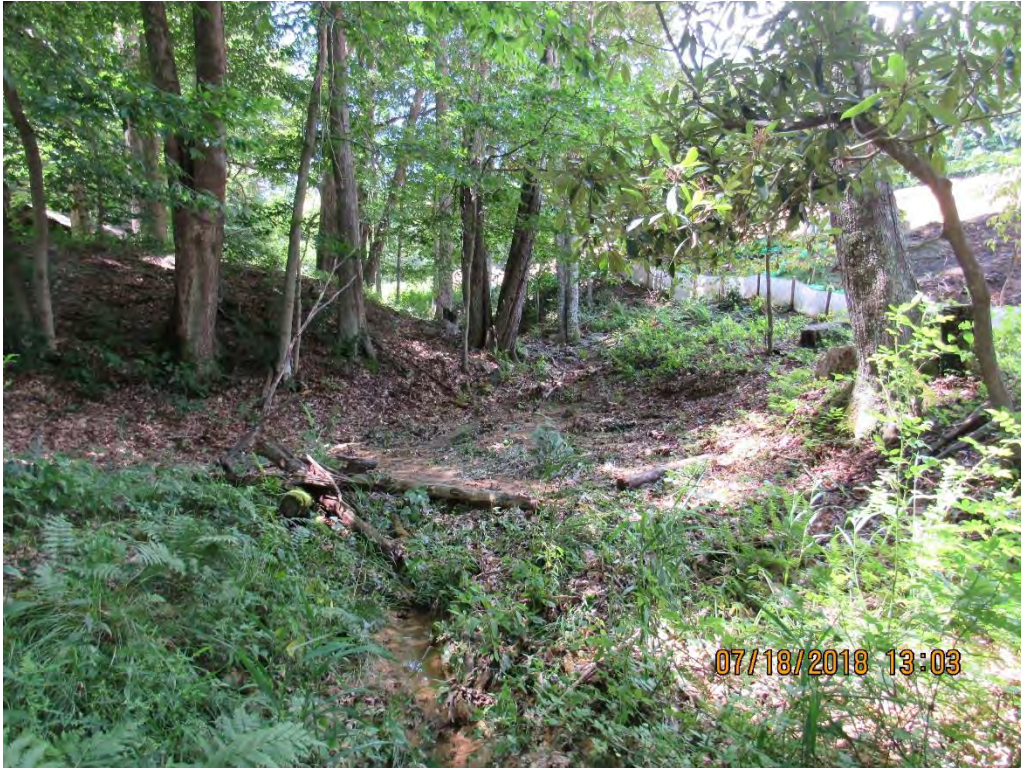
Photo 13: Up gradient of terminus of sediment laden water leaving site.

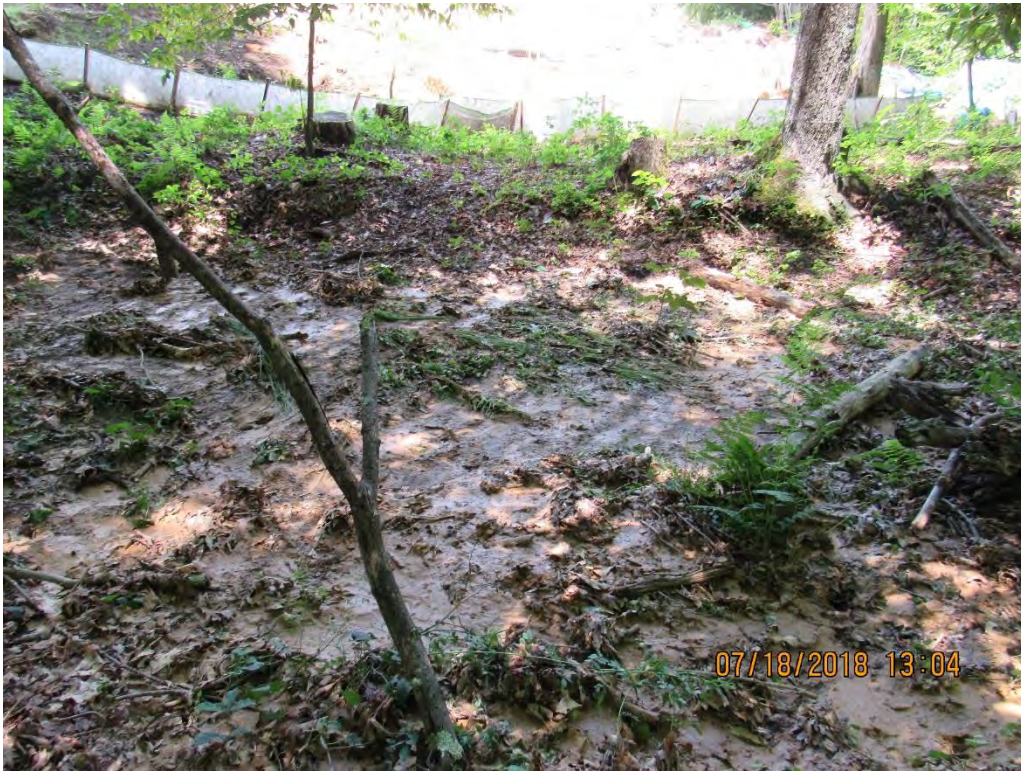
Photo 14: Sediment deposits off limits of disturbance from station 6785+50 control failure.

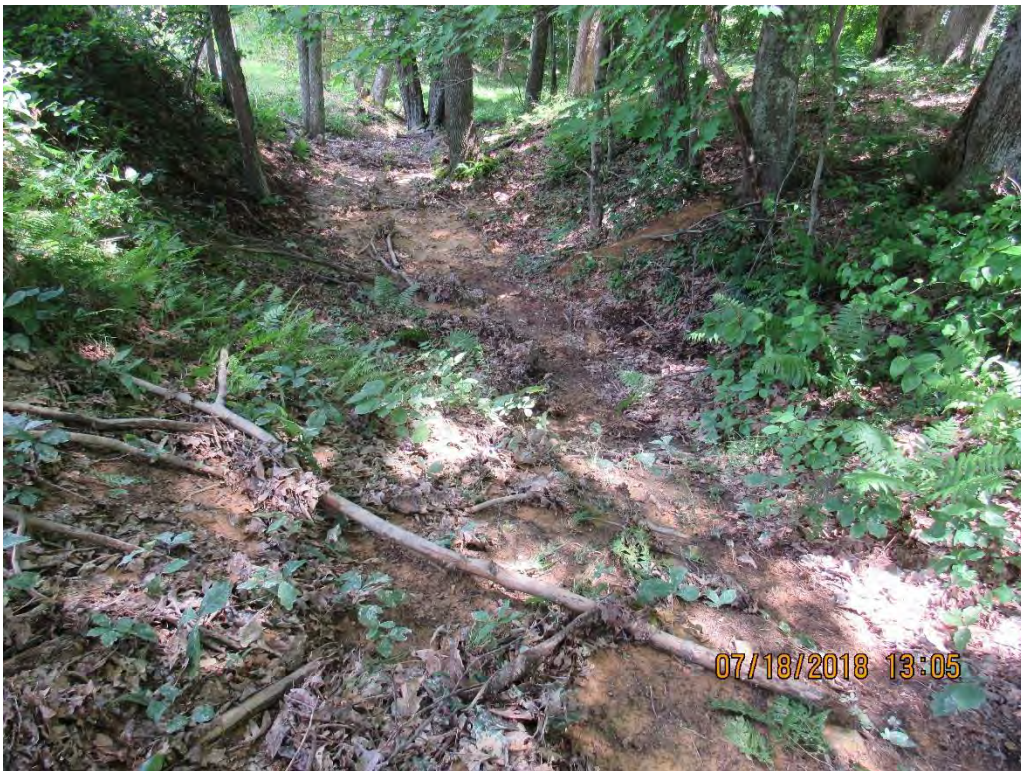
Photo 16: Down gradient view of scour from control failure at 6785+50.

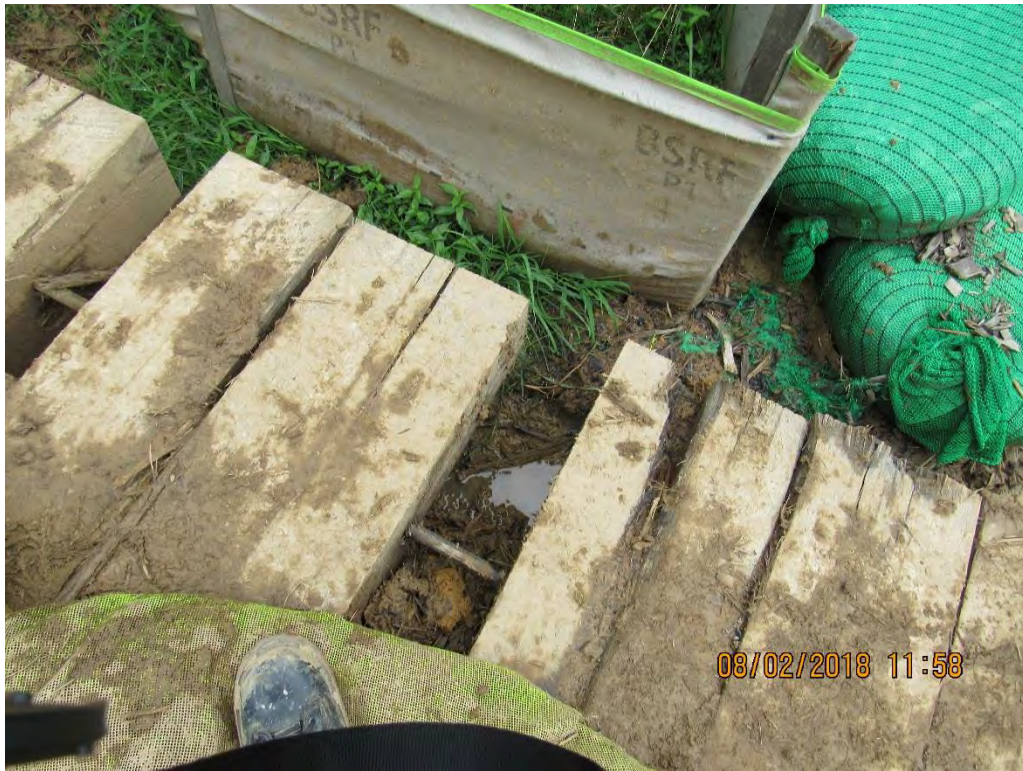
- Slate Run (station 9624+00)- Location of sediment laden water leaving site at last bridge over Slate Run. Upstream of bridge, Slate Run is dry (photo 17). Sediment deposits observed below base of bridge (photo 18) with sediment laden water traced under bridge matting (photo 19) to sump upgradient of stream (photo 20). Muddy conditions observed in Slate Run below sediment deposits at bridge mat.

Photo 19: Sediment laden water traced under bridge matting.

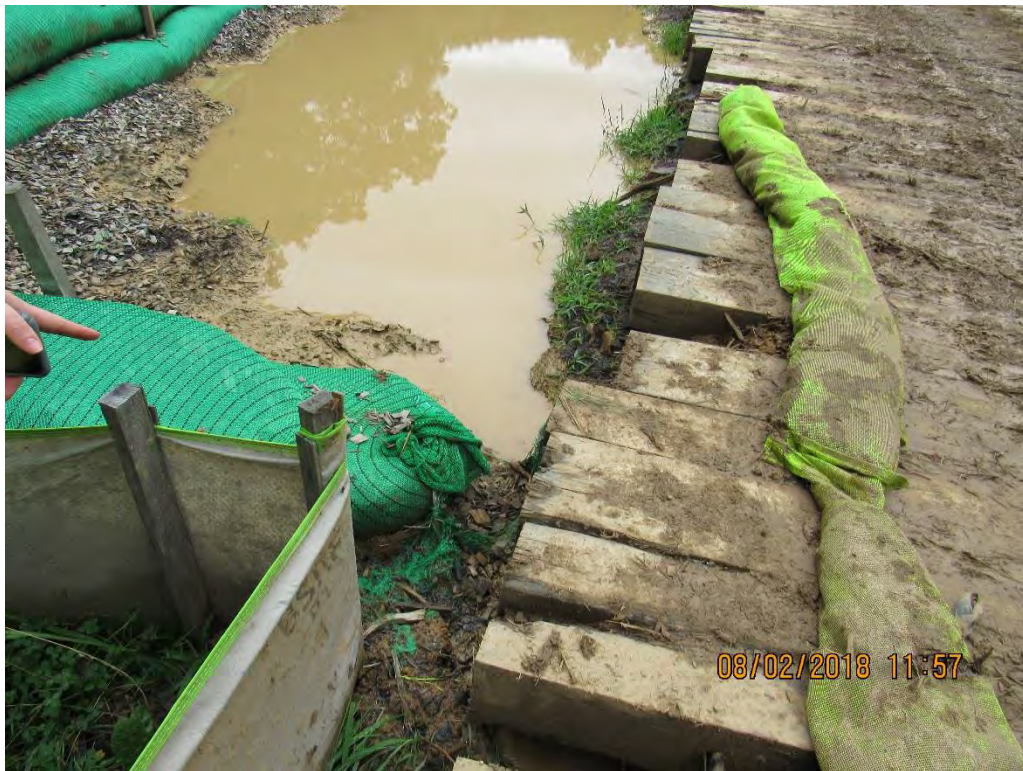
Photo 20: Source of sediment laden water in Slate Run-

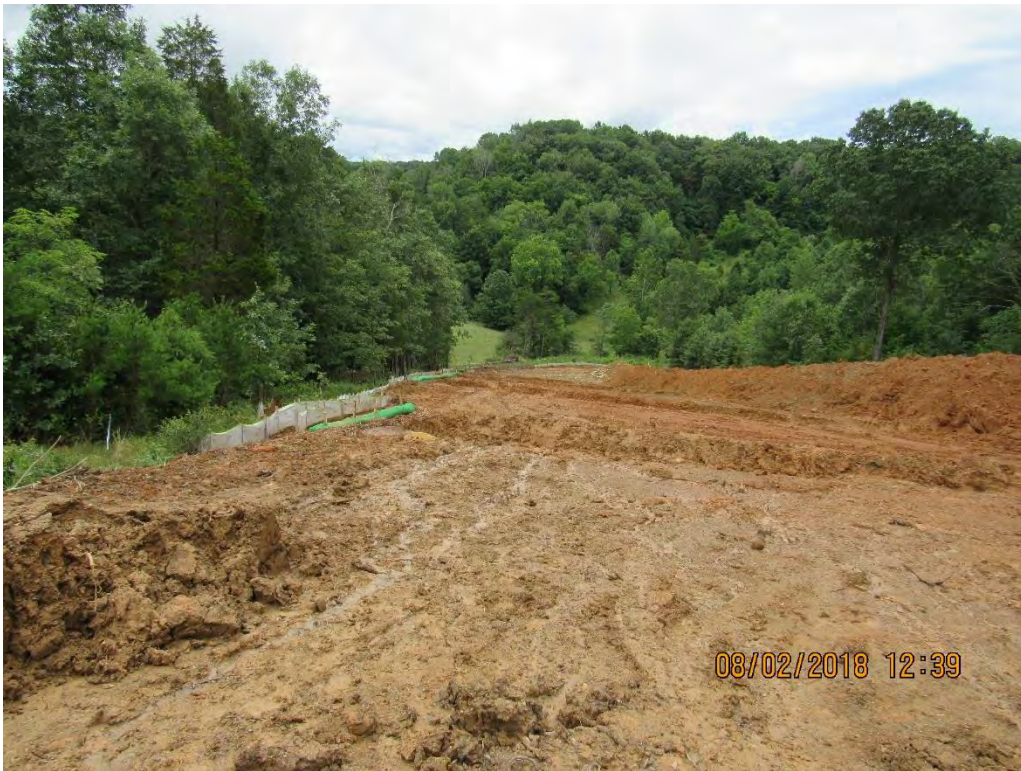
- Ellison Ridge Road & Access Road 221)- approximately station 9778+00 location of reported backhoe ‘stuck’ in mud along with failure of controls. Controls did fail; additional controls installed (sump was enlarged, additional filter fabric and compost filter socks added). (photo 21) Backhoe waiting for drier conditions to complete work. Seeders scheduled for midweek of following week to seed along access road (photo 22). Control failure lead to sediment laden water entering neighboring pond downstream of failure. Location entering stream from right of way (ROW) to pond was clear (photos 23-29).

- Photo 21: Controls failure location; additional controls installed (sump was enlarged, additional filter fabric and compost filter socks added).
