**The Wilderness Society et al. Comments on the
U.S. Forest Service Mountain Valley Pipeline and
Equitrans Expansion Project Draft Supplemental
Environmental Impact Statement (#50036)**

**WEST VIRGINIA DEPARTMENT OF ENVIRONMENTAL PROTECTION
WV OIL AND GAS CONSTRUCTION STORMWATER PERMIT**

FACILITY NAME:	Mountain Valley Pipeline Project			REG. #	EXPIRE DATE:
PERMITTEE	MOUNTAIN VALLEY PIPELINE, LLC			WVR310667	5/13/2018
ADDRESS/PHONE:	Attn: Matt Hoover 625 LIBERTY AVE, ST 1700 PITTSBURGH, PA 15222				
LOCATION:	Wileyville, WV			Entry Date/Time:	4/3/18 8:30am
COUNTY:	Wetzel			Exit Date/Time:	4/3/18 1:37pm
Site Representative /Phone	Matt Hoover Sr. Environmental Coordinator (412) 258-5627			PHOTOS <input checked="" type="checkbox"/>	
CO-PERMITTEE:				ADDRESS:	
SITE OPERATOR:	Precision Pipeline			ADDRESS:	
PERMITTED ACREAGE	4214	WEATHER:	Rain	LAST INSPECTION:	N/A
RECEIVING STREAM(S)	Mobley Run > Ohio River				NOV: 1
Regular Mail <input type="checkbox"/> Certified Mail <input checked="" type="checkbox"/>	Tracking #				
OVERALL FACILITY RATING:	Unsatisfactory		COMPLIANCE OUTCOME	Not Immediately Corrected

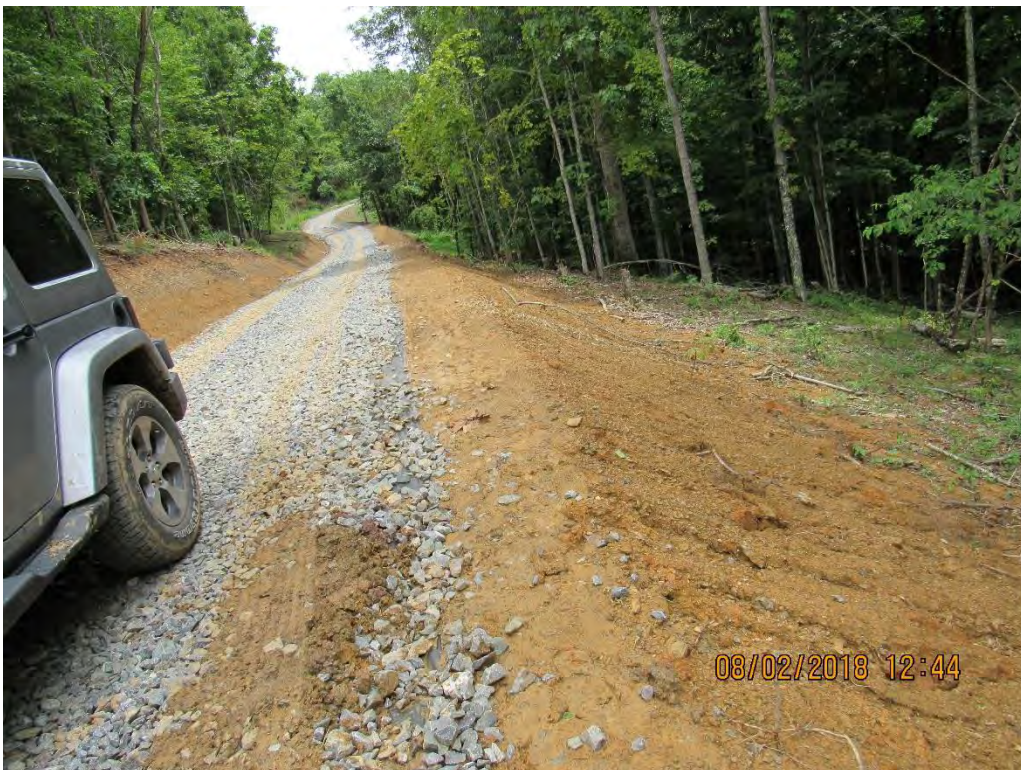
- Photo 22: Seeders scheduled for midweek of following week to seed along access road.

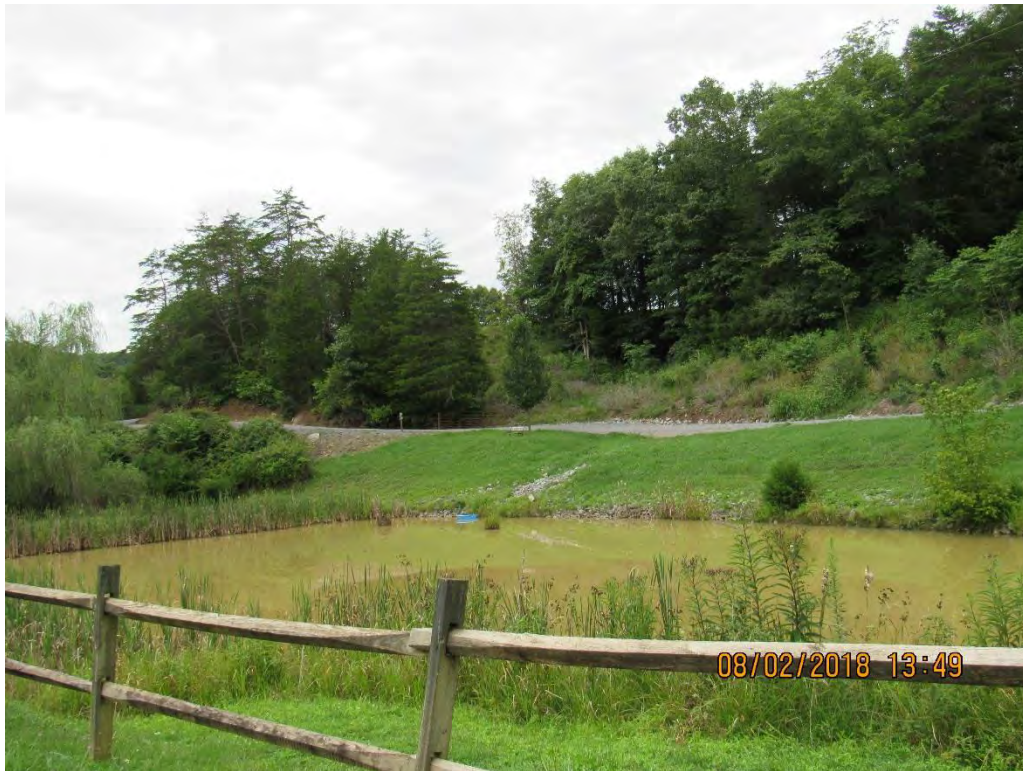
Photo 29: Neighbors pond several days after control failure on ROW.

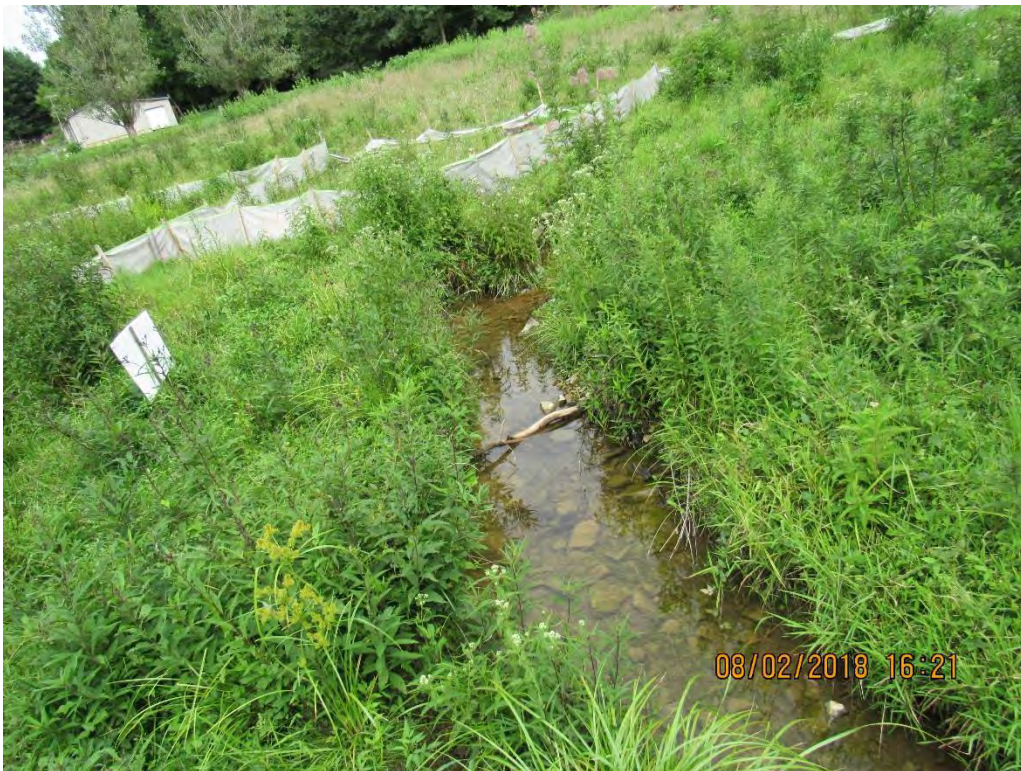
Photo 40: One of several feeder wetland streams leading into Painters Run.

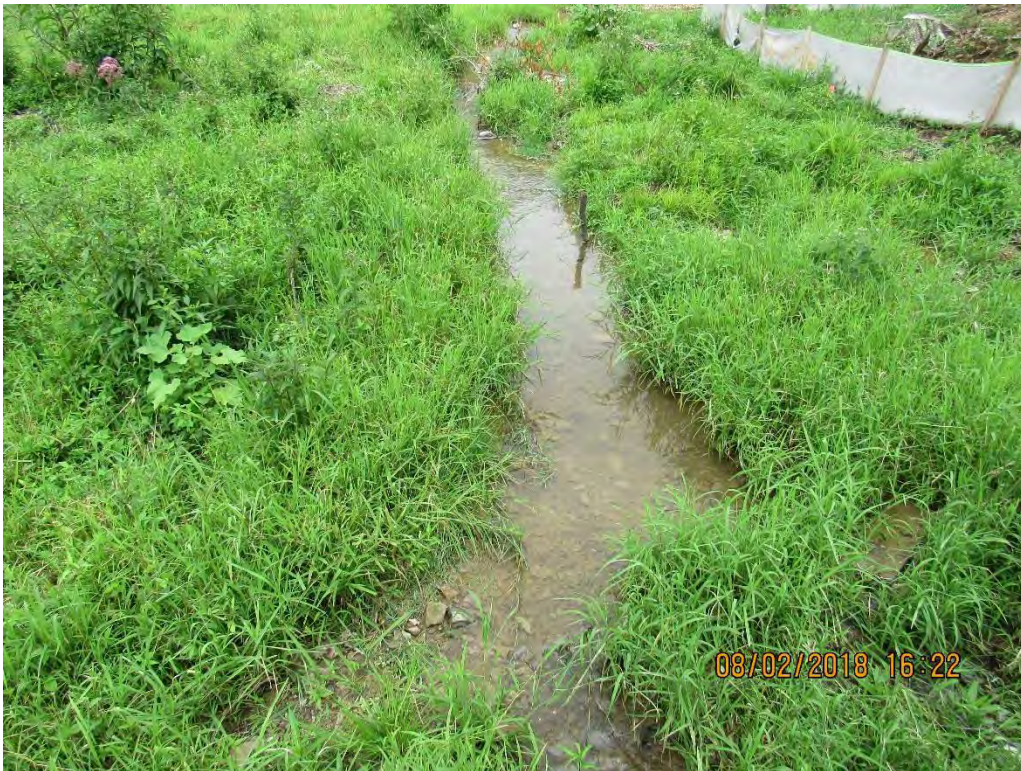
Photo 41: Another feeder wetland stream leading into Painters Run.

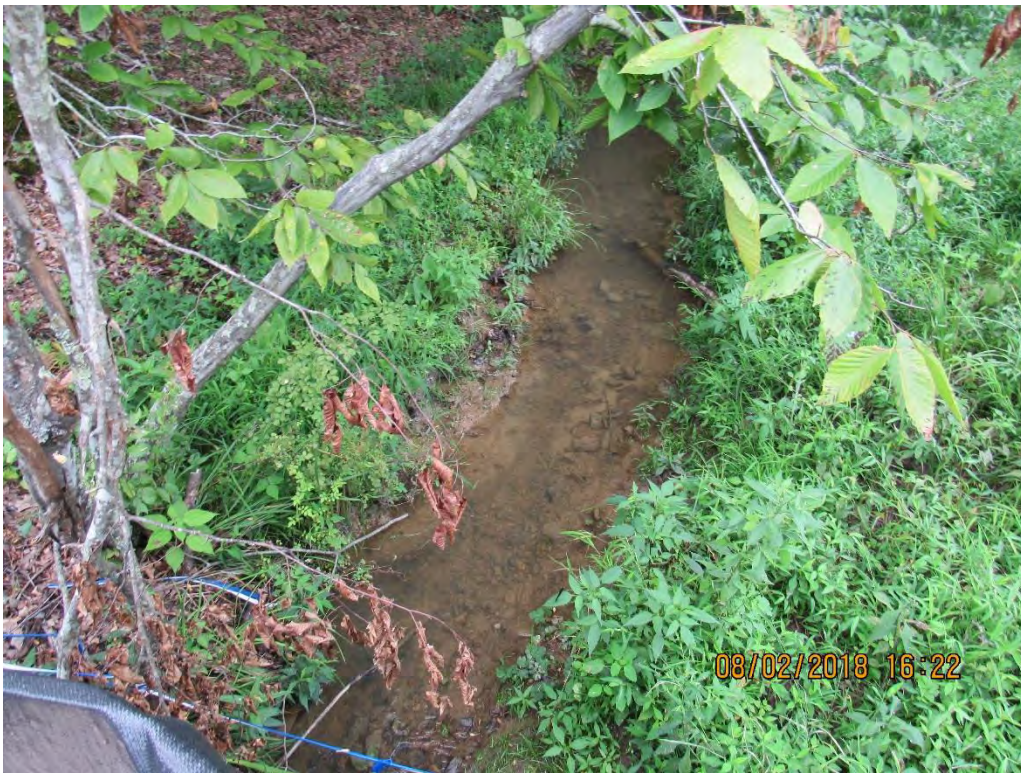
Photo 42: Painters Run below entry of feeder streams in above photos.

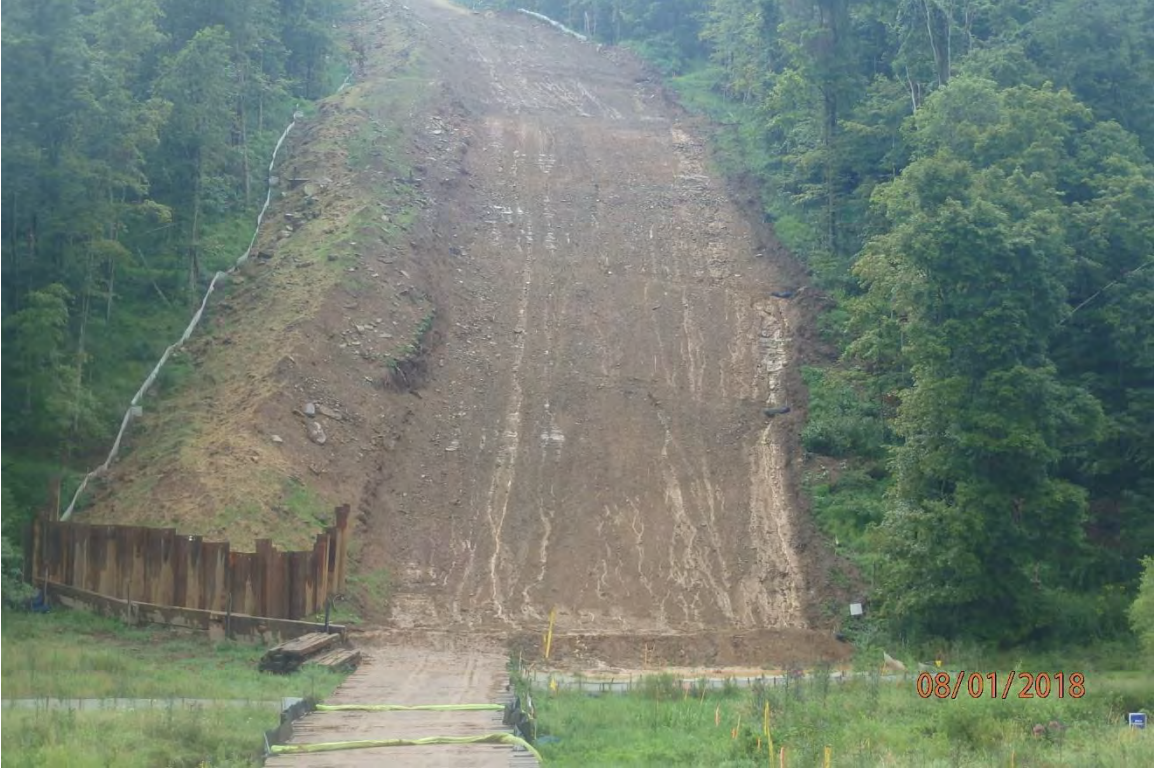
- 1). (2, 6, 7, 8, 13, 14, 19, 20 & 21) Improperly constructed water bars were found throughout the inspected area. Water bars did not shed stormwater off of the LOD in small quantities as designed. In many cases the water bars terminated prior to the edge of the Limits of Disturbance (LOD) and the installed perimeter controls which placed concentrated flow over the fill slope. Concentrated flow stormwater was then treated at the base of the hill with perimeter controls. In a few cases water bars terminated into unstable diversions that carried stormwater downslope to the base of the hill. Water bars that were in need of maintenance were also noted in areas scattered throughout the inspected area. Improperly constructed and poorly maintained water bars led to fill slope erosion, offsite sediment deposits and Conditions Not Allowable (CNA) in several instances. Offsite CNA deposits were noted in UNT Goose Run (39° 26.100' X 80° 28.4922'), Seal Run (39° 20.4891' X 80° 30.7324') and Grass Run (39° 20.1127' X 80° 31.3233'). CNA distinctly visible settleable solids were noted in Right Fork of Big Elk Creek (39° 26.6589' X 80° 28.9724'), Goose Run (39° 26.17952' X 80° 28.5256') and UNT Goose Run (39° 26.100' X 80° 28.4922').

Improperly installed water bars that have caused fill slope erosion in the Big Elk Creek watershed.
Deficiencies in site evaluation item numbers 6, 7, 8, 14, 19, 20 & 21 pictured.

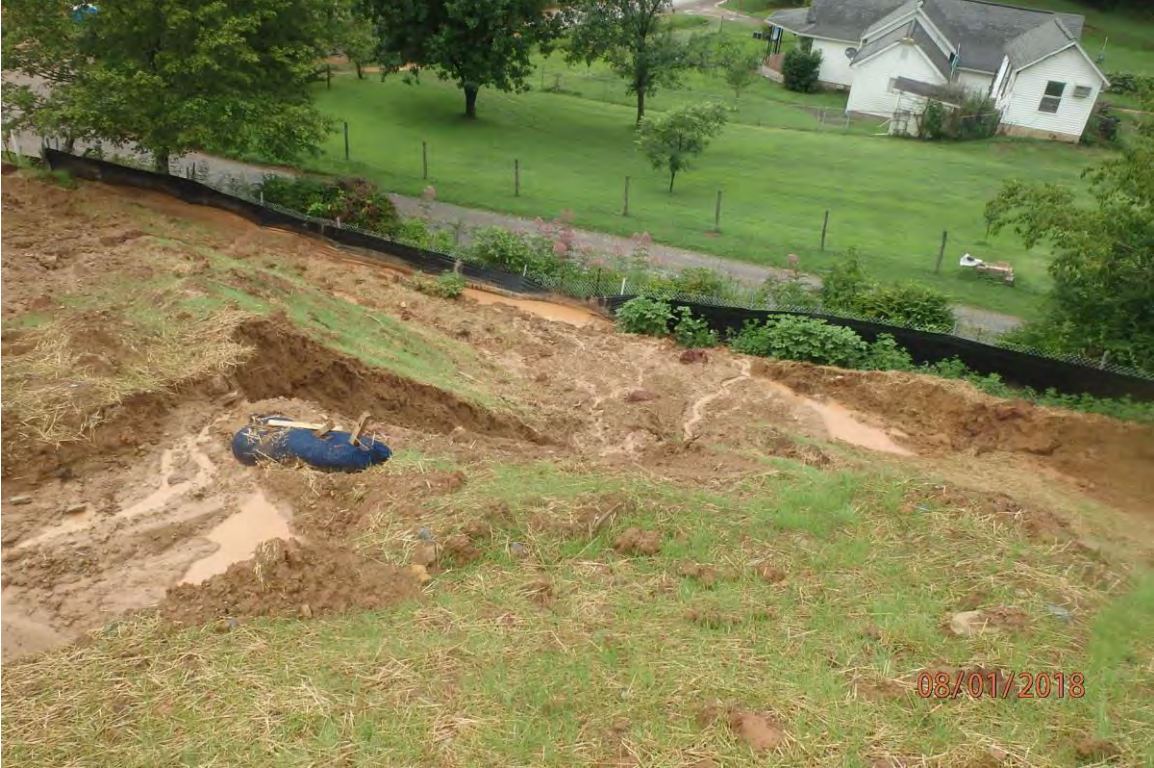
Concentrated flow from water bar outlet that is being treated by sheet flow BMP in the Big Elk Creek watershed. Deficiencies in site evaluation item numbers 1, 6, 7, 8, 13, 14, 19, 20 & 21 pictured.

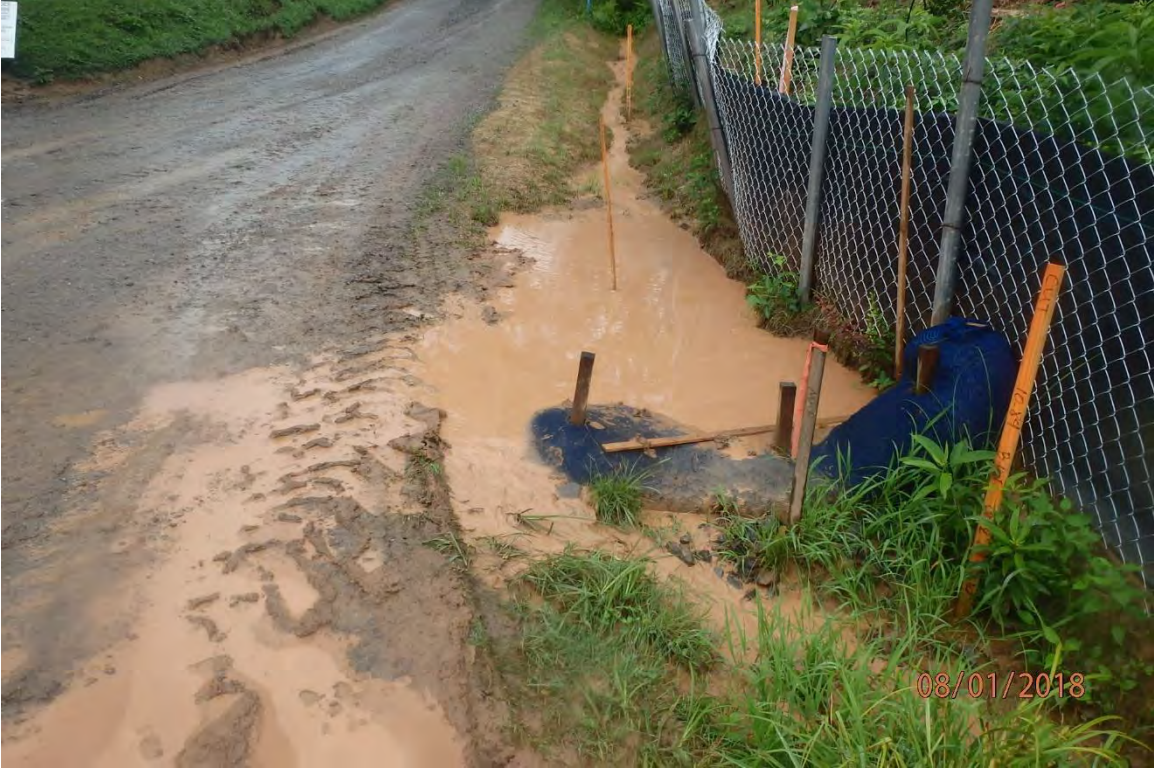
Sediment laden water that is bypassing the installed BMPs due to improper BMP operation and installation. Deficiencies in site evaluation item numbers 1, 6, 7, 13, 14, 19, 20 & 21 pictured.

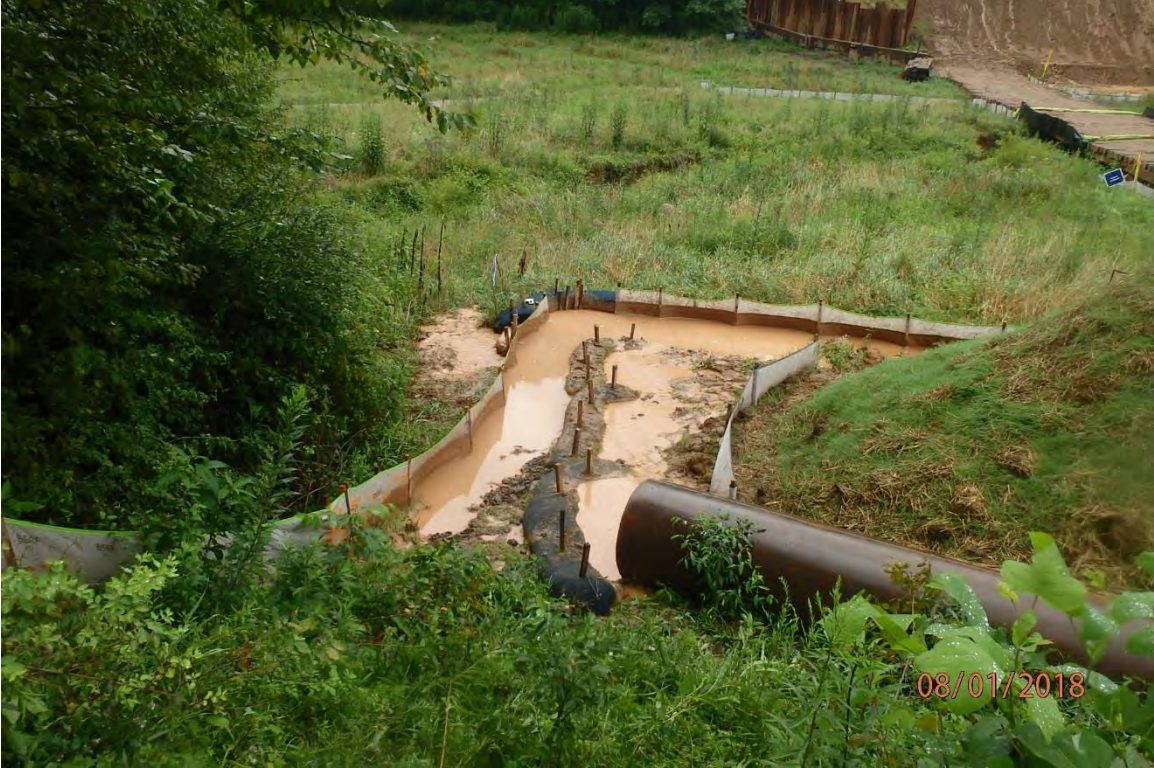
Improperly operated BMP that is causing sediment laden water to leave the site and CNA visible in Big Elk Creek. Deficiencies in site evaluation item numbers 1, 6, 19, 20 & 21 pictured.

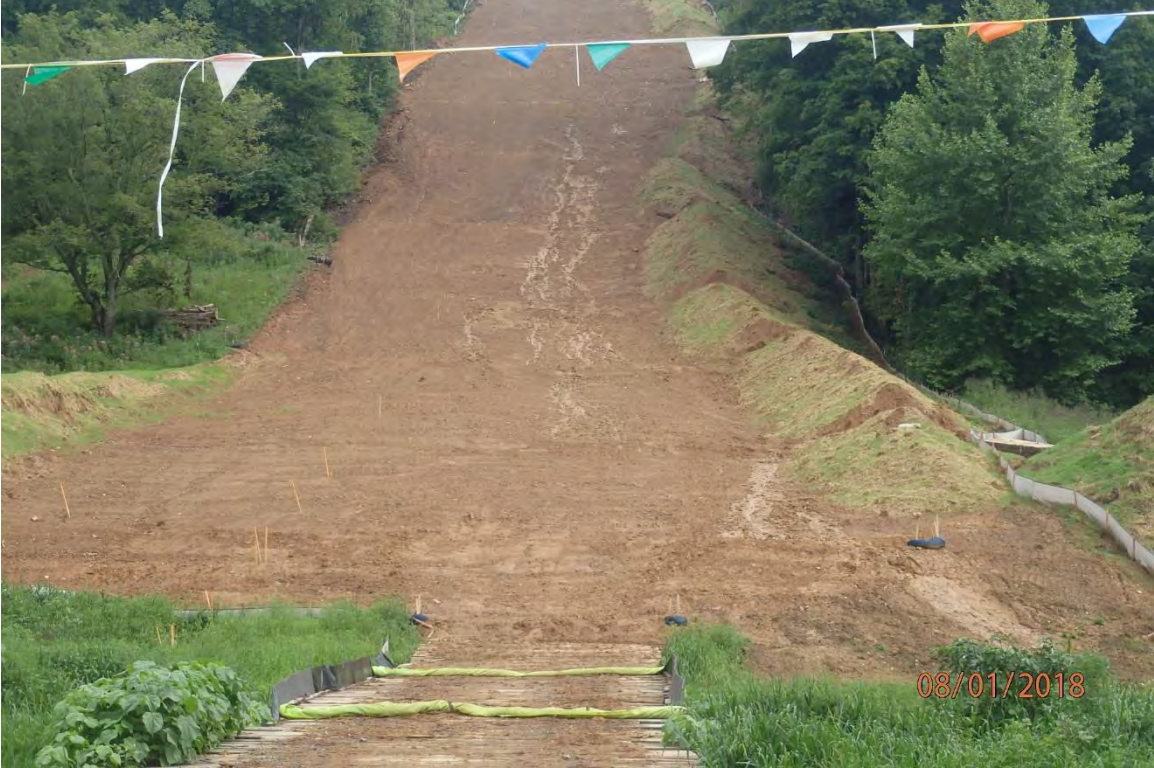
Improperly installed and poorly maintained water bars in the Goose Run watershed. Deficiencies in site evaluation item numbers 6, 7, 14, 19, 20 & 21 pictured.

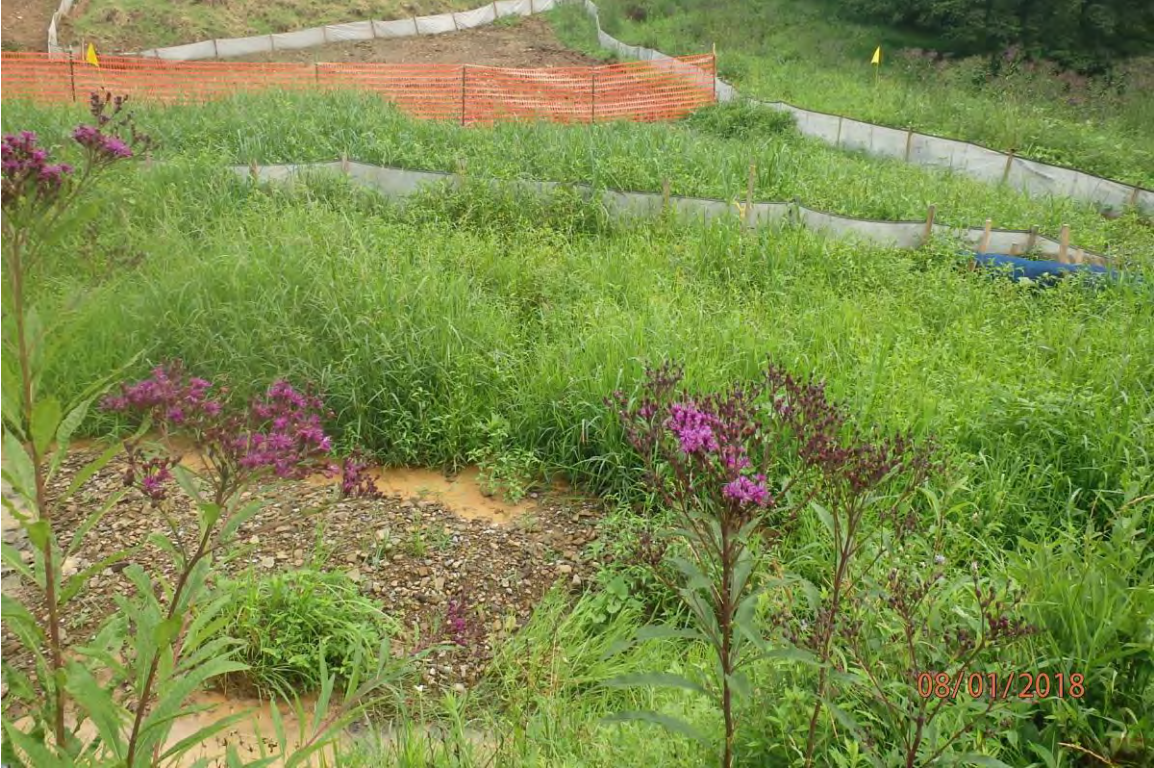
Perimeter controls adjacent to Goose Run that are undermined and allowing sediment laden water to leave the site. Deficiencies in site evaluation item numbers 1, 6, 19, 20 & 21 pictured.

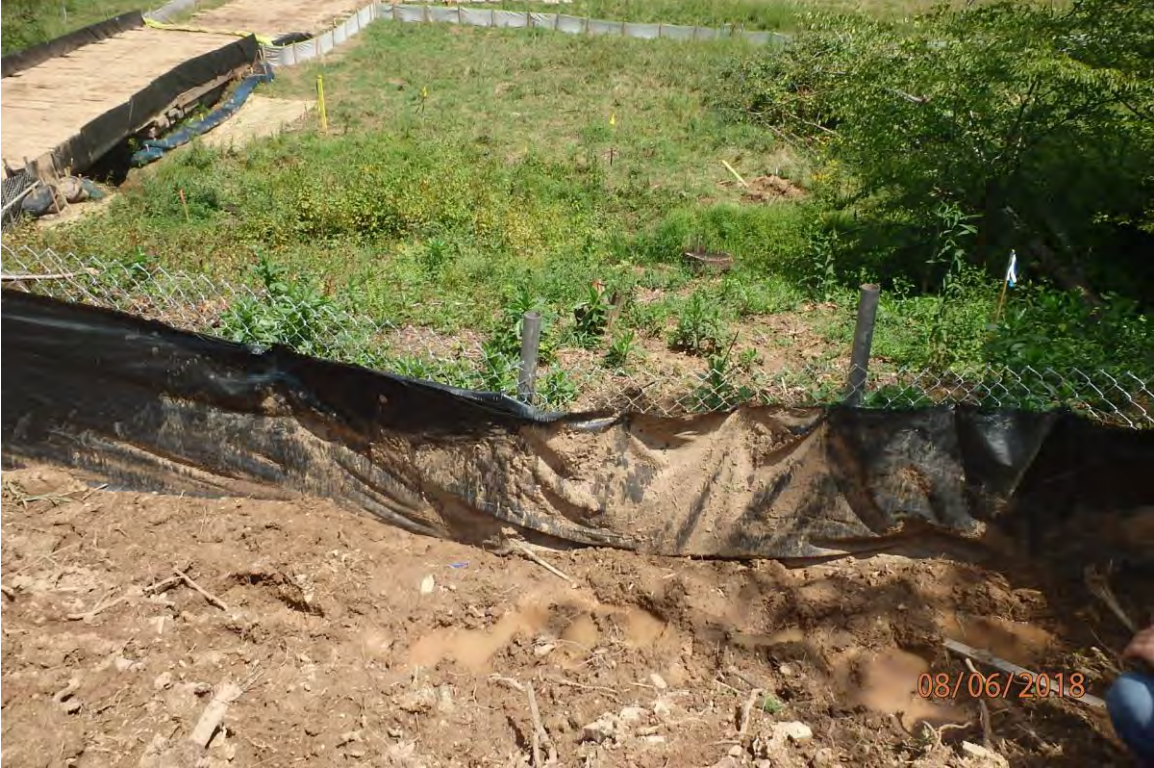
Perimeter control that was overwhelmed by concentrated flow and caused CNA deposits in Seal Run. Deficiencies in site evaluation item numbers 1, 2, 6, 7, 13, 14, 19, 20 & 21 pictured.

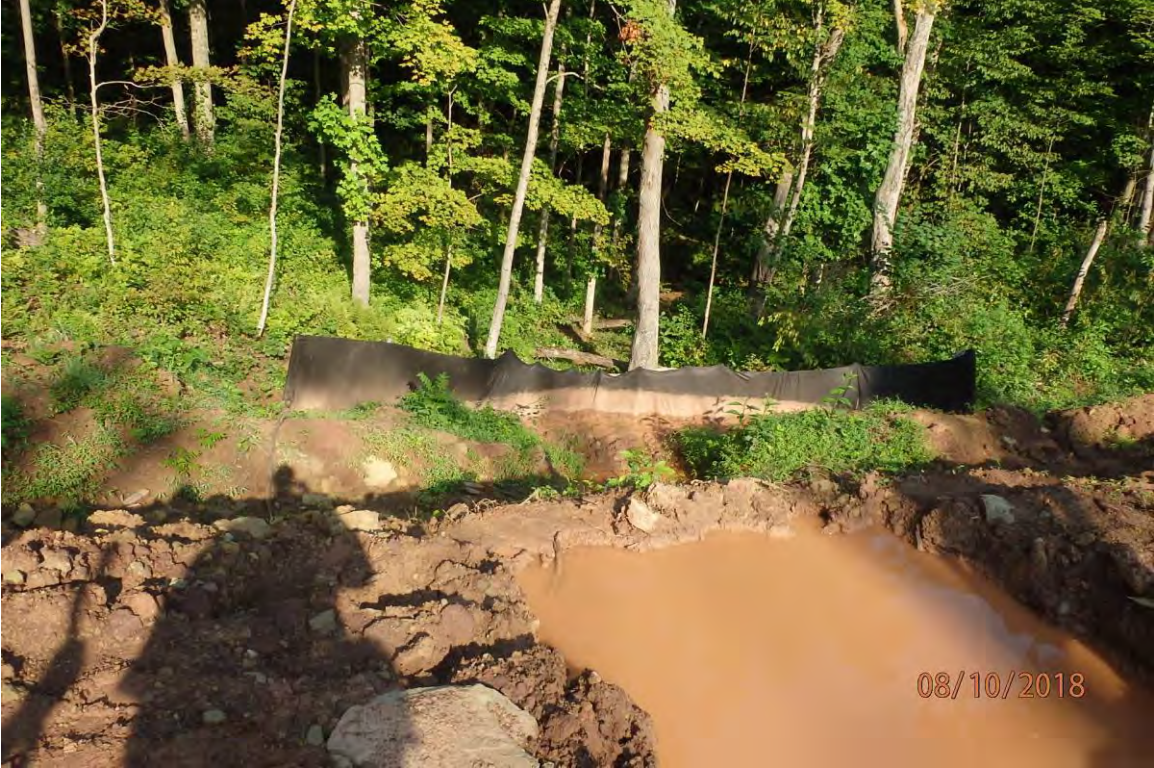
1). (2, 6, 7, 8, 14, 19, 20 & 21) Improperly constructed water bars were found throughout the inspected area. Water bars that did not shed stormwater off the LOD in small quantities as designed were noted during the inspection. In some cases, the water bars terminated prior to the edge of the Limits of Disturbance (LOD) and the installed perimeter controls which placed concentrated flow over the fill slope. Concentrated flow stormwater was then treated at the base of the hill with perimeter controls. In a few cases water bars terminated into unstable diversions, in a couple of instances it was the pipe trench, that carried stormwater downslope. Water bars that were installed at steep angles were also noted throughout the inspected area. Water bars that are installed at steep angles have caused the installed controls at the terminus of the water bar to fail due to excessive sediment deposits from the erosion of the water bar as well as the increased velocity of the stormwater. Improperly constructed water bars and poorly operated and maintained water bar terminus BMPs led to fill slope erosion, offsite sediment deposits and Conditions Not Allowable (CNA) in several instances. Offsite CNA deposits were noted in UNT Meathouse Fork (39° 11.891' X 80° 33.209'), UNT Dry Fork (39° 11.377' X 80° 33.566'), UNT Kincheloe Creek (39° 10.006' X 80° 34.736'), Wetland UNT Smoke Camp Run (W-I26) (39° 08.208' X 80° 34.610'), Wetland UNT Left Fork of Freemans Creek (W-B47) (39° 04.744' X 80° 34.904) and Laurel Run (39° 01.043' X 80° 35.867'). CNA distinctly visible settleable solids was noted in UNT Meathouse Fork (39° 11.891' X 80° 33.209').

Improperly operated and maintained BMP at a water bar terminus in the Meathouse Fork watershed that led to CNA deposits and distinctly visible settleable solids in UNT Meathouse Fork (39° 11.891' X 80° 33.209'). Deficiencies in site evaluation item numbers 6, 7, 19, 20 & 21 pictured.

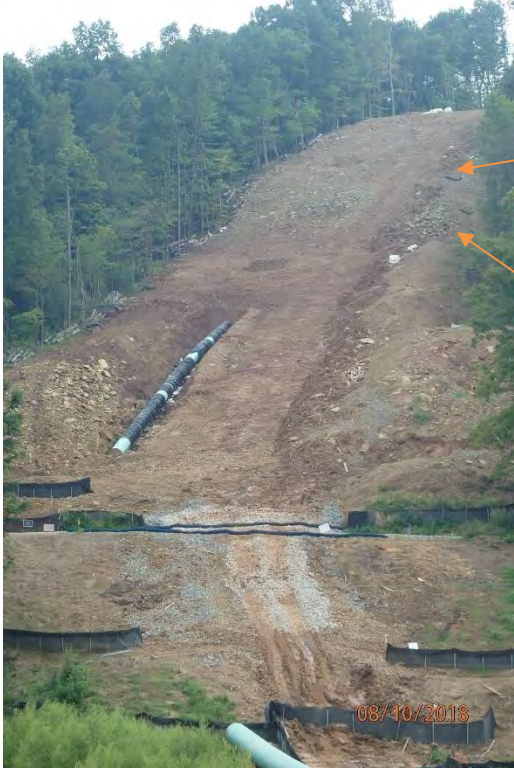
Diversion running parallel to the slope.

Water bar outlet that has been overwhelmed and caused CNA in UNT Kincheloe Creek.

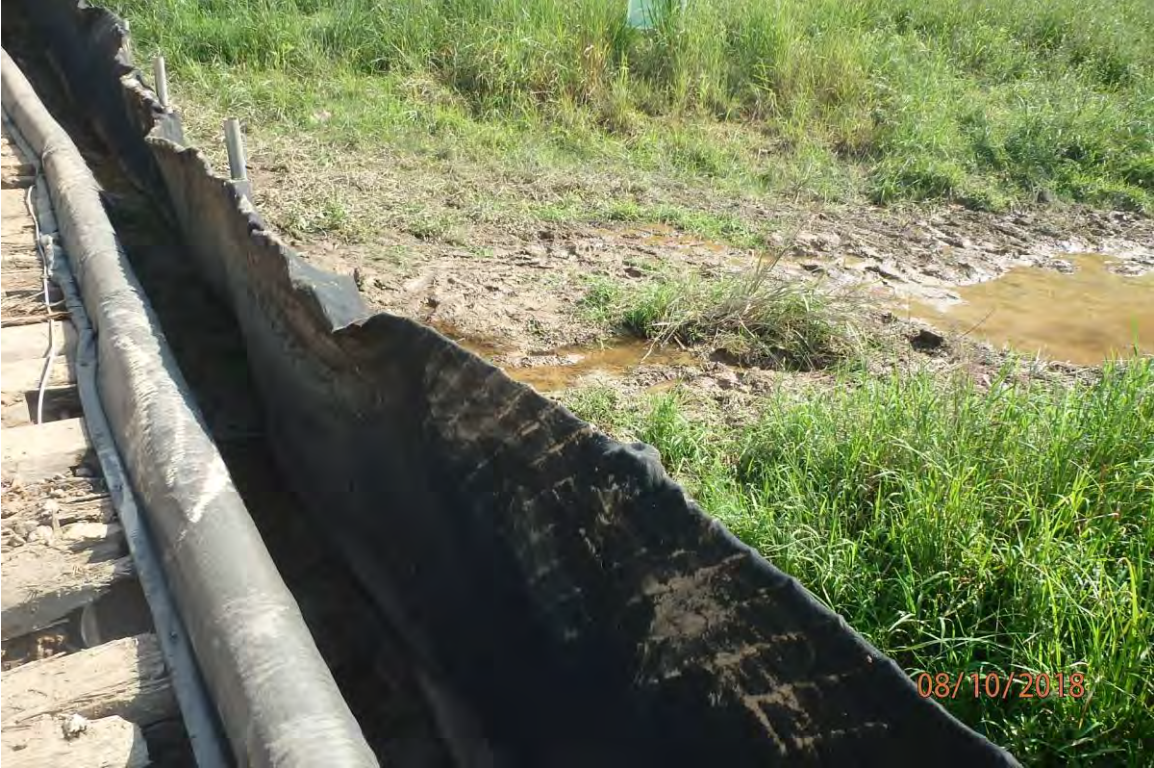
3). (1, 6, 19, 20 & 21) Improperly operated and maintained perimeter controls adjacent to the WJ-40 crossing led to offsite sediment deposits and CNA deposits in Wetland UNT Kincheloe Creek (WJ-40) (39° 10.060' X 80° 34.626').

Improperly operated and maintained perimeter controls adjacent to the WJ-40 crossing led to offsite sediment deposits and CNA deposits in Wetland UNT Kincheloe Creek (WJ-40) (39° 10.060' X 80° 34.626'). Deficiencies in site evaluation item numbers 1, 6, 19, 20 & 21 pictured.

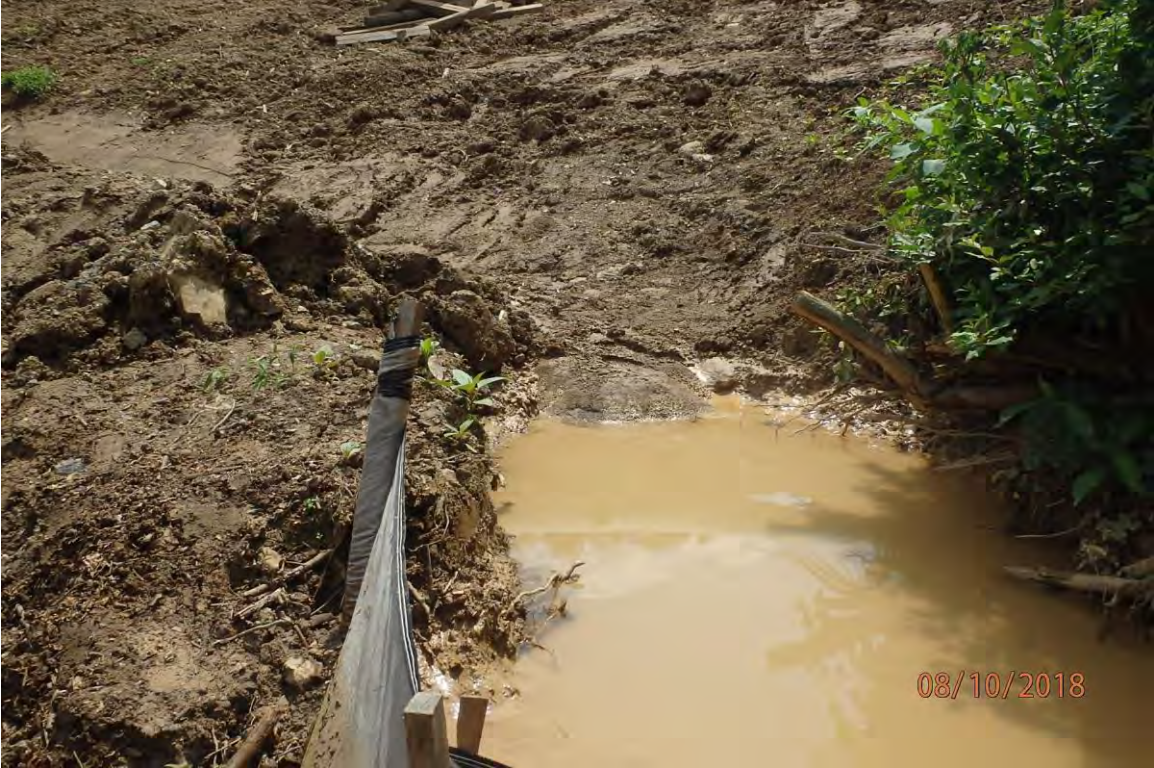
Water bar terminus BMP that was improperly operated and allowed sediment laden water to leave the site. This caused CNA deposits in wetland UNT Left Fork of Freemans Creek (W-B47) (39° 04.744' X 80° 34.904). Deficiencies in site evaluation item numbers 6, 7, 19, 20 & 21 pictured.

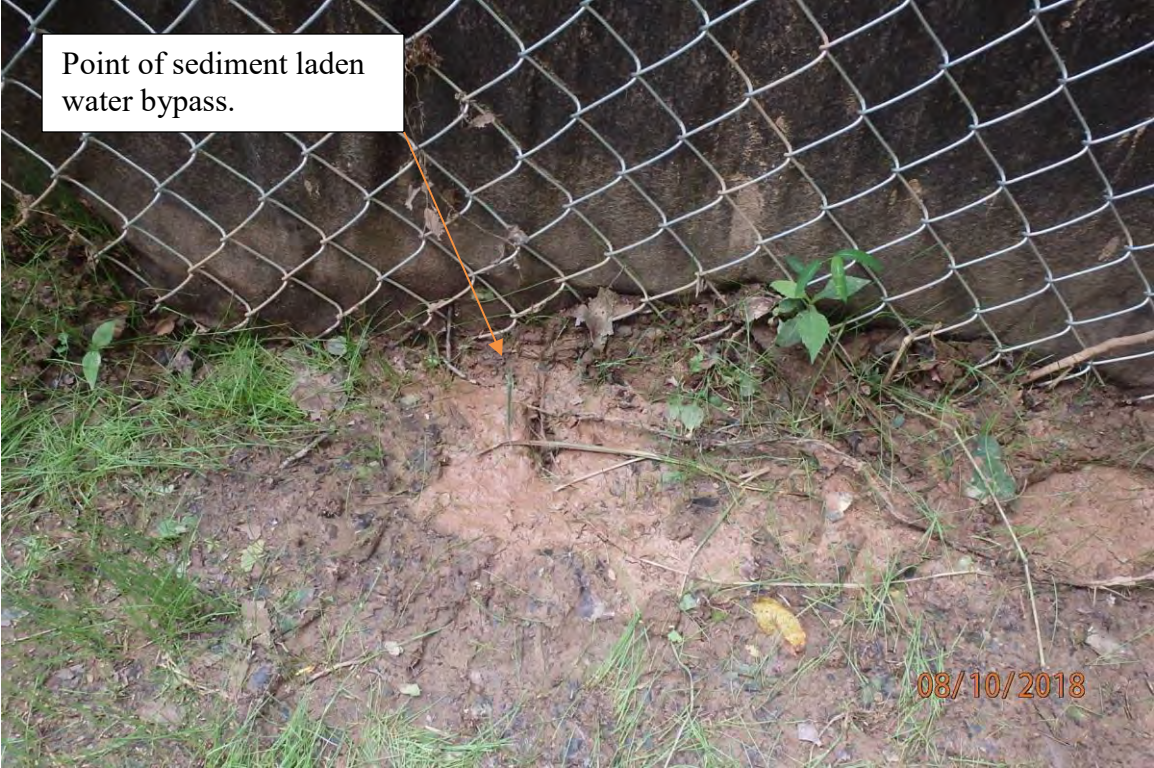
Offsite sediment deposits in Laurel Run (39° 01.043' X 80° 35.867') that originate from site. Deficiencies in site evaluation item numbers 6, 7, 14, 19, 20 & 21 pictured.

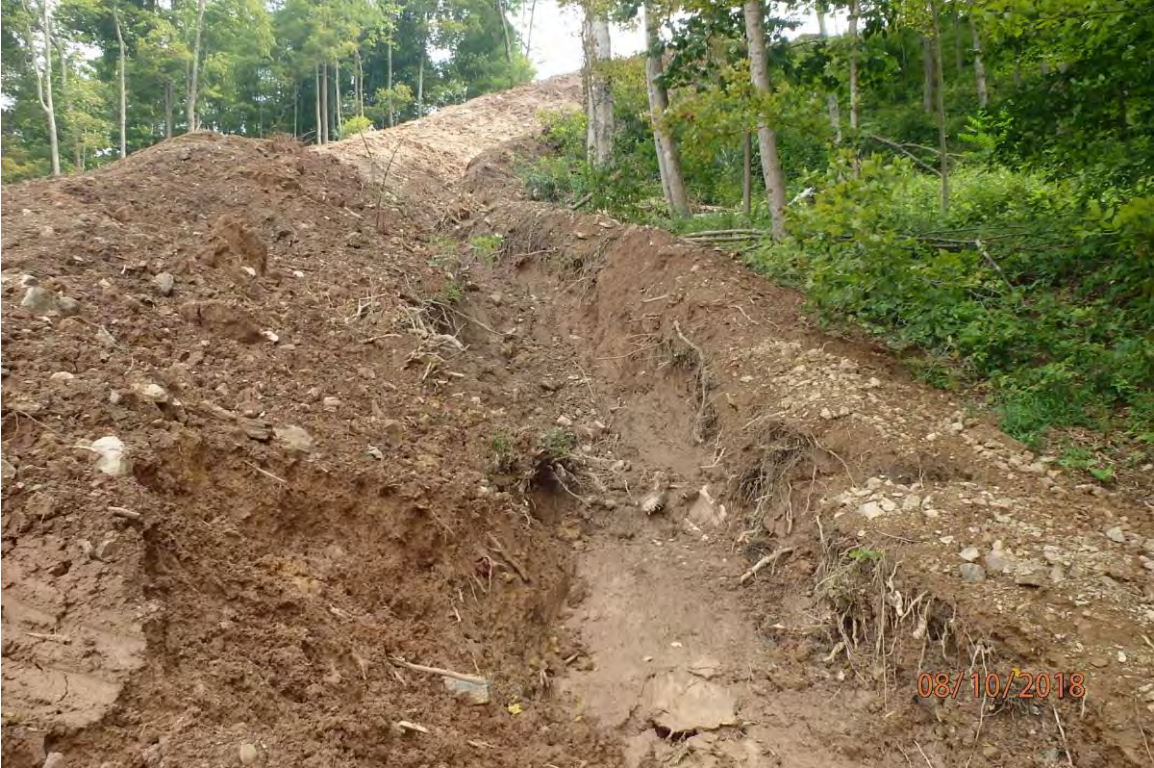
Unstable diversion that runs parallel to the slope and the associated erosion and offsite sediment deposits in the Cove Lick watershed. Deficiencies in site evaluation item numbers 2, 6, 8, 14, 19 & 21 pictured.

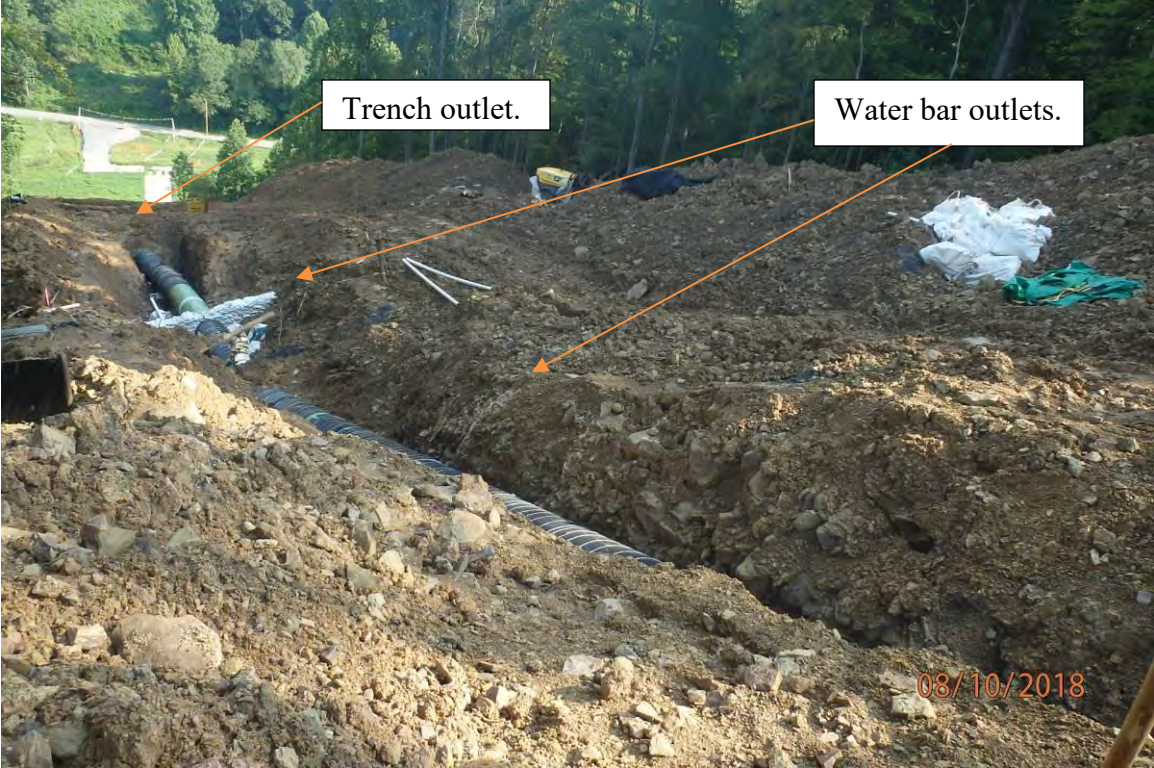
Issues with water bars that discharge into the pipe trench causing fill slope erosion. Deficiencies in site evaluation item numbers 2, 6, 8, 14, & 21 pictured.

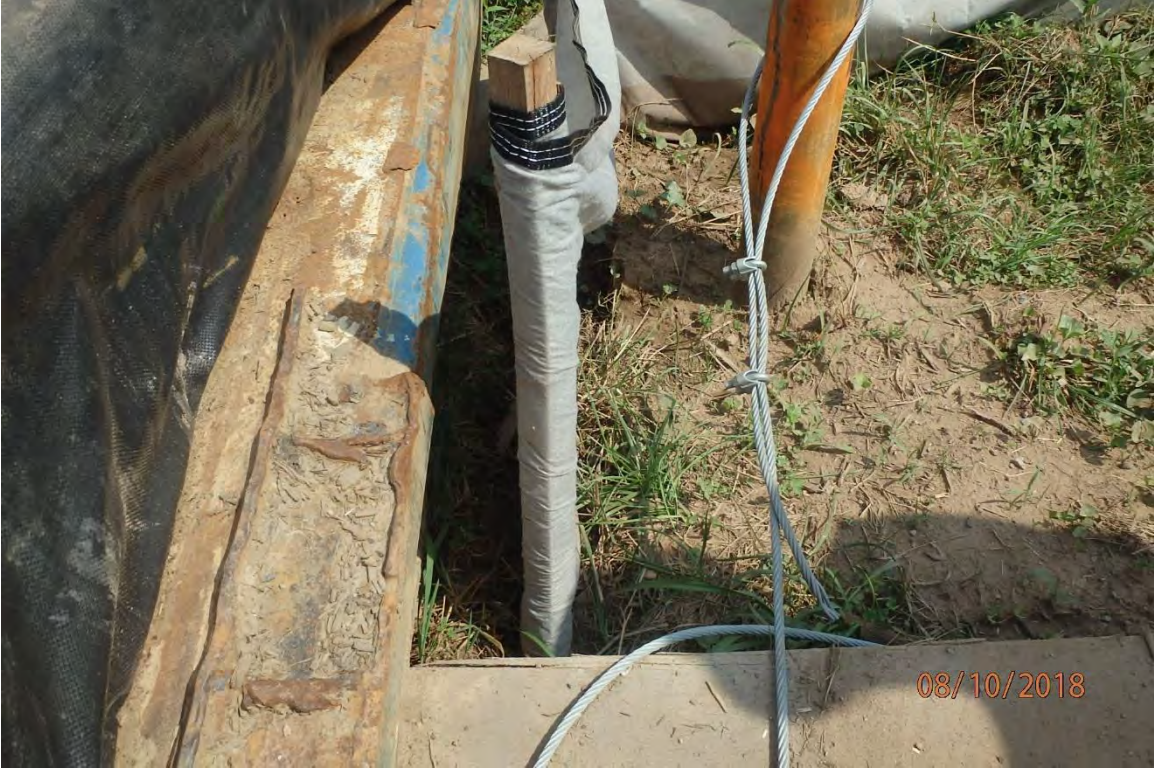
Sand Fork (S-163) crossing showing perimeter control not properly tied in to timber mat crossing. Marginal deficiencies in site evaluation item numbers 1, 19 & 21 pictured.

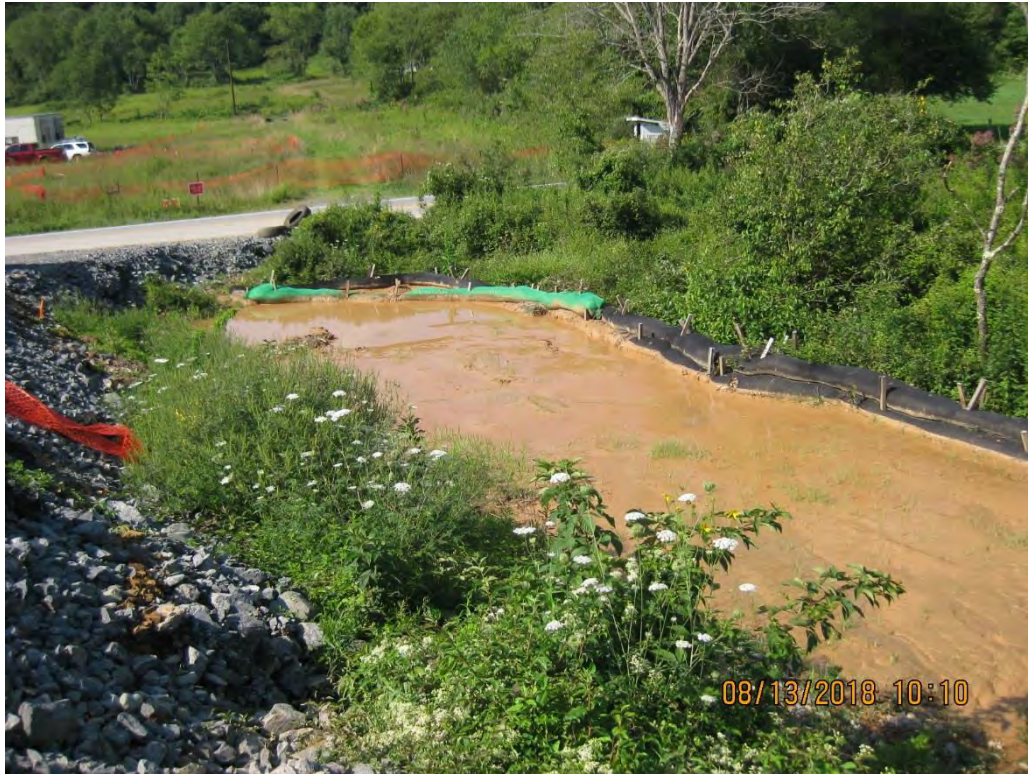
- (6. 13. 19. 20.) At St. 00+50 Sediment laden water had left the site via controls that had not been maintained. This control point is receiving concentrated stormwater from a large area and therefore requires an appropriately sized trapping structure. Perimeter controls were in place at the time of inspection. This area was identified in the 8-11-18 inspection log as requiring maintenance, which had not taken place. Sediment deposits were evident in adjacent wetland WQR-1 creating Conditions Not Allowable in the waters of the State.

At St. 00+50 Sediment laden water had left the site via controls that had not been maintained. This control point is receiving concentrated stormwater from a large area and therefore requires an appropriately sized trapping structure.

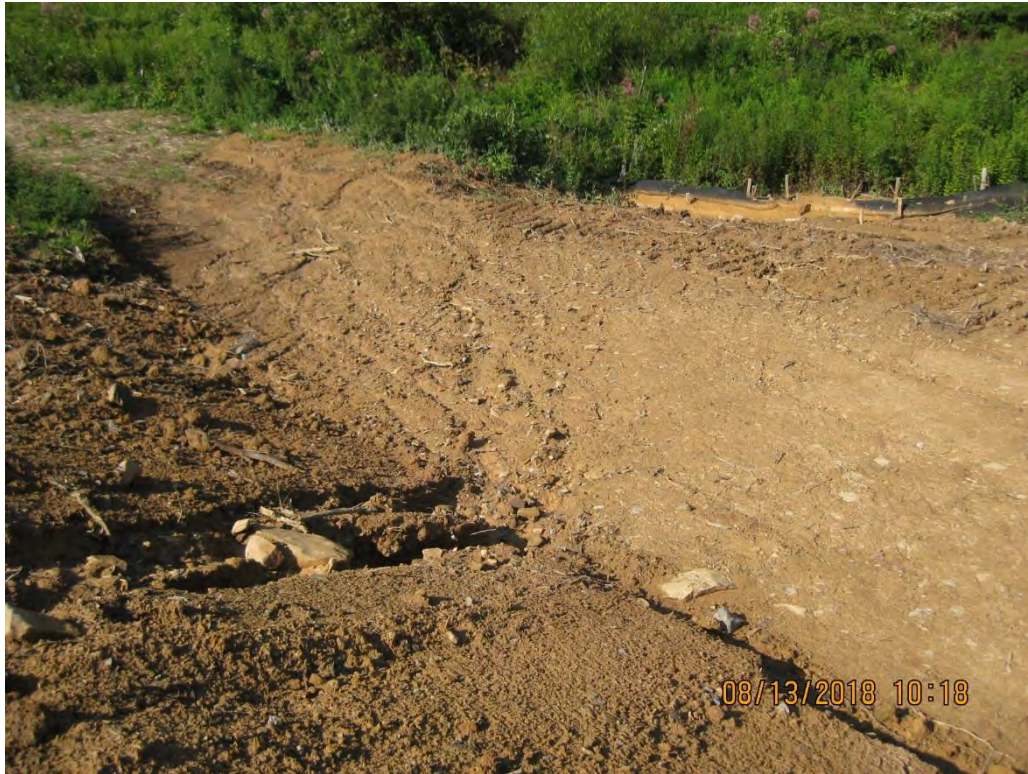
At St. 00+150 Sediment laden water left the site as a result of perimeter controls receiving concentrated flow and a lack of fill slope protection.

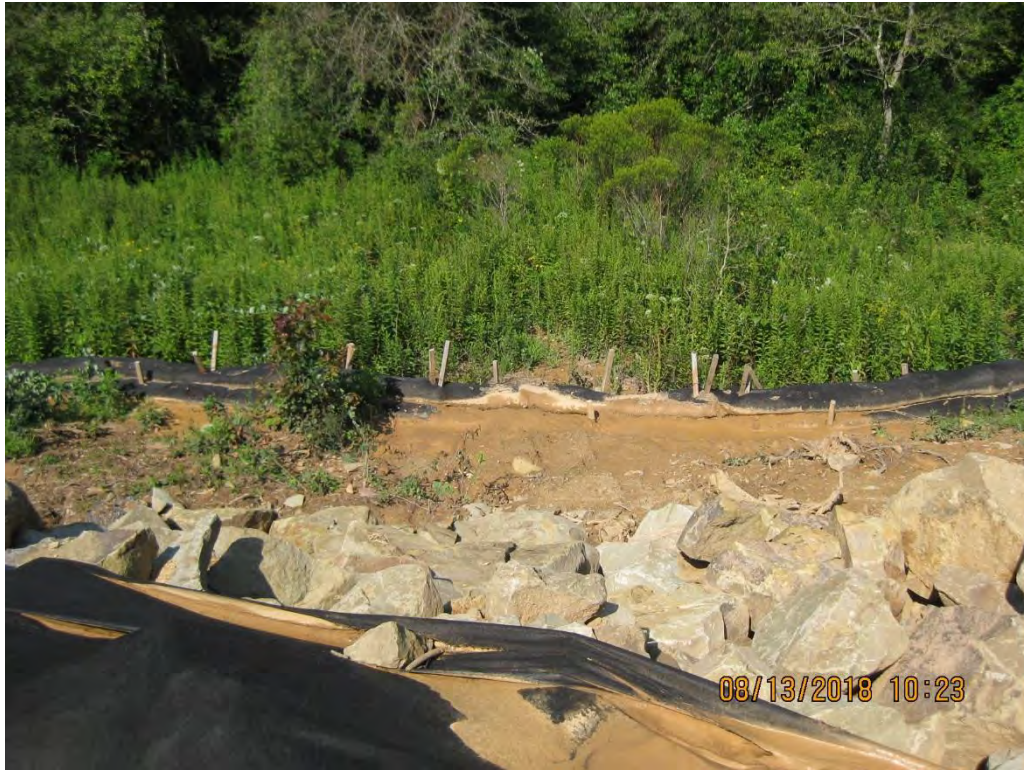
At St. 00+400 Sediment laden water left the site in three locations as a result of the lack of fill slope protection and the use of perimeter controls in an area of concentrated flow for a large drainage area that requires a sized trapping structure.

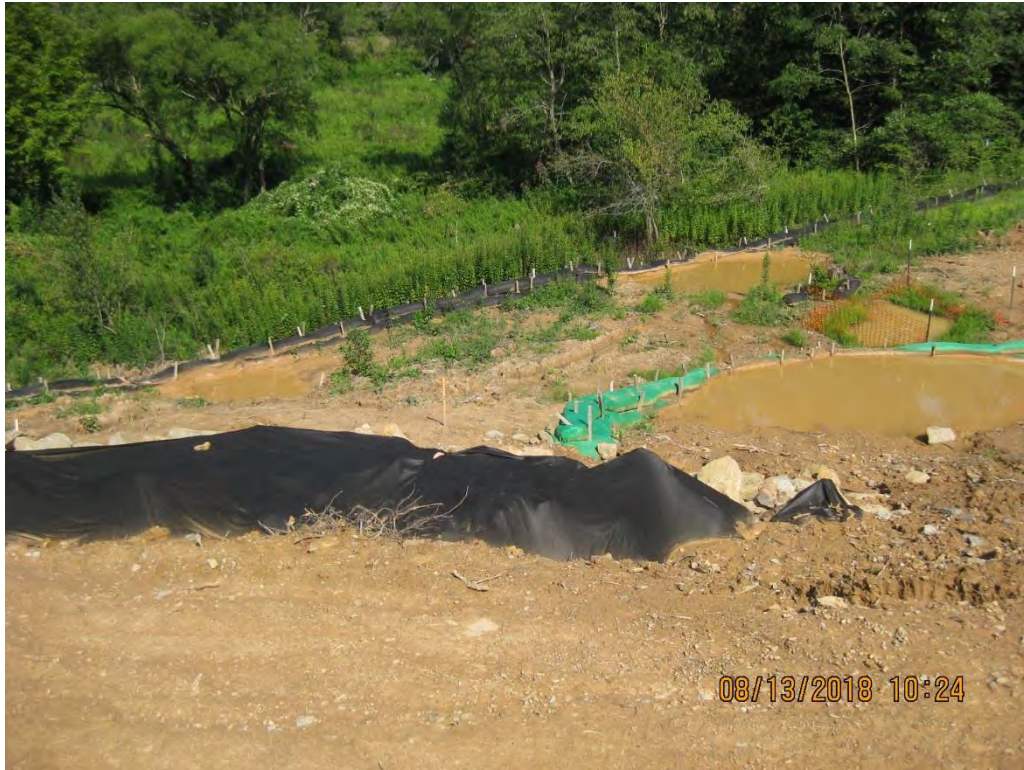
At St. 00+400 Sediment laden water left the site in three locations as a result of the lack of fill slope protection and the use of perimeter controls in an area of concentrated flow for a large drainage area that requires a sized trapping structure.
