**The Wilderness Society et al. Comments on the
U.S. Forest Service Mountain Valley Pipeline and
Equitrans Expansion Project Draft Supplemental
Environmental Impact Statement (#50036)**

**WEST VIRGINIA DEPARTMENT OF ENVIRONMENTAL PROTECTION
WV OIL AND GAS CONSTRUCTION STORMWATER PERMIT**

FACILITY NAME:	Mountain Valley Pipeline Project			REG. #	EXPIRE DATE:
PERMITTEE	MOUNTAIN VALLEY PIPELINE, LLC			WVR310667	5/13/2018
ADDRESS/PHONE:	Attn: Matt Hoover 625 LIBERTY AVE, ST 1700 PITTSBURGH, PA 15222				
LOCATION:	Wileyville, WV			Entry Date/Time:	4/3/18 8:30am
COUNTY:	Wetzel			Exit Date/Time:	4/3/18 1:37pm
Site Representative /Phone	Matt Hoover Sr. Environmental Coordinator (412) 258-5627			PHOTOS <input checked="" type="checkbox"/>	
CO-PERMITTEE:				ADDRESS:	
SITE OPERATOR:	Precision Pipeline			ADDRESS:	
PERMITTED ACREAGE	4214	WEATHER:	Rain	LAST INSPECTION:	N/A
RECEIVING STREAM(S)	Mobley Run > Ohio River				NOV: 1
Regular Mail <input type="checkbox"/> Certified Mail <input checked="" type="checkbox"/>	Tracking #				
OVERALL FACILITY RATING:	Unsatisfactory		COMPLIANCE OUTCOME	Not Immediately Corrected

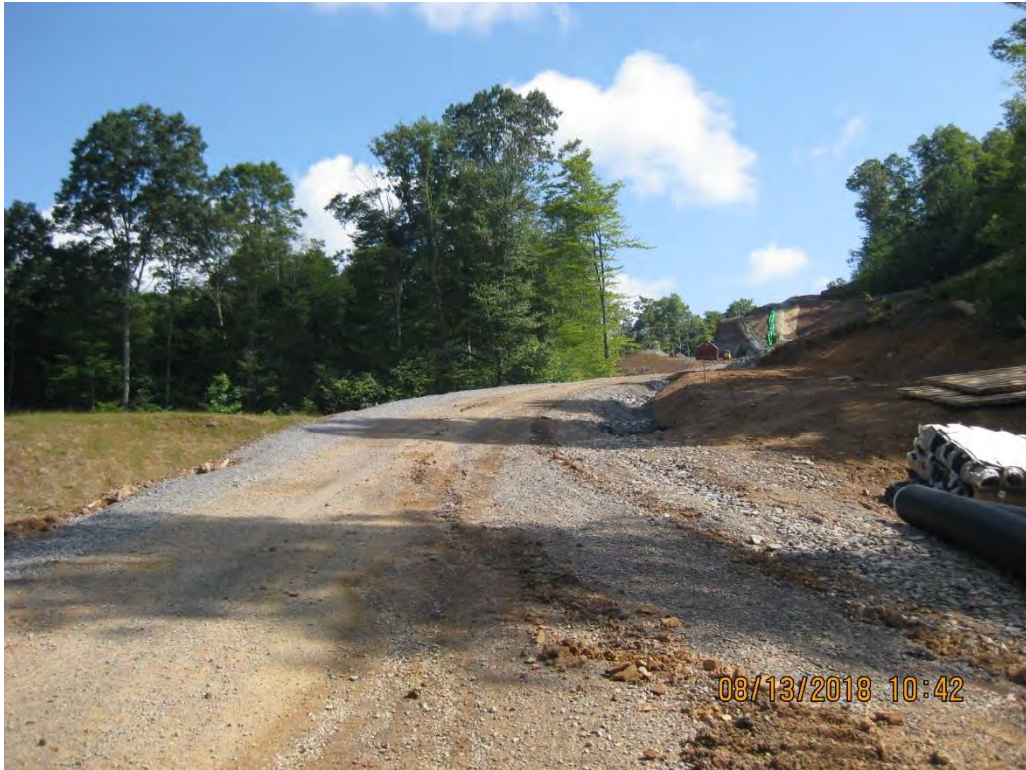
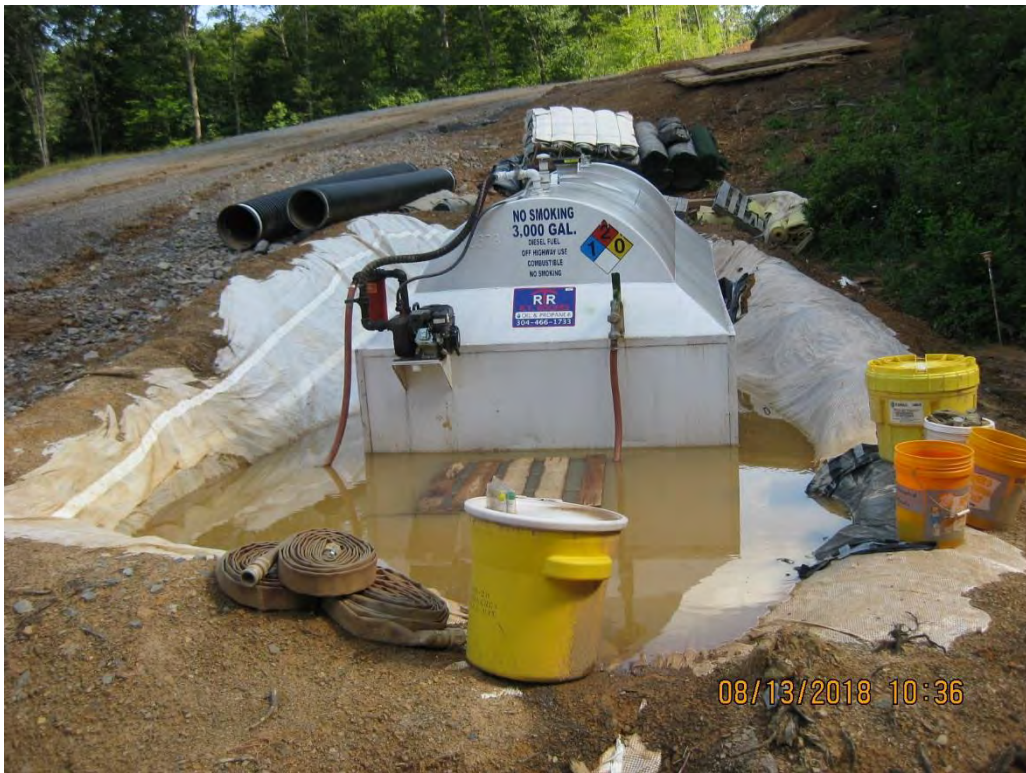
The roadside diversion with checks and several cross drains were not in place on site as prescribed in the SWPPP. This lack of stormwater control in the lower portion of the site was causing unnecessary erosion, lack of treatment and standing water in the fuel storage area.

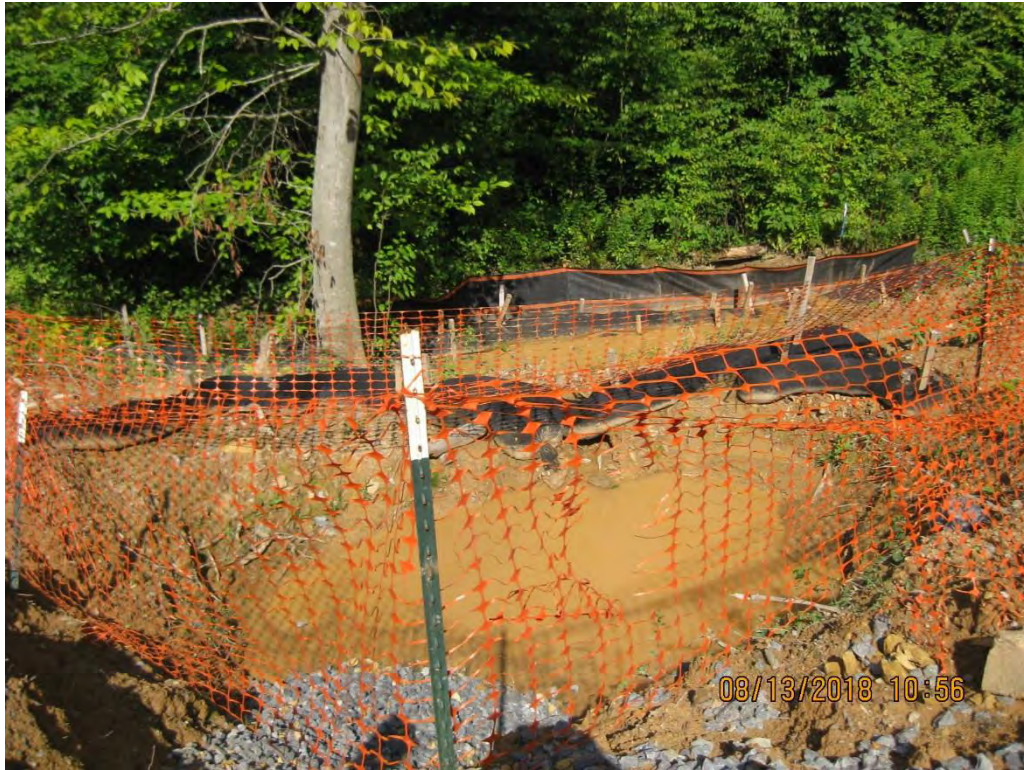
At St. 00+650 Sump/CFS/Priority 1 SF for terminus of upper diversion has not been maintained, sediment laden water left the site as a result.

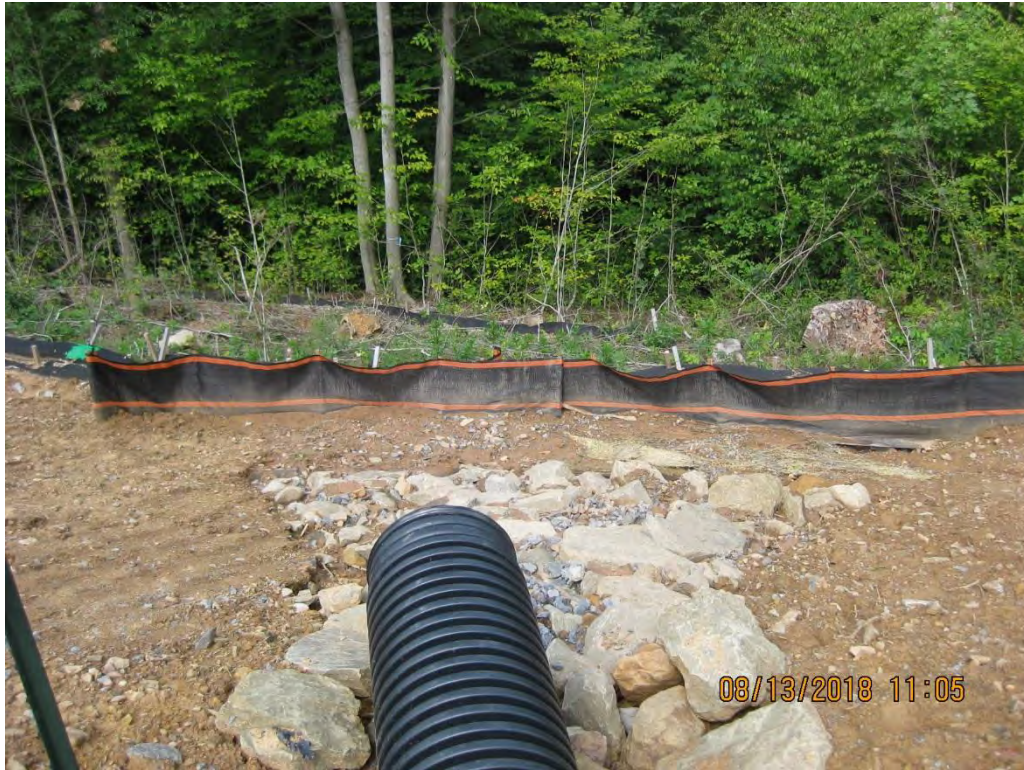
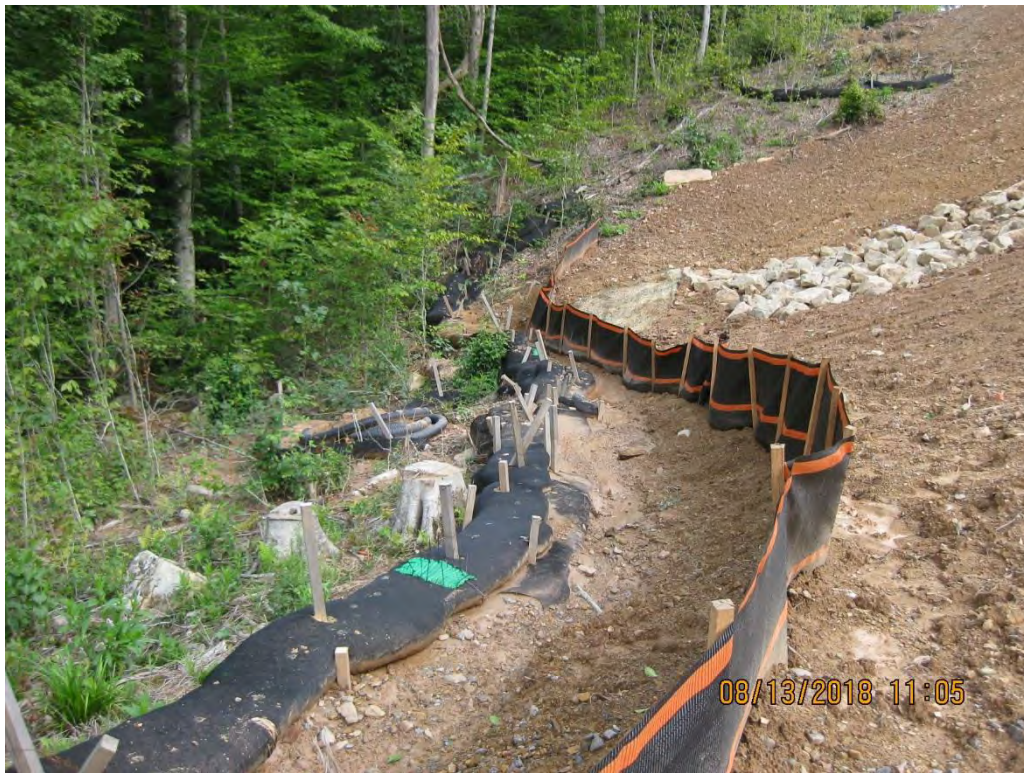
6. (6. 13. 19.) At St. 00+950 this deficiency is rated as marginal, EI Cole produced evidence that these controls were properly maintained prior to the most recent .9 inch rain event the day before. Controls for the termini of two cross drains had been undercut/inundated allowing sediment laden water to leave the site. It was agreed that the SWPPP should be modified and concentrated flow BMPs (trapping structures) be used in these areas. The use of appropriate sized rock was also discussed and agreed upon for the aprons on the upper and lower sides of the road cross drain/clean water diversion.

At St. 00+950 this deficiency is rated as marginal. Controls for the termini of two cross drains had been undercut/inundated allowing sediment laden water to leave the site.

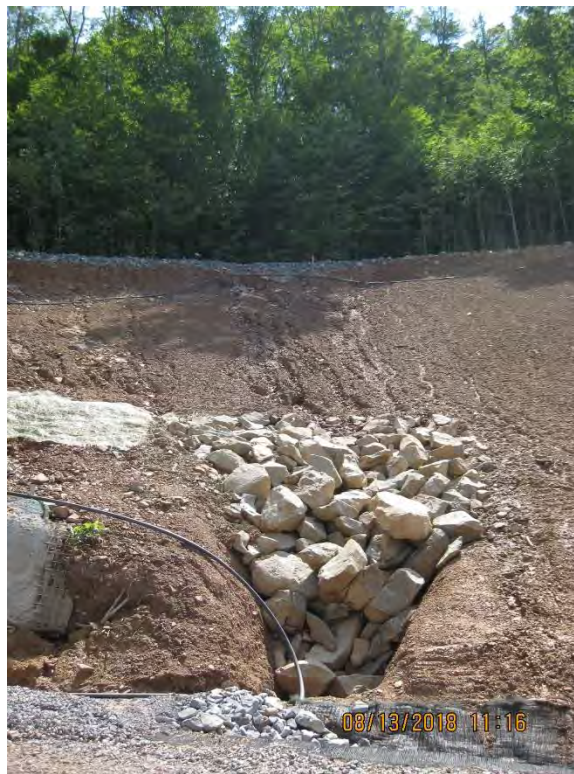
7. (14.) At St. 00+950 the lack of fill slope protection caused significant rilling above the aforementioned road cross drain rock apron.
8. (13. 19. 20.) At St. 00+220 a series of perimeter controls used in a concentrated flow area had failed allowing sediment laden water to leave the site. Sediment deposits were noted in receiving stream A-104 creating Conditions Not Allowable in the Waters of the State.

At St. 00+950 the lack of fill slope protection caused significant rilling above the aforementioned road cross drain rock apron.

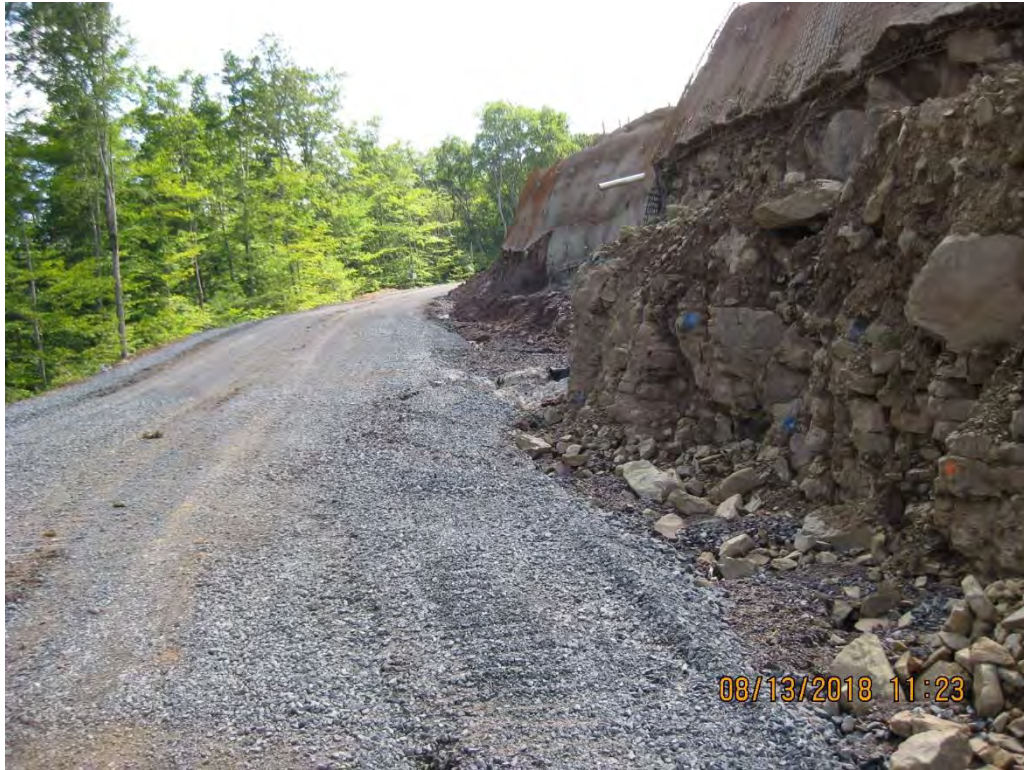
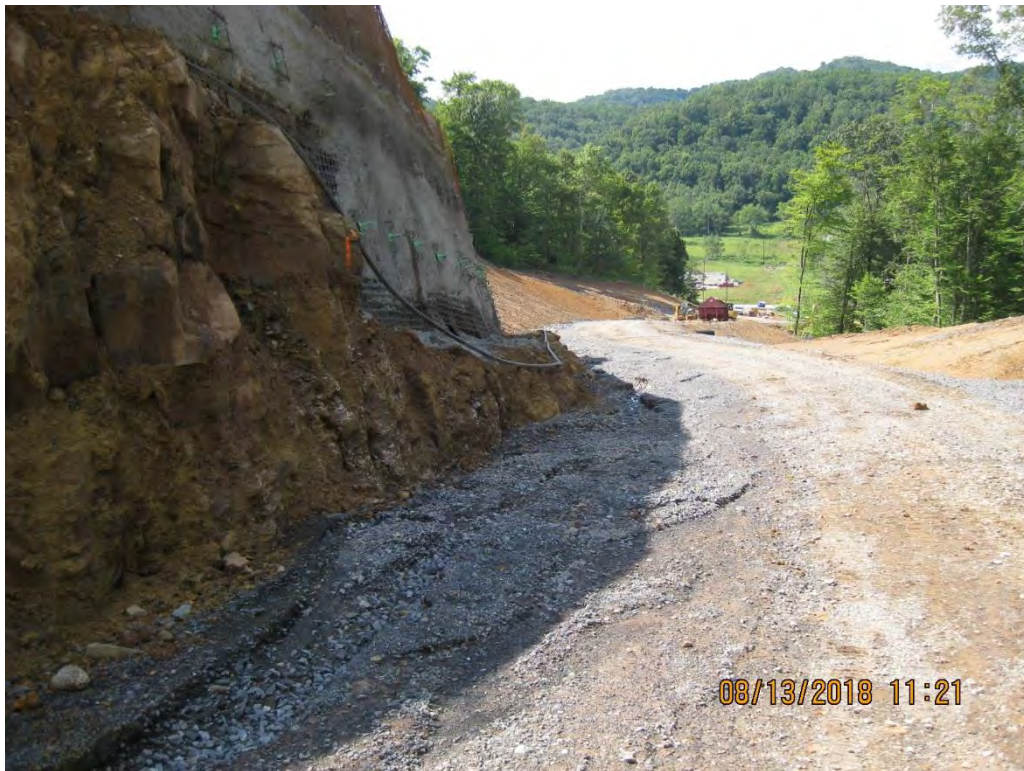
The roadside diversion with checks and several cross drains were not in place on site as prescribed in the SWPPP.

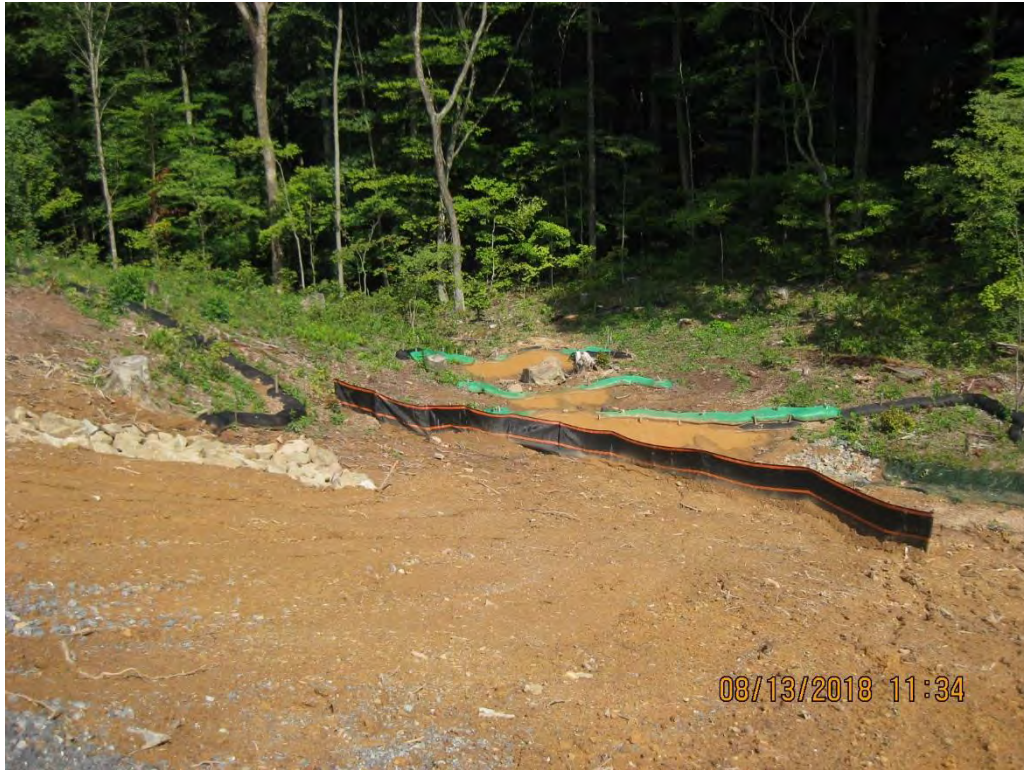
At St. 00+220 a series of perimeter controls used in a concentrated flow area had failed allowing sediment laden water to leave the site.

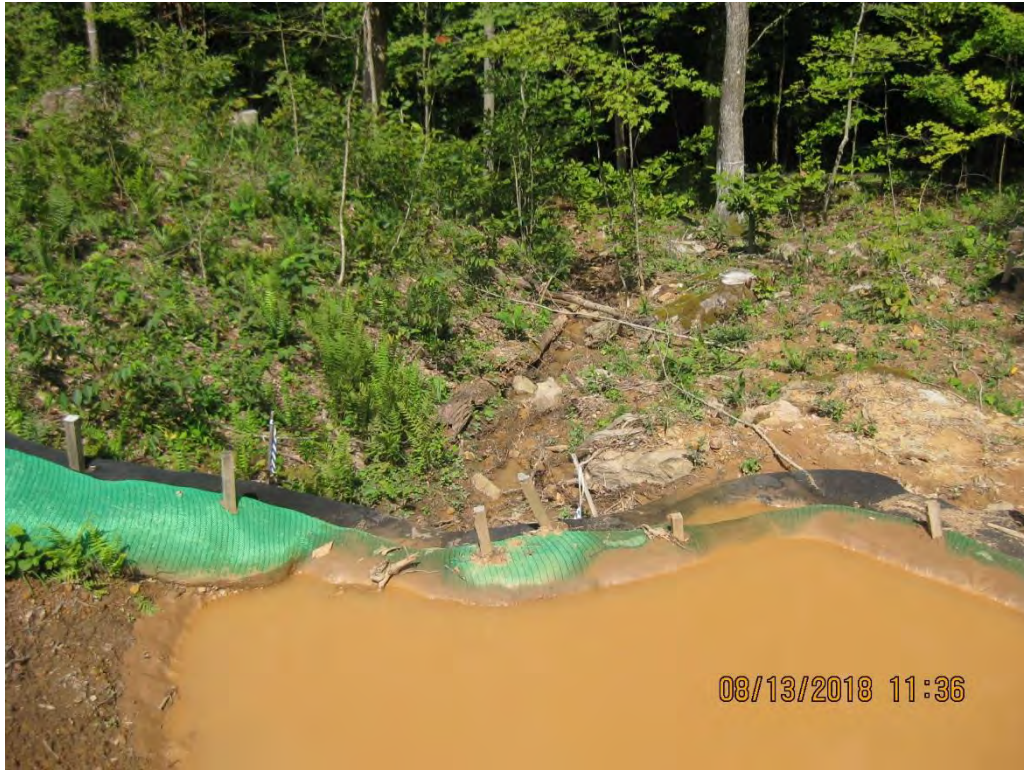
At St. 00+220 a series of perimeter controls used in a concentrated flow area had failed allowing sediment laden water to leave the site. Sediment deposits were noted in receiving stream A-104 creating Conditions Not Allowable in the Waters of the State.

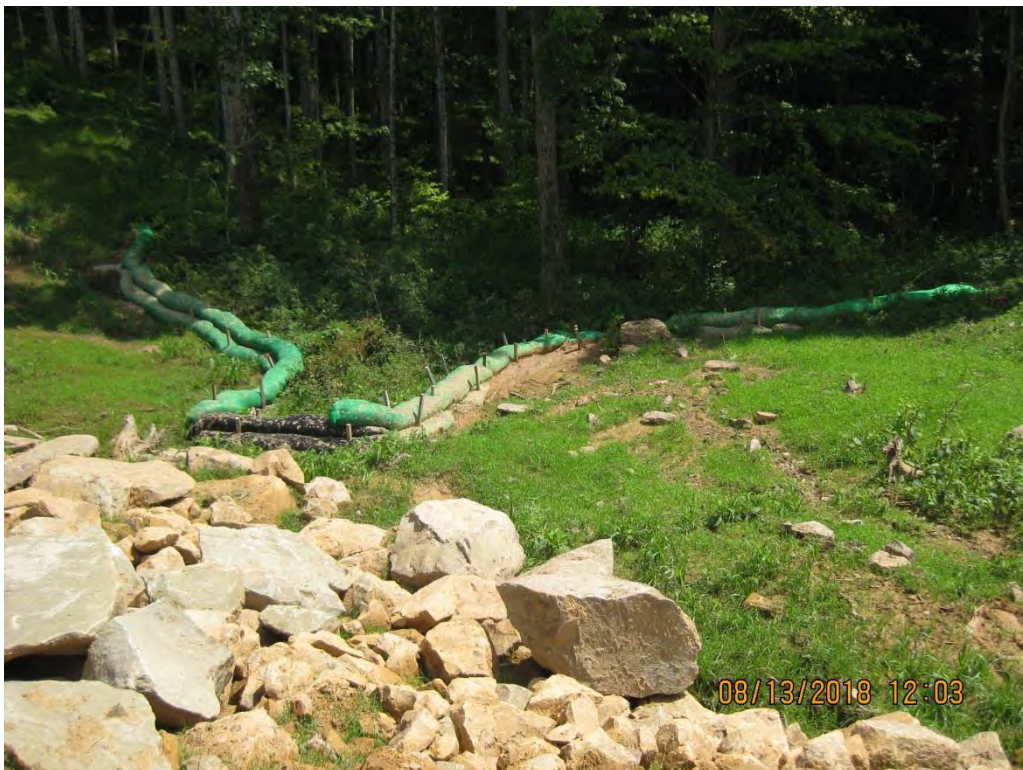
Maintenance needed for CFS below the east wall.

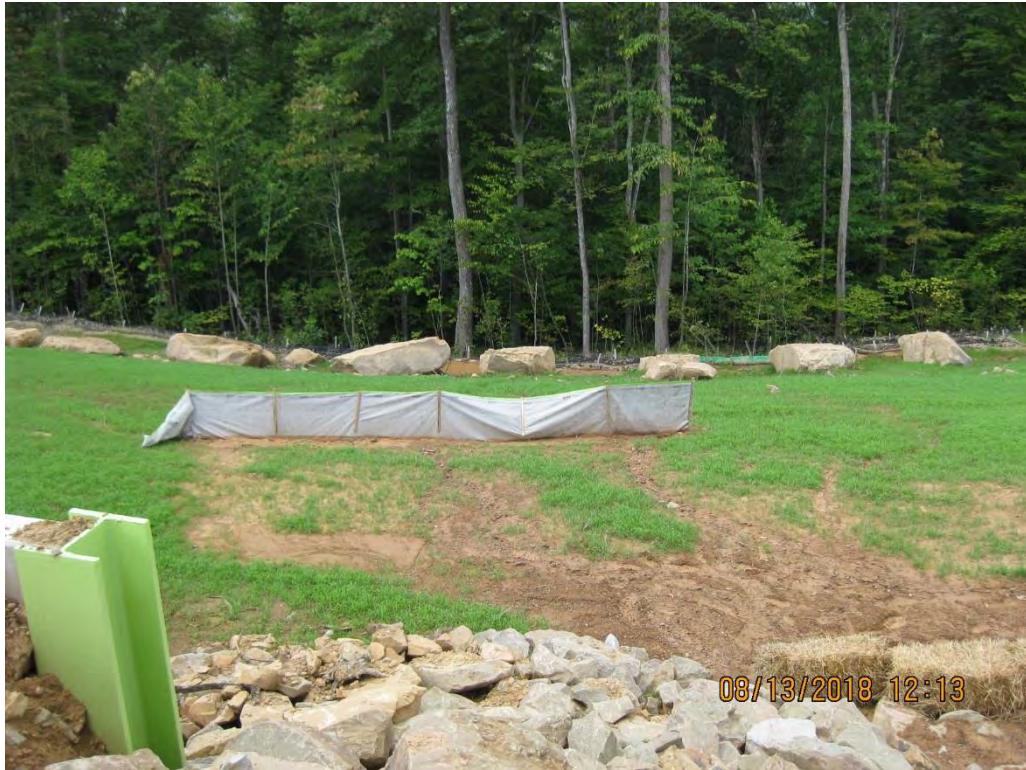
Maintenance needed for CFS at Southwest wall (marginal).

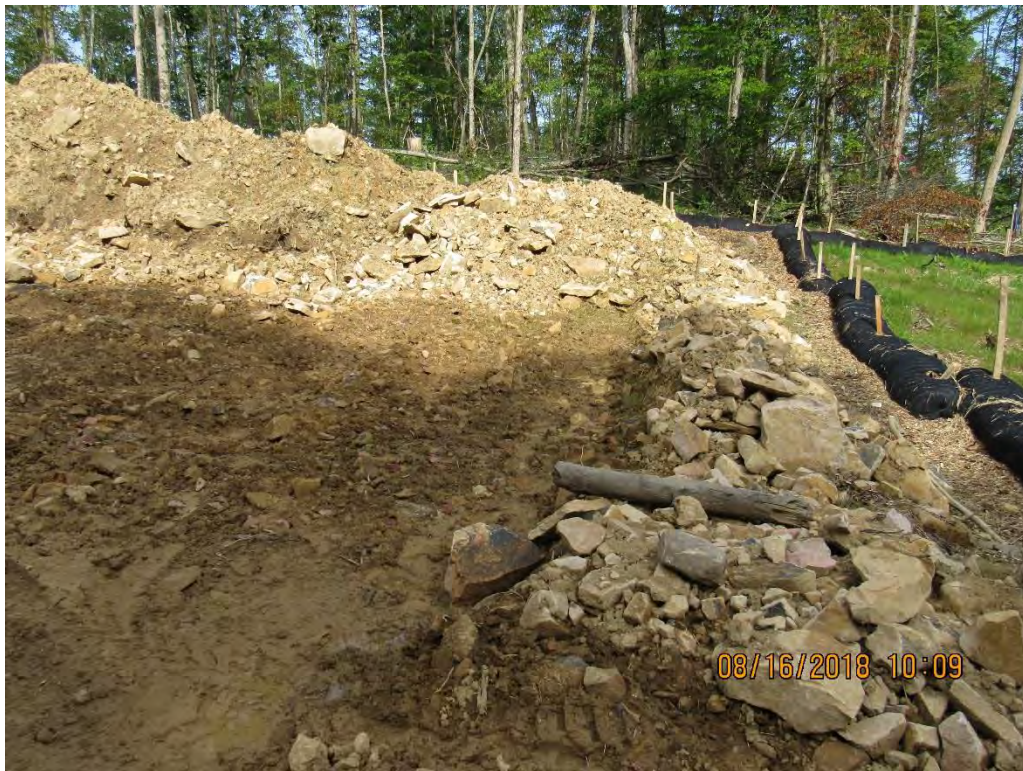
Photo 6: Western view of water bar without outlet near Bingham Road station 7450+00.

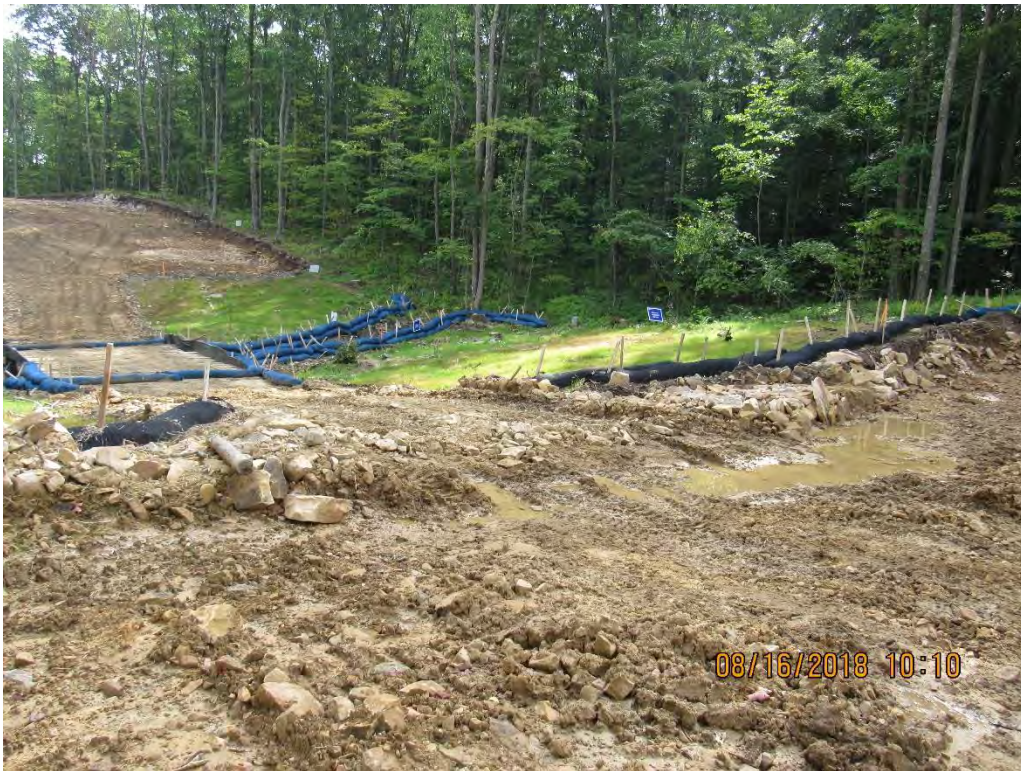
Photo 7: Middle section of water bar without outlet near Bingham Road station 7450+00.

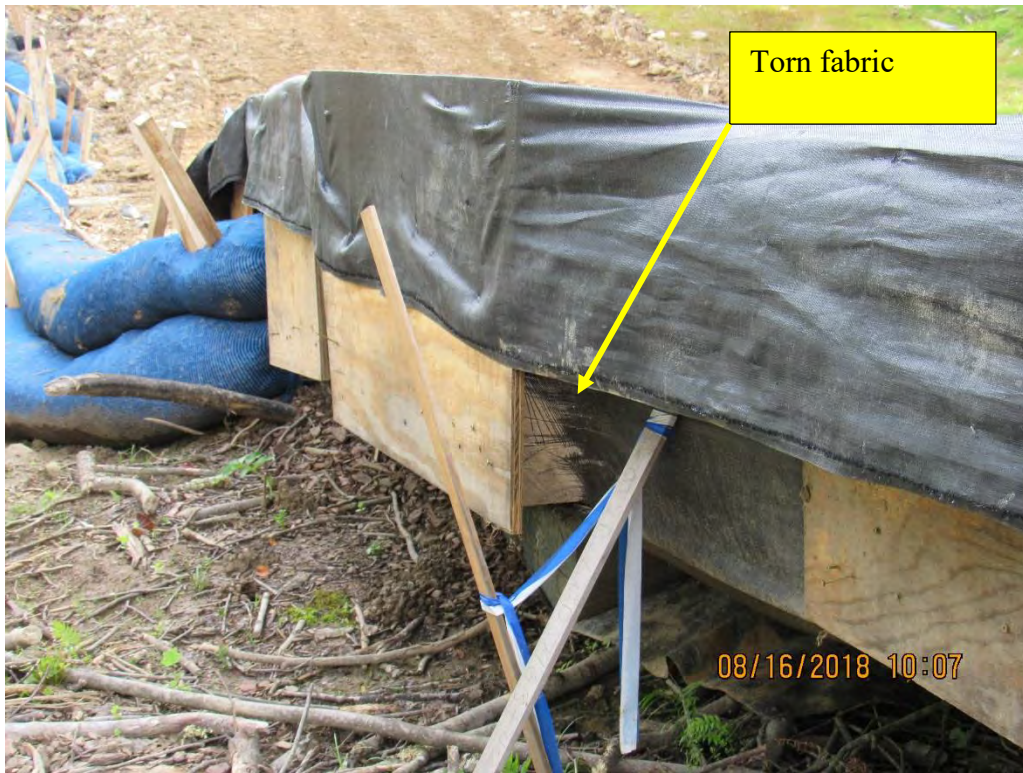
Photo 10: Exterior view of punctured fabric in Photo 9.

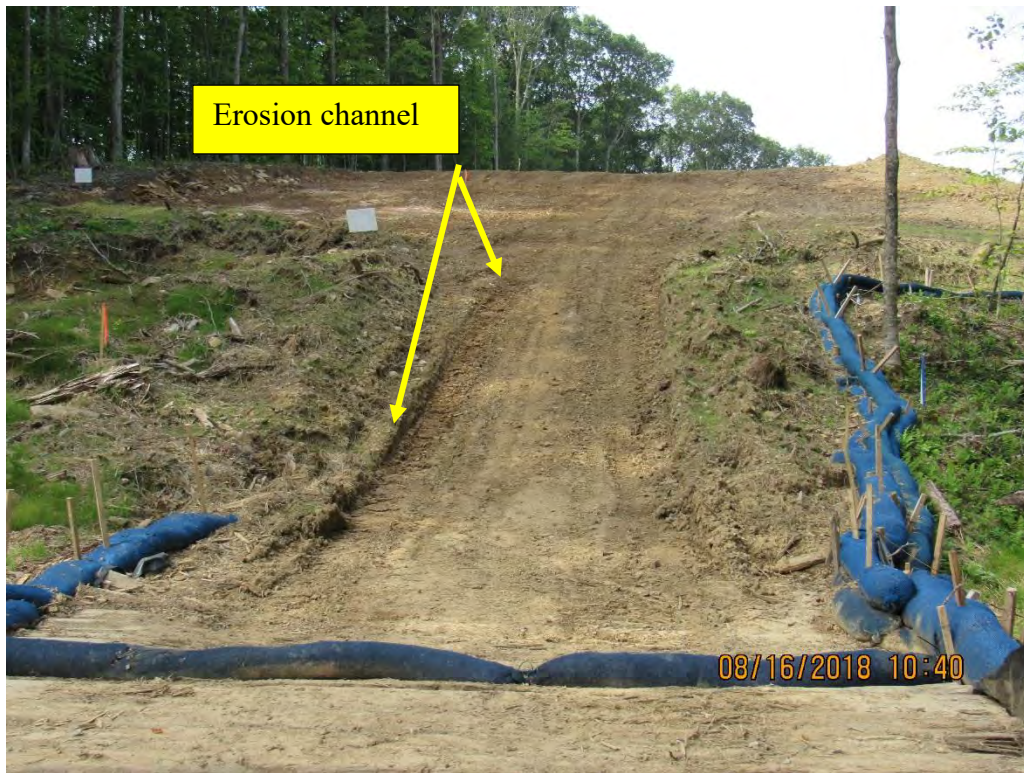
Photo11: Entrance off Bingham Road (station 7450+00) with inadequate slope breakers near stream.

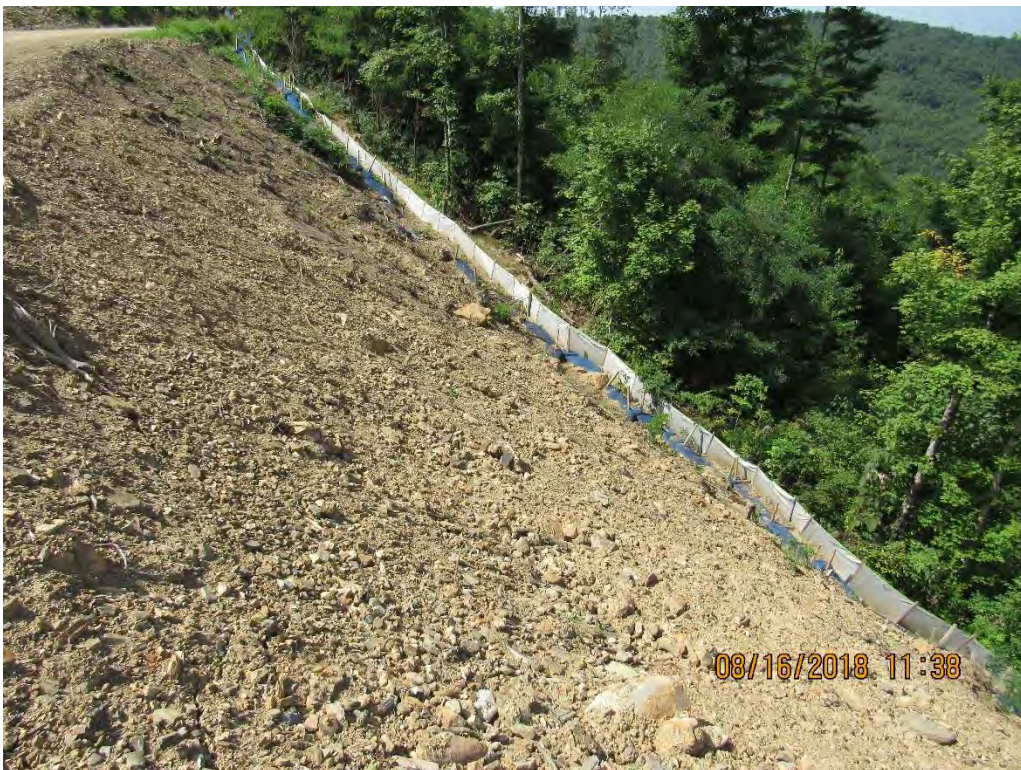
Photo 16: Southern view of Bamboo Road near Station 7158+00 without fill slope protection and temporary stabilization.

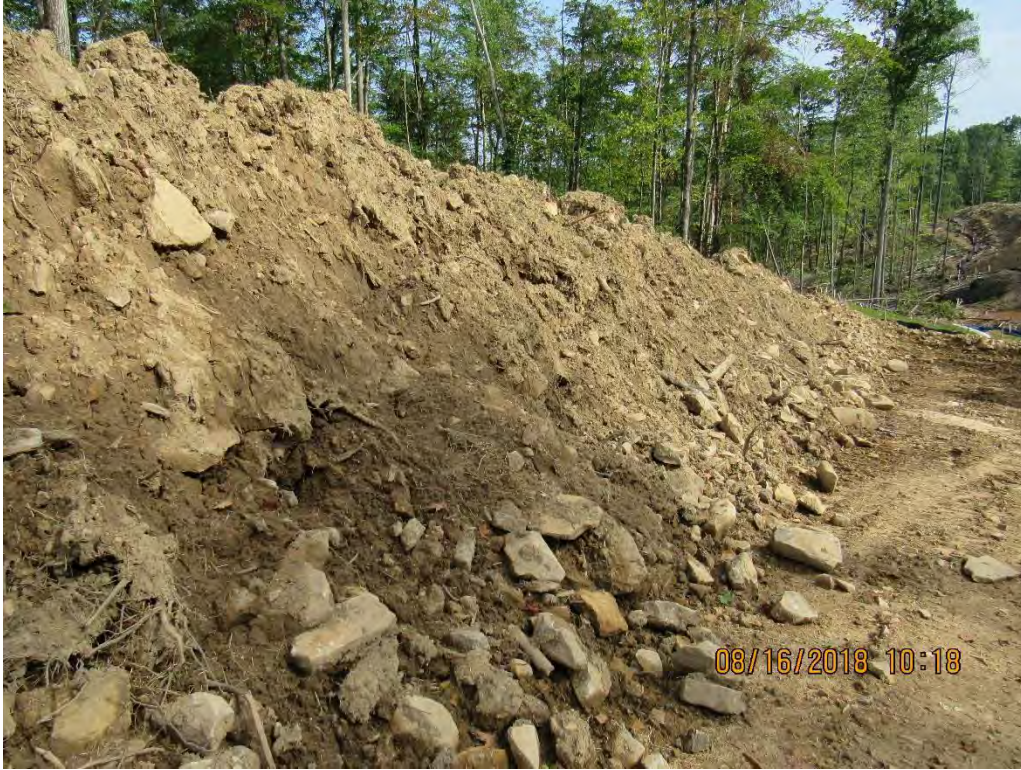
Photo 19: Northern view of waste pile with inadequate stabilization. (Photo taken near Bingham Road station 7450+00)

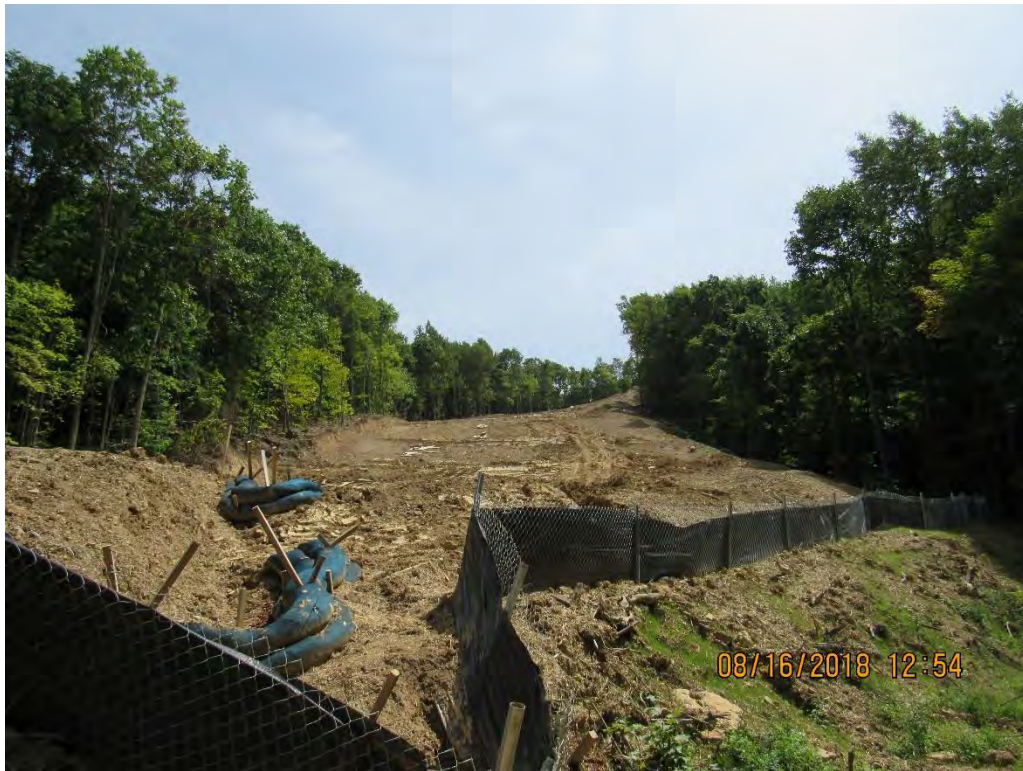
- 6, 7, 13, 15, 19, & 21. – Right of Way (ROW) stations 7079+00 to 7093+50 slope lacks adequate number of water bars, installed water bars continue to fail (Photos 21 & 22). Terminus of water bar at base of slope (station 7084+00) is allowing sediment laden water to leave the site via road side ditch and installed culvert connected to WV State Road 17/4 (SR) culvert (Photos 23-30).

Photo 21: ROW slope between stations 7084+00- 7093+50 with inadequate number of water bars.

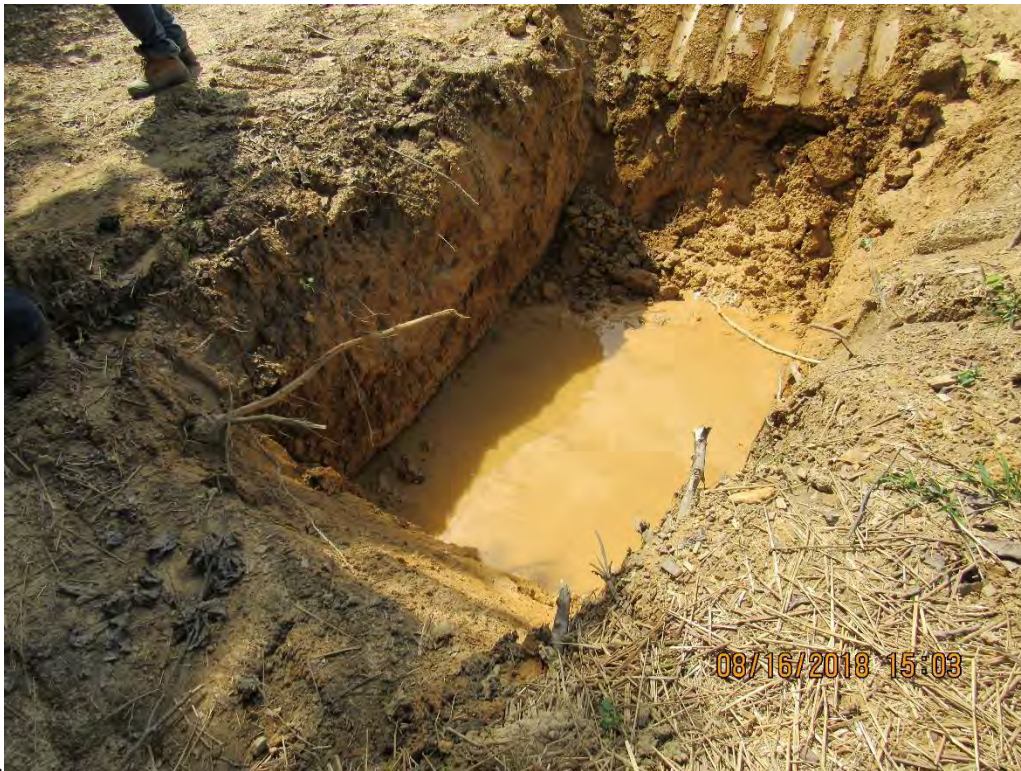
Photo 33: Recommended installation of safety fence around sumps near Wahoo Road station 6781+51.

- Wahoo Road (Station 6781+51)- location of control failure leading to NOV# W18-52-004-CP. Sumps added to terminus of water bars. Per EI Cheek, installed sumps have not failed with recent rain events. (Photos 31 & 32)
- Recommendations:
 - Station 6781+51 (Wahoo Road)- add safety fencing to installed sump (Photo 33).
 - Station 6968-6978+70- add additional water bars to slope.
 - Station 6978+70- Lengthen "J" hooks at base of pipe slope drains. (Photo 34)
 - Station 7232+00- add additional control to bridge adjacent to wetland. (Photo 35)

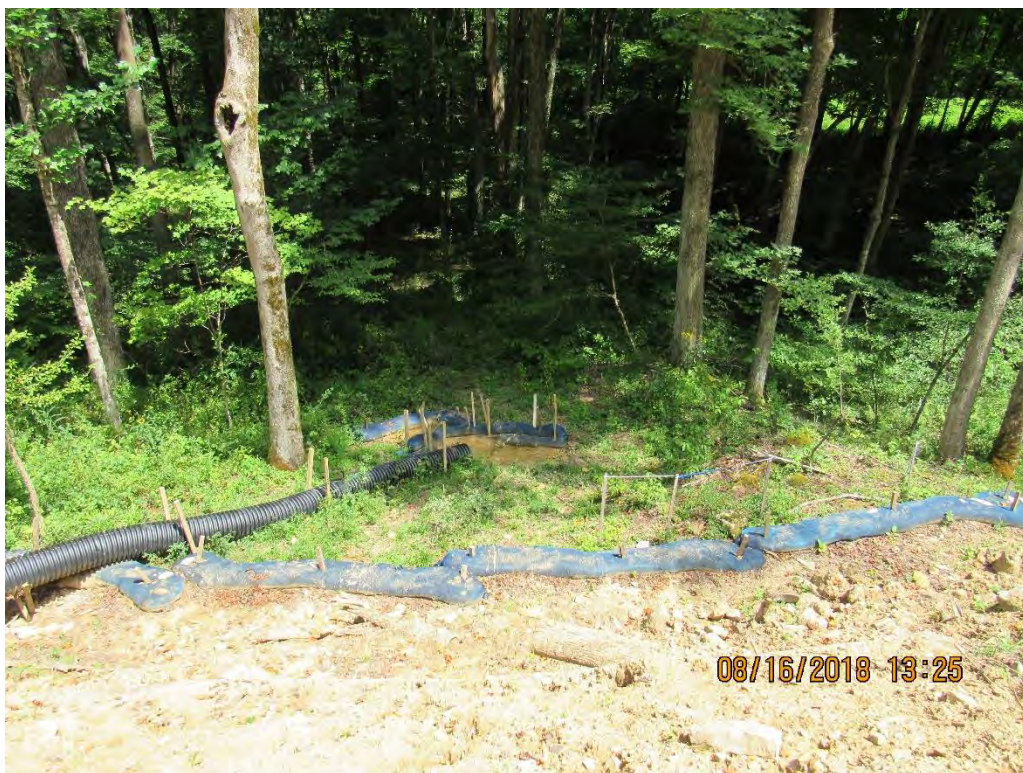
Photo 34: Recommended to lengthen 'J' hooks at end of pipe slope drains at station 6978+70.

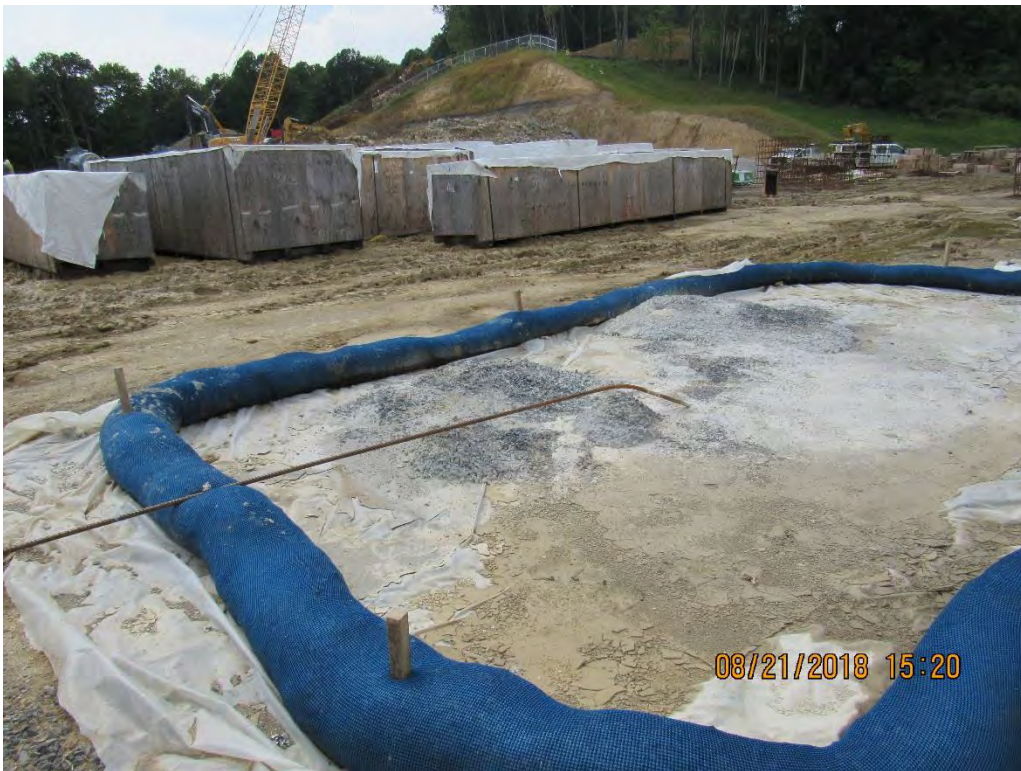
- 6. & 15.- Under drains outlets were not completed during install at last inspection. Notated to finish installation in report. Installation remains unfinished (Photos 1 & 2).
- 8. – Slope on northwestern side of site has not had re-seeding applied to areas without growth. (Photos 3 & 4). Middle of slope has good vegetative growth. Re-seeding was completed by hand at locations on fill slopes with minimal growth noted at last inspection but due to lack of sufficient rain, seed has not begun to grow (Photos 5 & 6).
- 13. & 17. Concrete wash out is filtering water instead of capturing for removal releasing water without treatment for pH adjustment. (Photos 7 & 8)

Photo 7: Improperly implemented control for concrete wash out area.

Photo 8: Improperly implemented control for concrete wash out area.

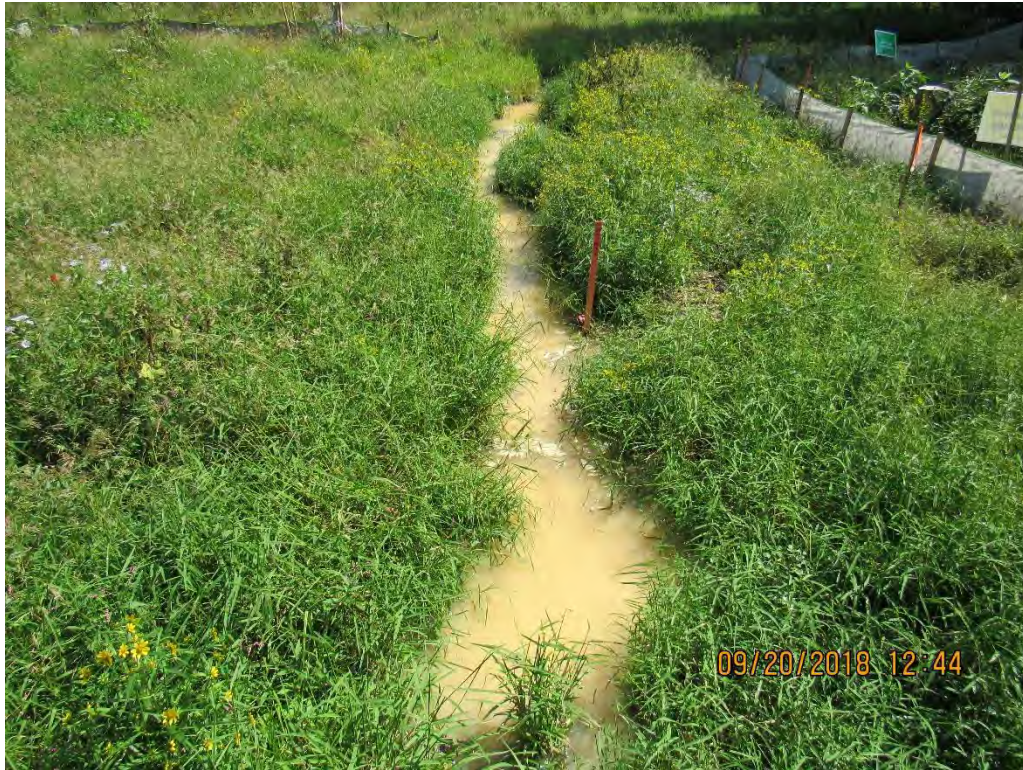
Photo 1: Plume in UNT of Painters Run from control failure off access road 231.01 near station 10270+49.

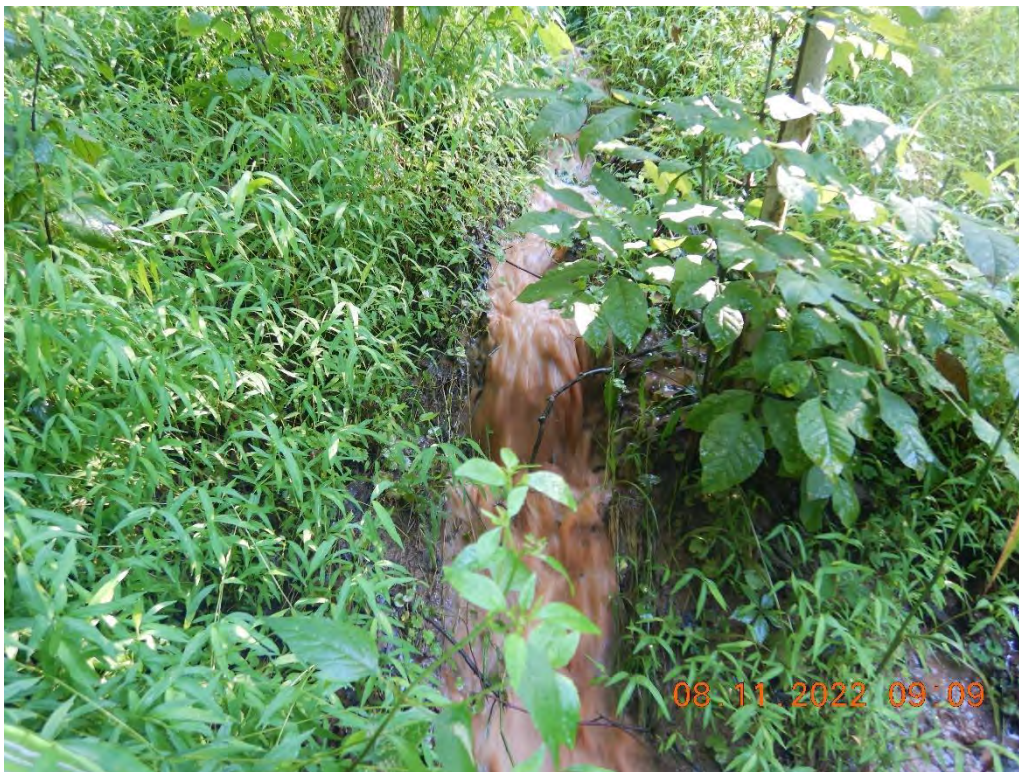
Photo # DSCN2172 – Sediment laden water flowing downhill.

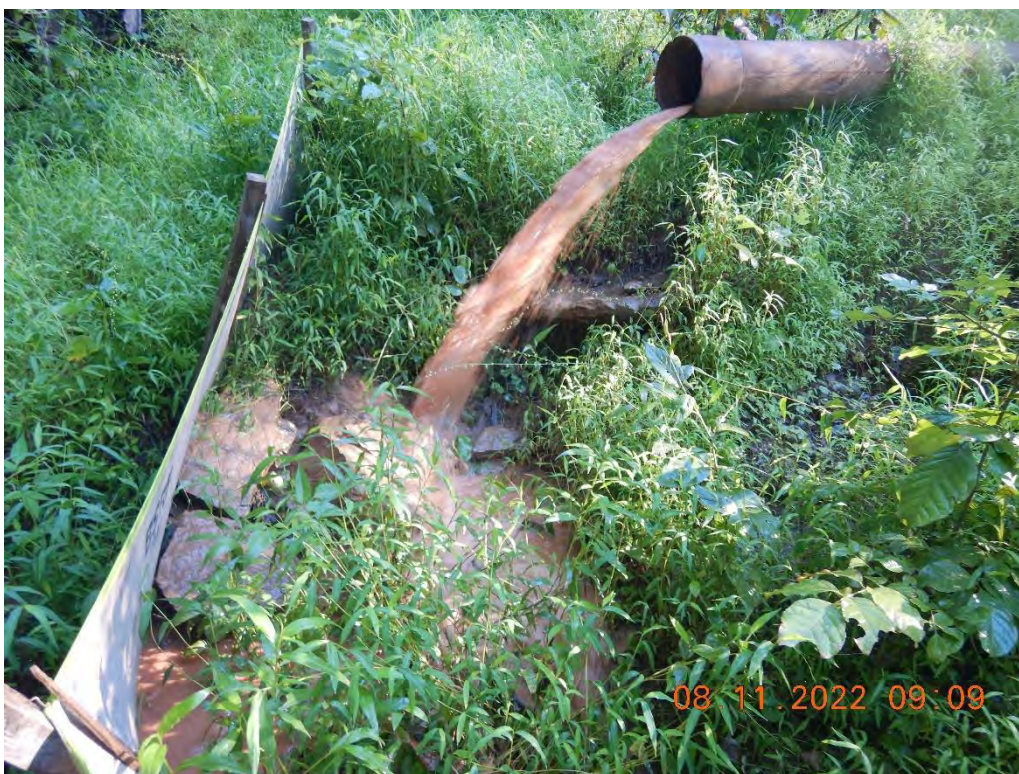
Photo # DSCN2176 – Sediment laden water discharging from the outlet end of a culvert that runs below an access road maintained by others. This sediment laden water originated from the Mountain Valley Pipeline project.

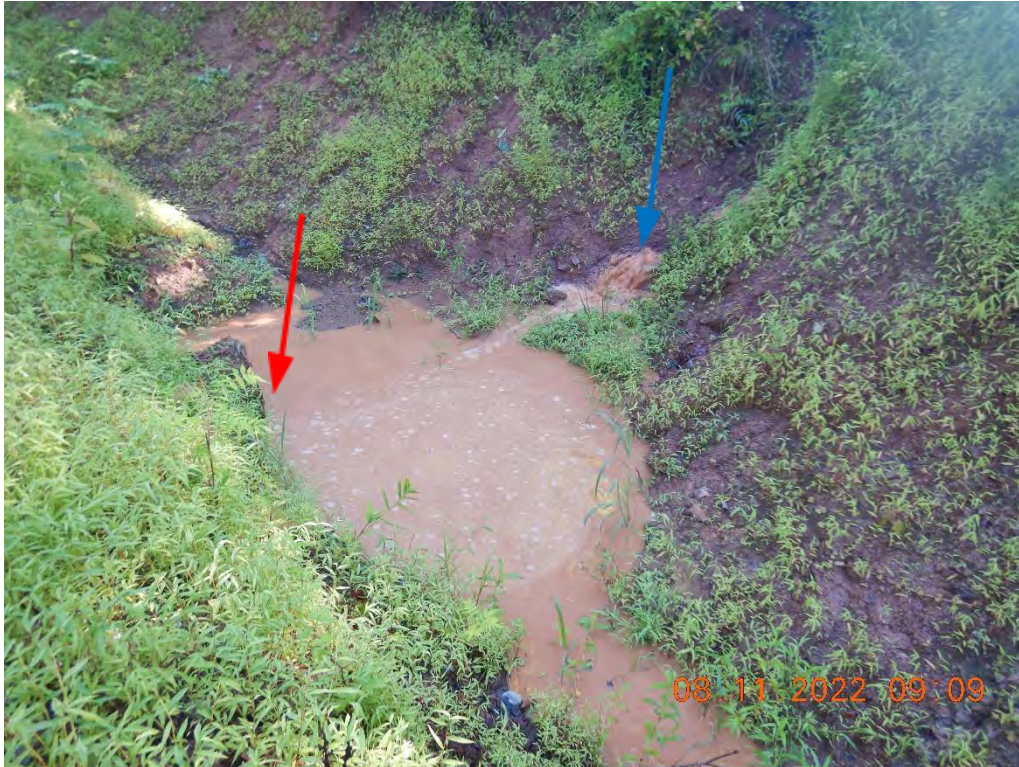
Photo # DSCN2177 – Inlet end of the culvert shown in photo DSCN2176. The culvert inlet is located near the red arrow. Sediment laden water is entering the ditch line at the blue arrow after flowing downhill from the Mountain Valley Pipeline project.

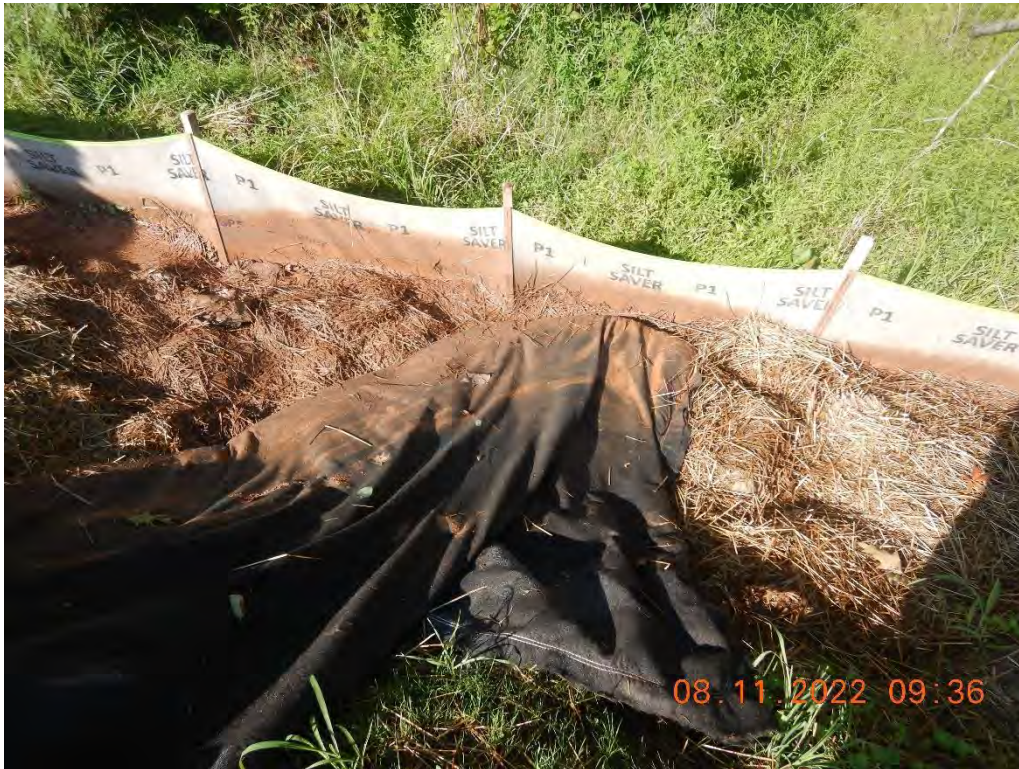
Photo # DSCN2184 – View of the filter bag after the pump had been shut down.
