**The Wilderness Society et al. Comments on the
U.S. Forest Service Mountain Valley Pipeline and
Equitrans Expansion Project Draft Supplemental
Environmental Impact Statement (#50036)**

**WEST VIRGINIA DEPARTMENT OF ENVIRONMENTAL PROTECTION
WV OIL AND GAS CONSTRUCTION STORMWATER PERMIT**

FACILITY NAME:	Mountain Valley Pipeline Project			REG. #	EXPIRE DATE:
PERMITTEE	MOUNTAIN VALLEY PIPELINE, LLC			WVR310667	5/13/2018
ADDRESS/PHONE:	Attn: Matt Hoover 625 LIBERTY AVE, ST 1700 PITTSBURGH, PA 15222				
LOCATION:	Wileyville, WV			Entry Date/Time:	4/3/18 8:30am
COUNTY:	Wetzel			Exit Date/Time:	4/3/18 1:37pm
Site Representative /Phone	Matt Hoover Sr. Environmental Coordinator (412) 258-5627			PHOTOS <input checked="" type="checkbox"/>	
CO-PERMITTEE:				ADDRESS:	
SITE OPERATOR:	Precision Pipeline			ADDRESS:	
PERMITTED ACREAGE	4214	WEATHER:	Rain	LAST INSPECTION:	N/A
RECEIVING STREAM(S)	Mobley Run > Ohio River				NOV: 1
Regular Mail <input type="checkbox"/> Certified Mail <input checked="" type="checkbox"/>	Tracking #				
OVERALL FACILITY RATING:	Unsatisfactory		COMPLIANCE OUTCOME	Not Immediately Corrected

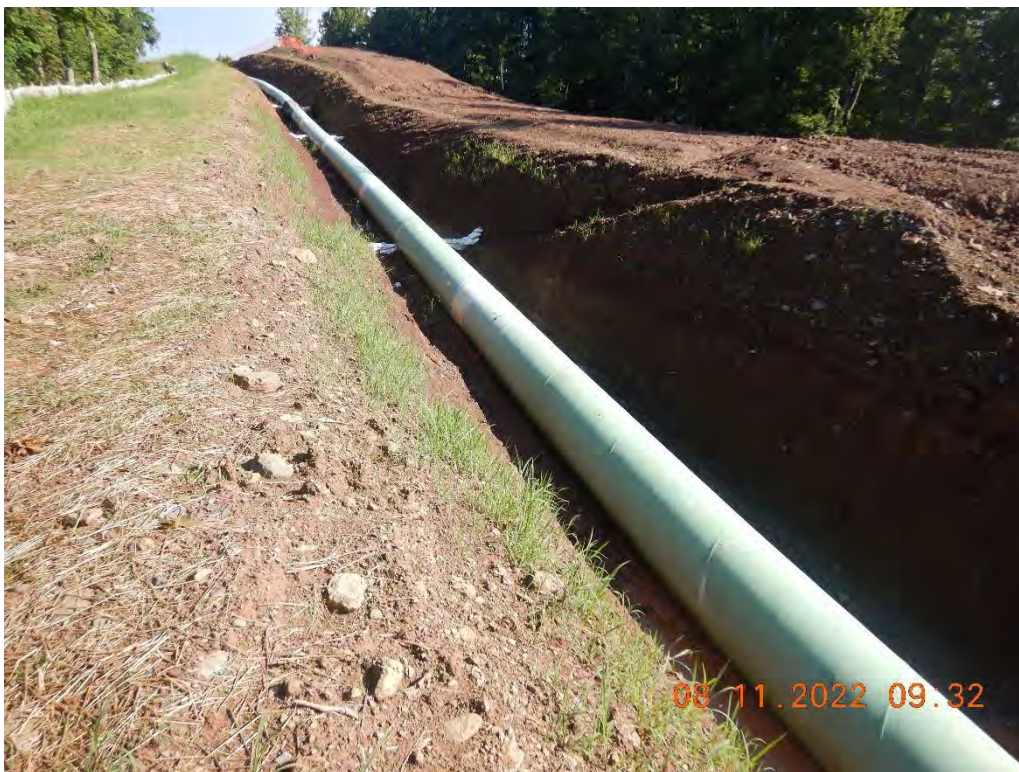
Photo # DSCN2183 – View of the open trench directly to the north of the low spot where accumulated water was being evacuated from the trench.

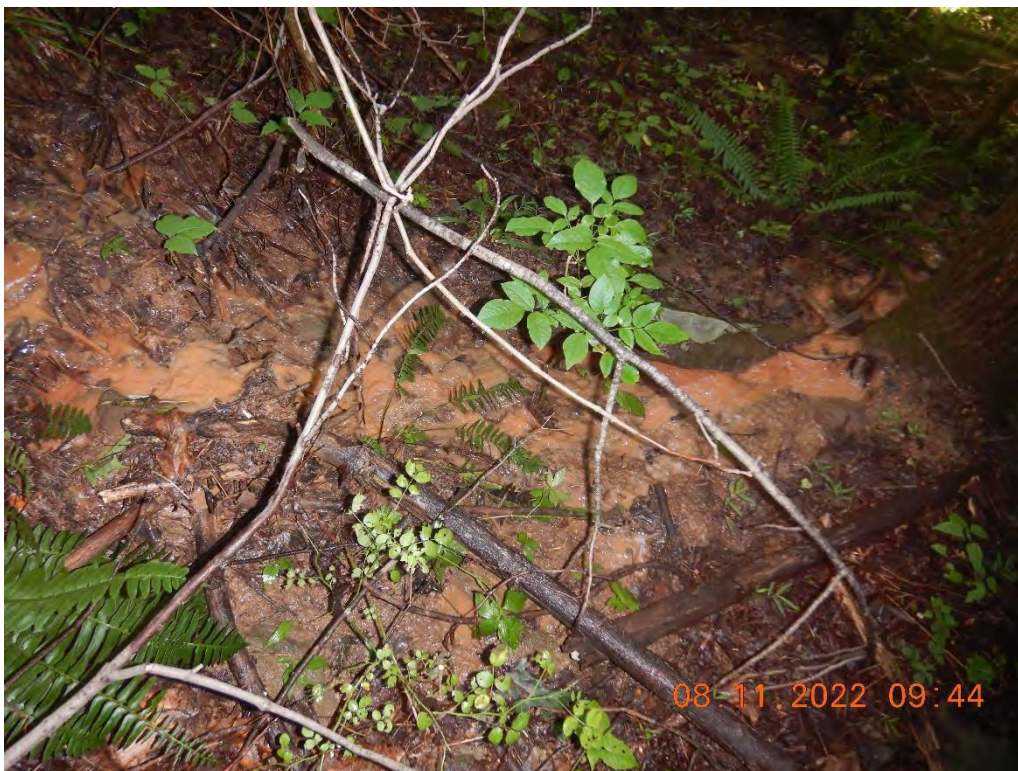
Photo # DSCN2191 – Sediment laden water offsite at or near coordinates 39°6331' X -80°31.2333'.

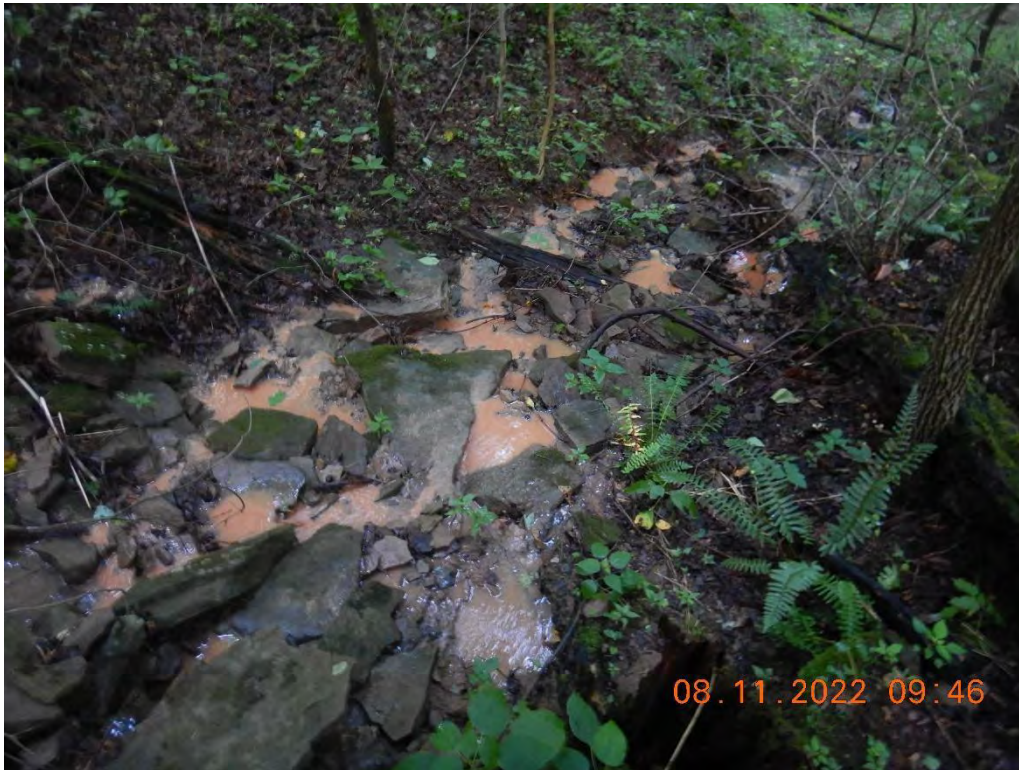
(20) Sediment laden water that was being discharged offsite flowed downgrade for several hundred feet prior to entering the head of an unnamed tributary of Stout Run and thereby creating Conditions Not Allowable (CNA) in the form of distinctly visible settleable solids at or near coordinates 39°29.6184' X -80°31.2514'. CNA was observed farther downstream at or near coordinates 39°29.6123' X -80°31.2753.

Photo # DSCN2194 – Sediment laden water that originated from the Mountain Valley Pipeline project entering the head of an unnamed tributary of Stout Run at or near coordinates 39°29.6184' X -80°31.2514'.

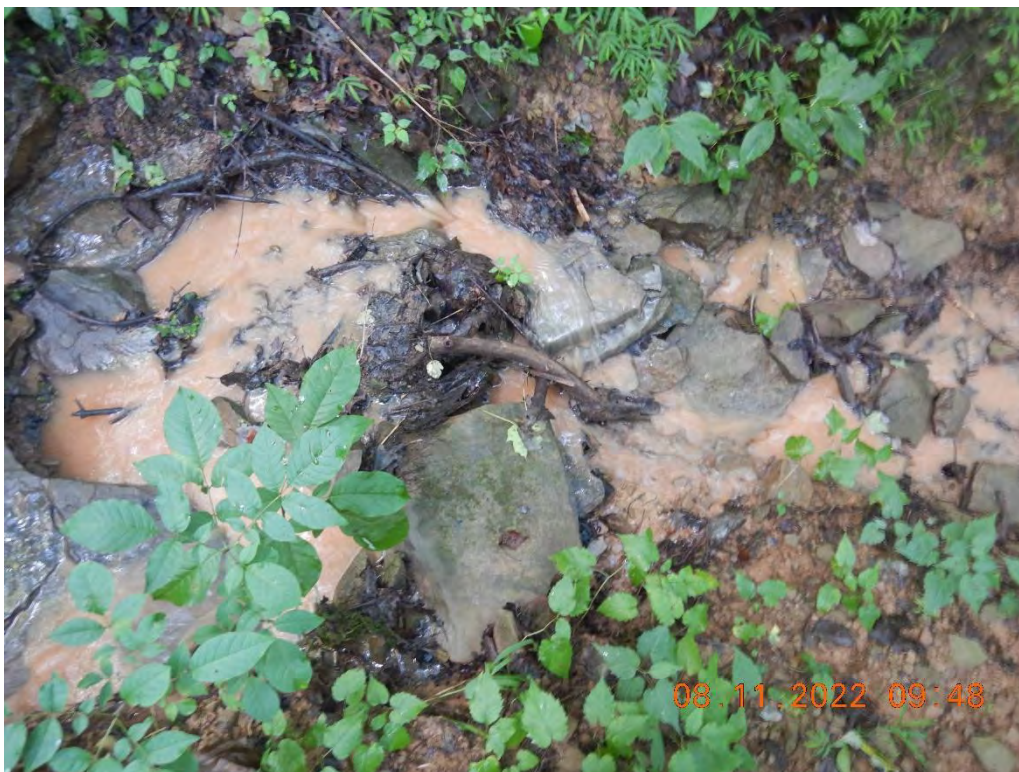
Photo # DSCN2199 – Sediment laden water flowing an unnamed tributary of Stout Run at or near coordinates 39°29.6123' X -80°31.2753.
